Nature Pools

Noosa Blue Resort

Pool Shell GPR and Strength Assessment

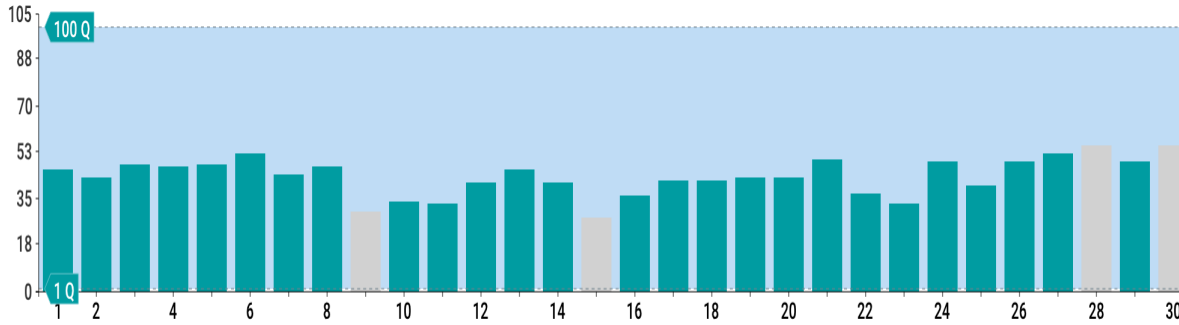
Measurement Bar Graph

A total of twenty-six valid rebound readings were recorded with an average rebound value of 43.5 Q and a standard deviation of 5.6 Q.

Lower rebound values recorded during testing were typically associated with impacts on the exposed pebblecrete aggregate finish. When testing was conducted on areas of exposed concrete paste, rebound values were consistently higher, generally ranging between 50 Q and 60 Q, indicating a relatively hard concrete matrix.

Based on typical correlations between rebound number and compressive strength, the results are consistent with concrete that is likely to meet or exceed the project target strength of 25 MPa, and potentially within the range of **30 MPa to 40 MPa equivalent compressive strength**.

Readings 26
 Average 43.5 Q
 Standard deviation 5.6 Q

Minimum	33 Q
Maximum	52 Q
Range	19 Q
Relative Span	43.5%

Rebound hammer testing provides an indicative measure of surface hardness only and cannot be used as a definitive determination of compressive strength. Confirmation of in situ compressive strength would require extraction and laboratory testing of concrete core samples.
