Concrete Slab and Moisture Ingress Investigation

55/25 Corella Road, Gympie QLD

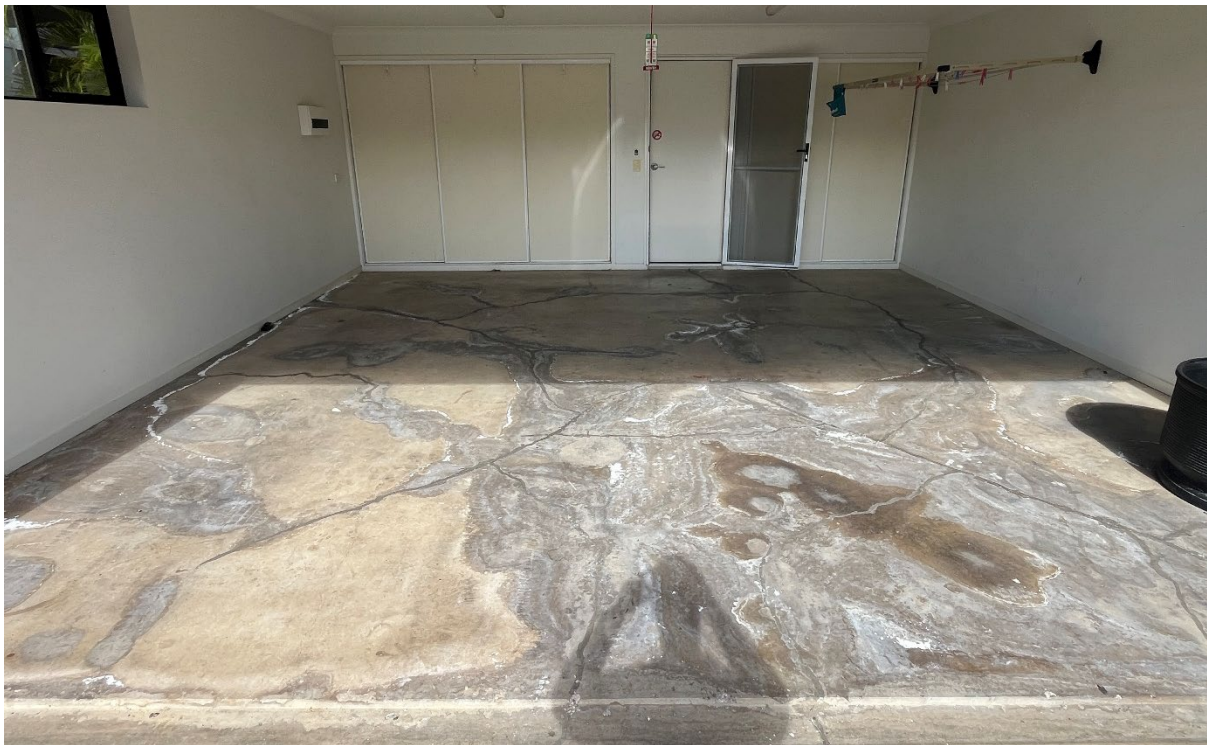
Extensive efflorescence was present across the slab surface, particularly concentrated along crack lines and at slab perimeter locations. The distribution of salt deposits was non-random and consistent with active moisture migration through the slab, with moisture evaporating at the surface and leaving behind soluble salts.

Surface staining and darkened zones were observed across the slab, frequently aligned with cracking. The cracking pattern was extensive and interconnected, forming a network of pathways across the slab. The cracks varied in width and orientation and did not exhibit characteristics typical of reinforcement corrosion, instead suggesting movement-related distress.

Figure 1: Figure 1 represents the context of the work area with severe efflorescence visible across the surface, and cracking suggestive of subgrade movement or degradation.

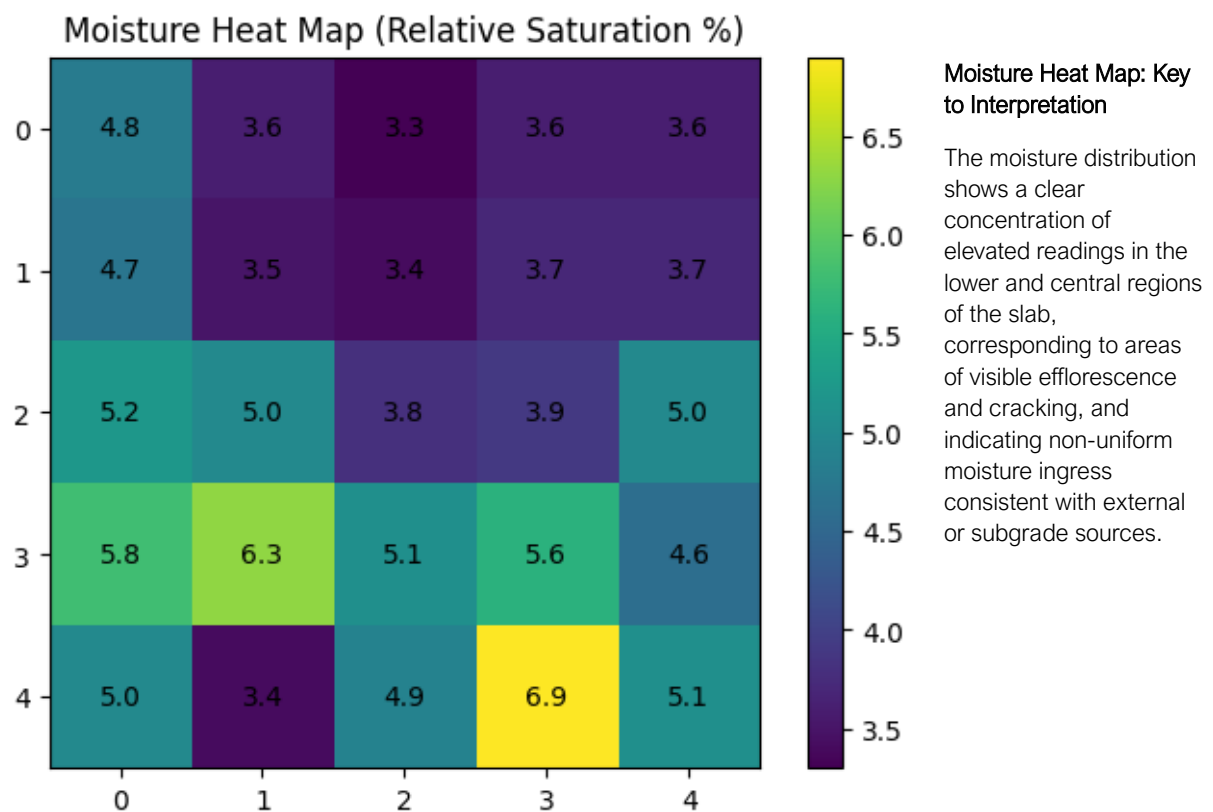
Surface moisture mapping undertaken using impedance testing recorded elevated moisture levels across the slab. Readings ranged from approximately 3.3% to 6.9%, with the highest values consistently recorded in areas exhibiting visible efflorescence and cracking. This correlation indicates that moisture is preferentially migrating through these zones.

Figure 2: Moisture heat map with values indicating relative saturation across the slab.

The distribution of moisture, as confirmed through impedance testing, closely correlates with areas of visible efflorescence and cracking. Elevated moisture readings across the slab, particularly in the mid- to lower-region of the test grid, indicate that the slab is subject to persistent moisture exposure rather than intermittent surface wetting. This pattern is consistent with moisture originating from the subgrade or from external sources adjacent to the slab.

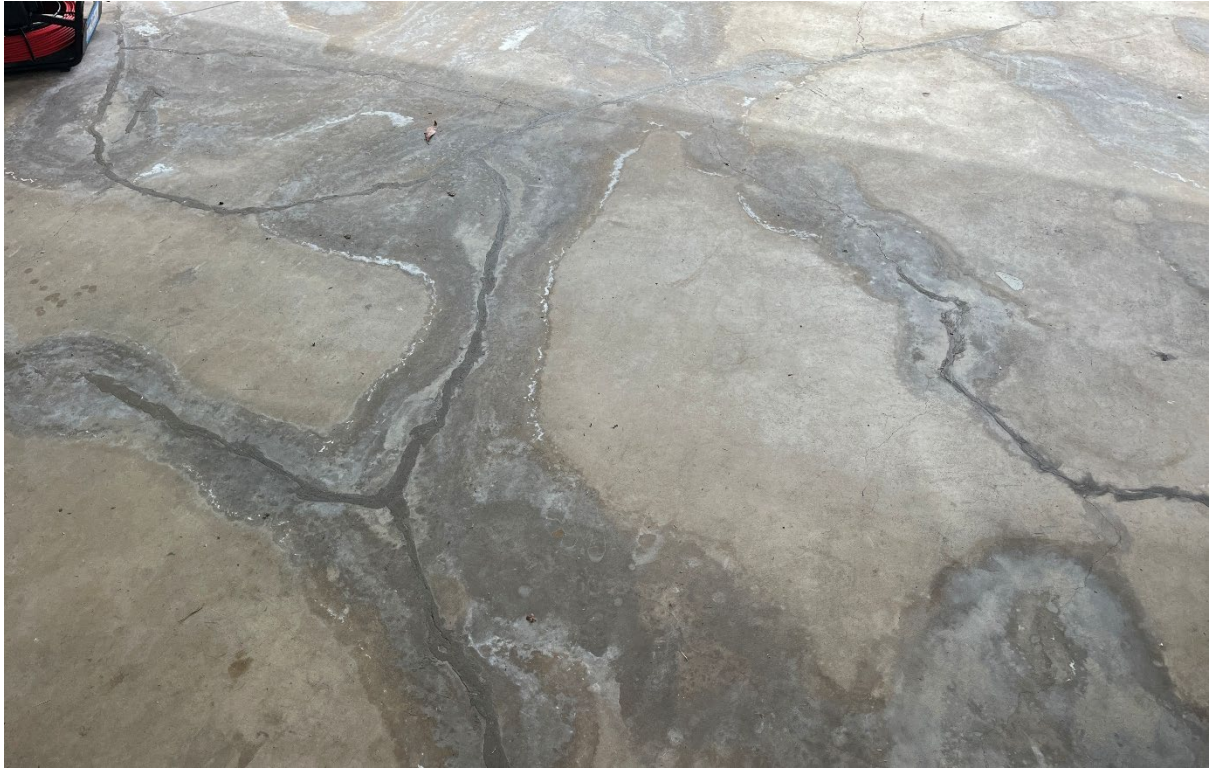
Figure 3: Figure 3 shows a close-up of the efflorescence and cracking pattern, which, due to its non-longitudinal nature, appears to indicate subgrade movement as a cause.

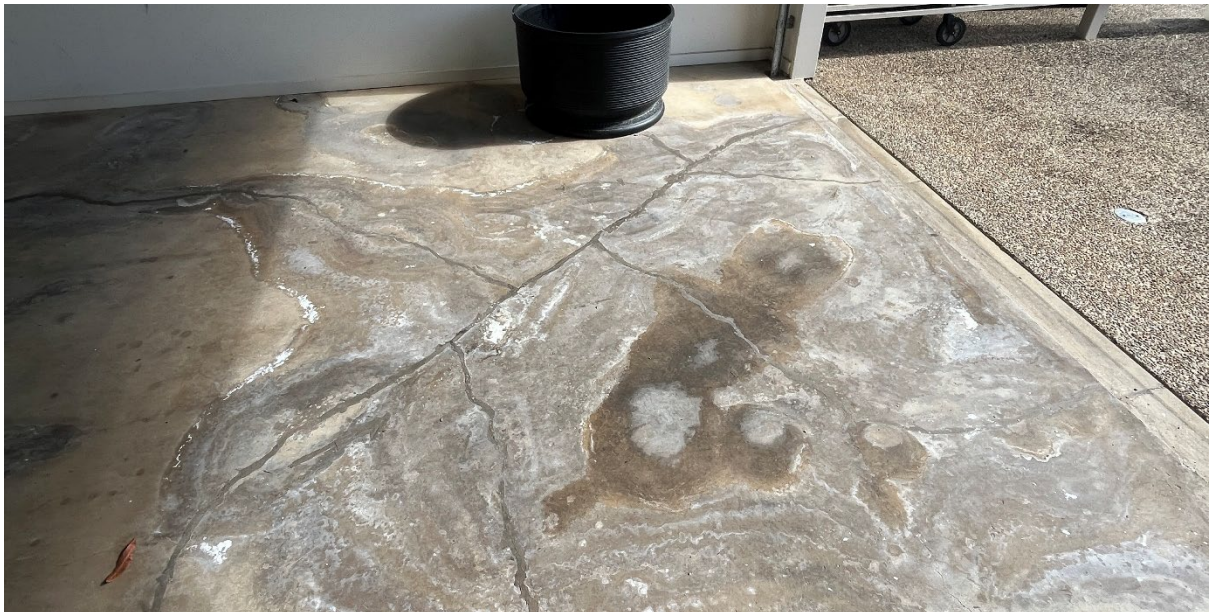
Figure 4: Figure 4 shows a localised area of surface moisture accumulation and staining, characterised by darker discolouration and associated efflorescence. The irregular shape and diffuse boundaries of the wet patch are consistent with moisture migrating through the slab rather than originating from a surface spill or isolated event.

The location of the wetting aligns with surrounding cracking and areas of elevated moisture readings, suggesting that moisture is being transmitted through the slab via preferential pathways. This behaviour is consistent with sustained moisture ingress from the subgrade or adjacent ground conditions.

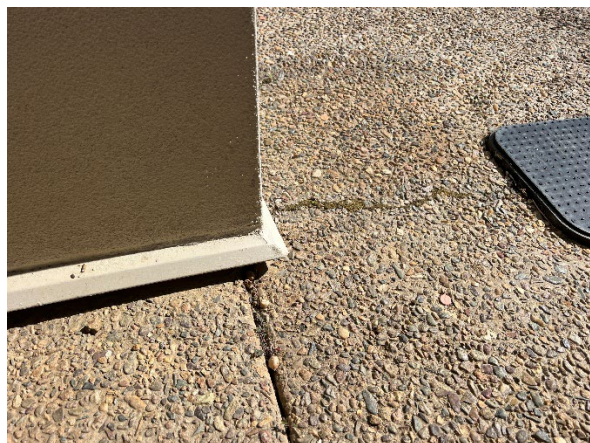
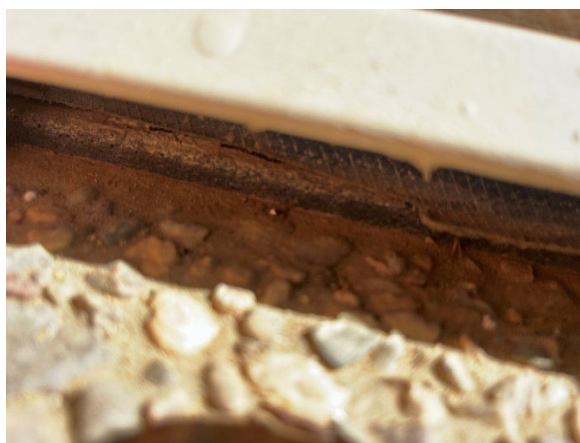
Figures 5 and 6: Figures 5 and 6 illustrate separation and displacement along the slab edge, consistent with differential movement between the slab and adjacent ground. These conditions indicate subgrade instability or loss of support at the slab perimeter.

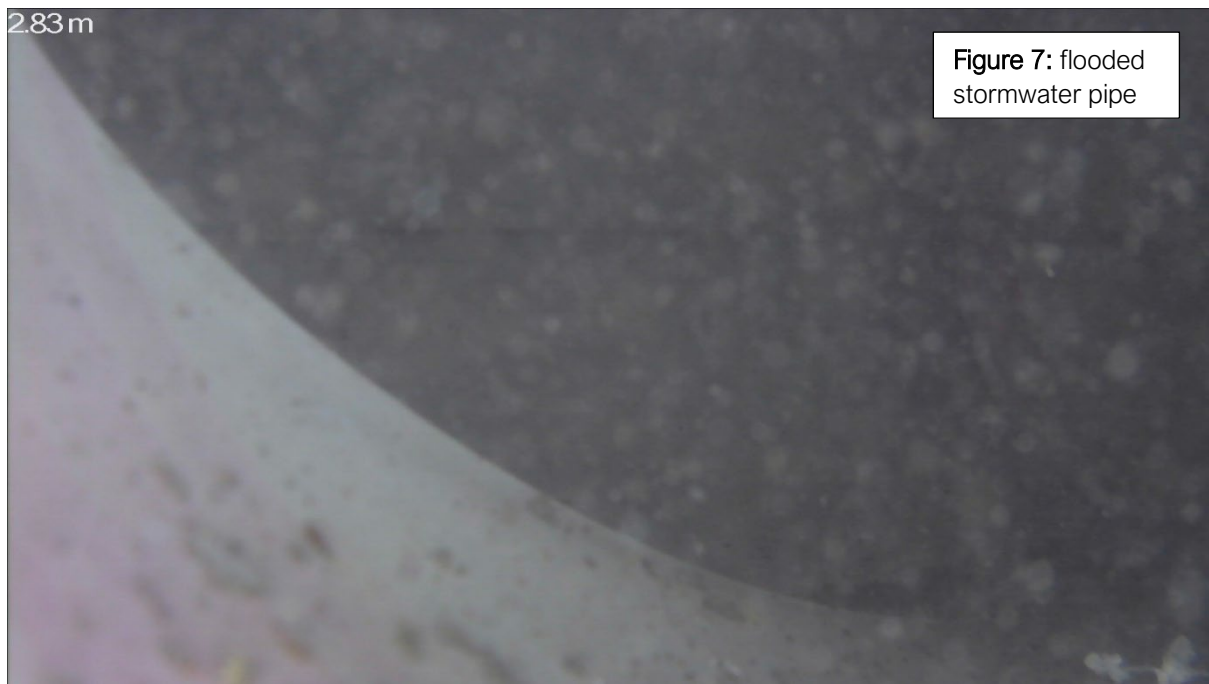
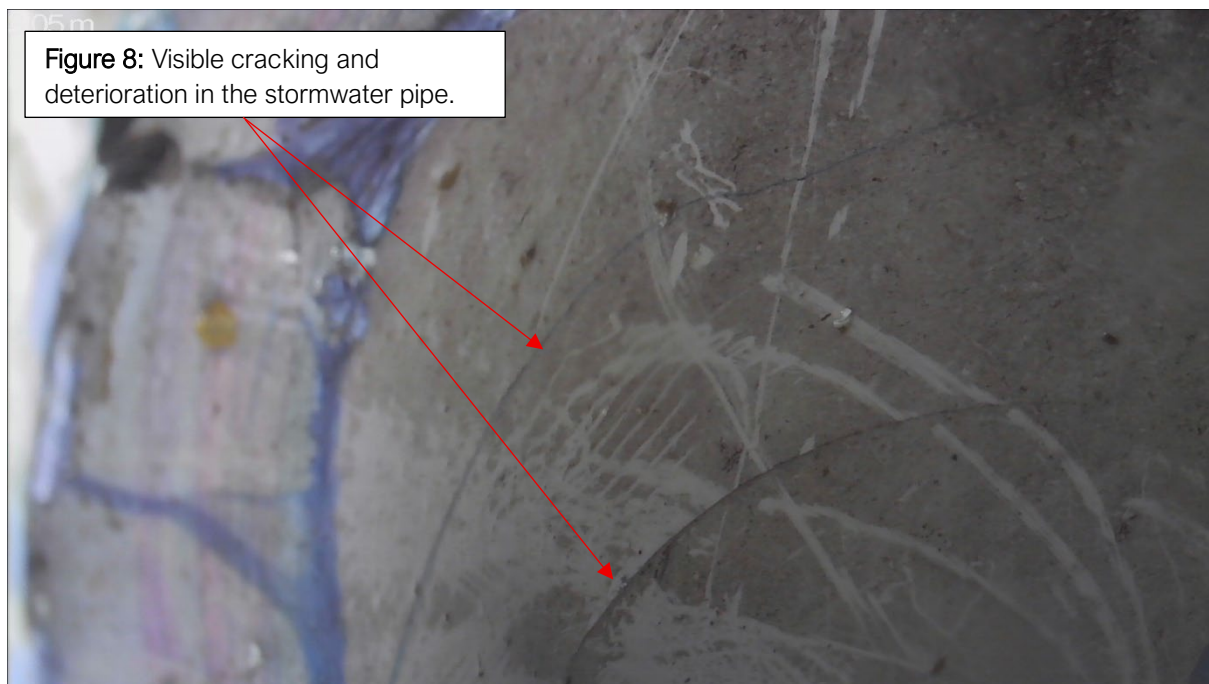
A CCTV inspection of the stormwater downpipe revealed standing water, confirming that the system is not freely draining. Cracking within the pipe was also observed. These conditions indicate that stormwater is likely not being effectively conveyed away from the structure and may instead be discharging into the surrounding soil.

The presence of a flooded and compromised stormwater system represents a significant source of ongoing moisture input into the subgrade. Over time, this can lead to soil softening, localised erosion or washout, and the development of voids beneath the slab.

Figures 7 and 8: Figures 7 and 8 illustrate the internal condition of the stormwater line. Figure 7 confirms the presence of standing water within the pipe, indicating inadequate drainage. Figure 8 shows hairline cracking along the pipe wall, which is likely to permit leakage into the surrounding subgrade and contribute to localised soil saturation.

1. Stormwater System Rectification

A licensed drainage contractor should be engaged to conduct a detailed inspection and rectify the stormwater system.

The CCTV inspection confirmed that the downpipe is holding water and has cracked, indicating that the system is not functioning as intended. It is recommended that:

- The stormwater line is to be cleared, repaired, or replaced as required
- The system is confirmed to be free-flowing to a suitable discharge point
- Any damaged or leaking sections should be rectified to prevent the discharge of water into the surrounding subgrade

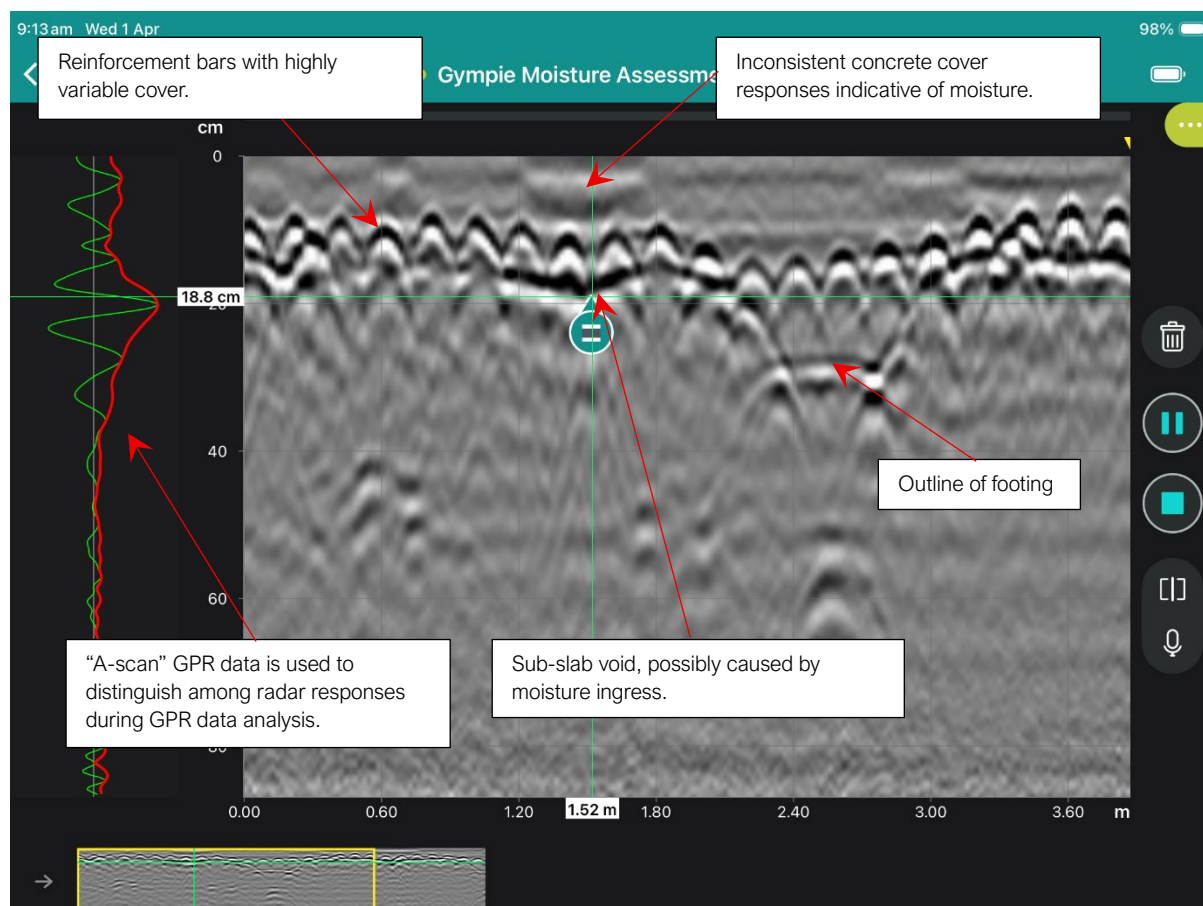
Ground-penetrating radar assessment identified variability in reinforcement cover across the slab, with measured cover ranging from approximately 50 mm to 150 mm. This level of variability suggests inconsistent slab construction and contributes to differential moisture behaviour within the slab.

In addition, GPR data identified anomalous responses within the upper slab zone, indicating localised changes in material properties, potentially associated with moisture variation or heterogeneity within the concrete matrix. Subsurface anomalies consistent with localised voiding or loss of support beneath the slab were also identified. These findings suggest that the slab is not uniformly supported and may have experienced differential movement over time.

Figure 9: Figure 9 depicts representative GPR B-scan data collected across the slab. The upper portion of the scans shows reinforcement with highly variable cover, generally ranging between approximately 50 mm and 150 mm, indicating inconsistent placement or variable slab thickness.

Notably, the near-surface zone exhibits areas of disrupted, irregular signal response, characterised by reduced continuity and localised scattering. This behaviour is consistent with changes in material properties within the slab, which may be associated with moisture, variable concrete quality, or localised deterioration.

At greater depths, localised anomalies are observed as hyperbolic reflections and zones of signal disturbance beneath the slab. These features indicate subsurface irregularities and are consistent with potential voiding or loss of support within the subgrade.

4. Subgrade and Slab Support Assessment

A geotechnical or structural assessment is recommended to further evaluate the condition of the founding soils and slab support.

- investigation of subgrade moisture conditions
- verification of potential voiding beneath the slab
- assessment of differential settlement across the slab

Where voiding or loss of support is confirmed, remedial measures such as pressure grouting or slab stabilisation may be required.
