# SOUTH-EAST SCANNING

## GPR Scanning and Moisture Assessment Report for Norfolk Island Regional Council Burnt Pine, Norfolk Island

# Executive Summary

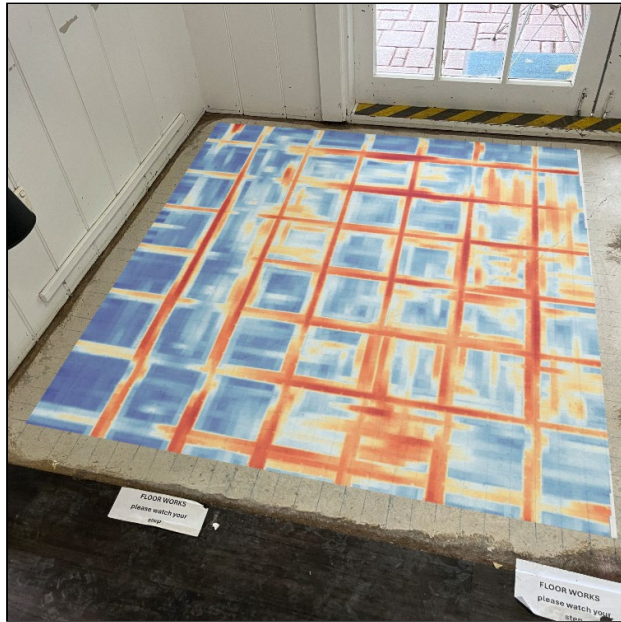
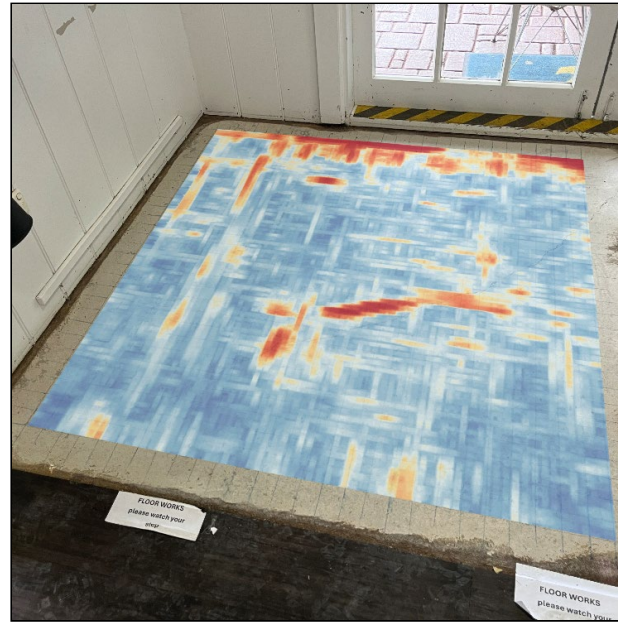
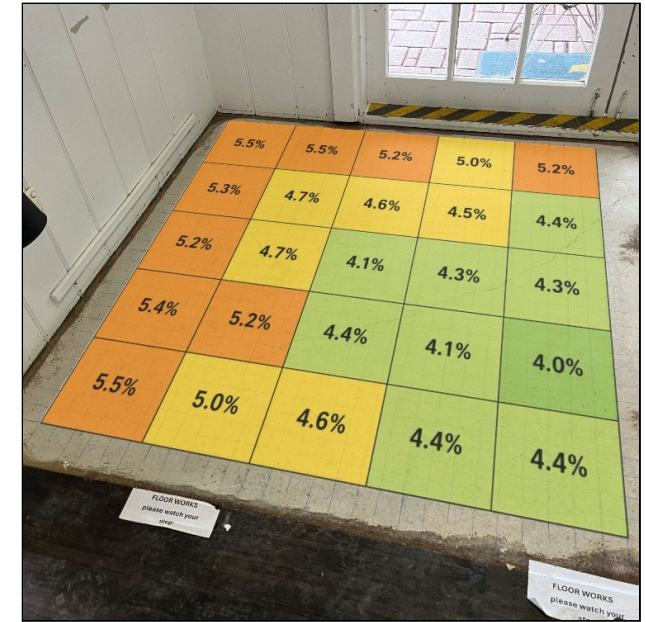
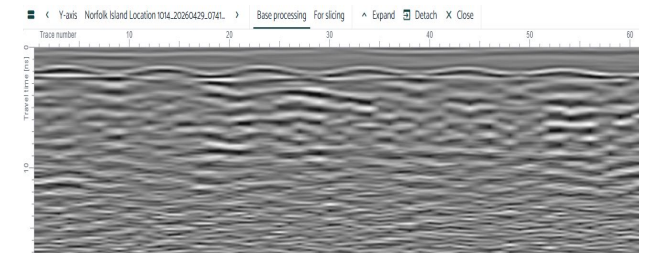
# Location 1 (Foyer Area): Data and Interpretation

Location 1 was assessed using a high-resolution grid with approximately 50 mm scan spacing. A diagonal crack was observed in the slab near the external building edge.

Moisture readings in this area ranged from approximately 4.0% to 5.5%, with higher values generally concentrated toward the perimeter. GPR data indicated reinforcement cover in the order of 100 mm to 120 mm, with minor subsurface anomalies identified. Localised responses consistent with voiding were observed, and depth-slice analysis indicated anomaly patterns aligning with the observed crack orientation.

Moisture mapping indicates a clear gradient across the slab, with elevated levels toward the external edge, consistent with lateral ingress. GPR depth slices identify localised zones of elevated response beneath the reinforcement layer, suggesting subsurface irregularities that may be associated with moisture accumulation or minor voiding.

B-scan data is diffuse and non-uniform, indicating variability within the slab and underlying subgrade. Overall, the slab does not exhibit the consistent response expected of a dry, uniform slab-on-ground system.

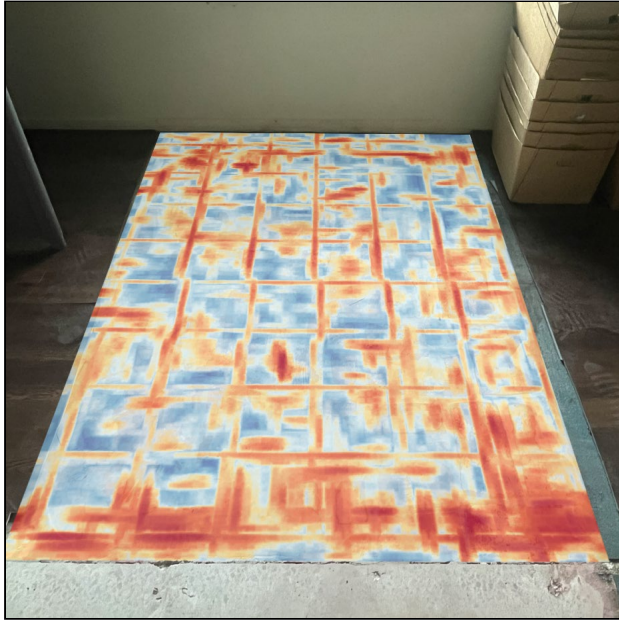
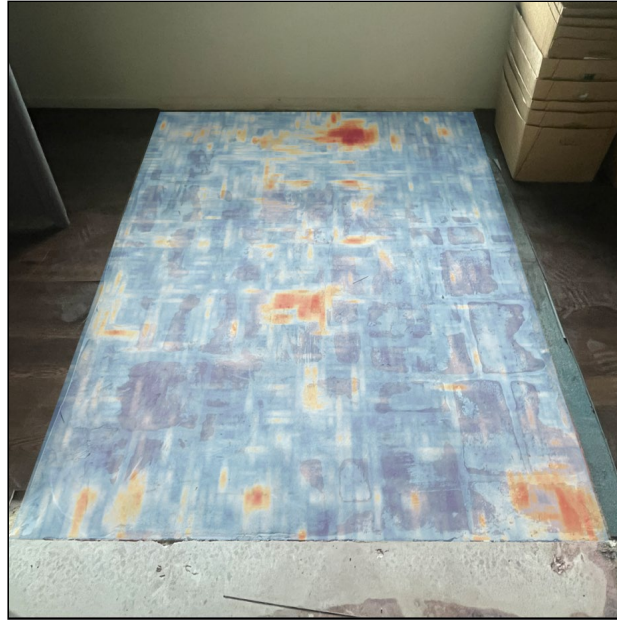
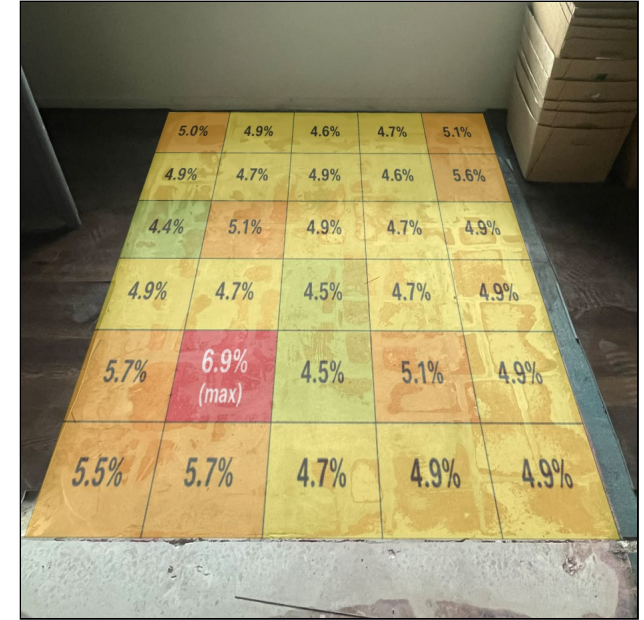
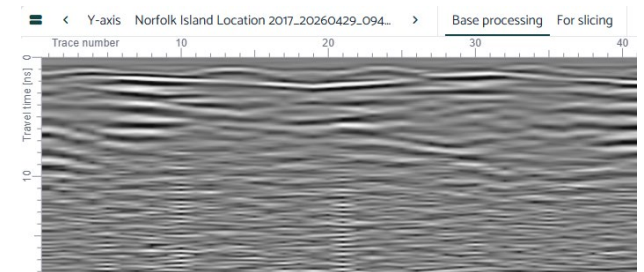
# Location 2 (Front Office): Data and Interpretation

Location 2 exhibited some of the most pronounced indicators of slab distress.

Moisture readings ranged from approximately 4.4% to 6.9%, representing the highest recorded values across all investigation areas. Longitudinal cracking was observed, and reinforcement cover was highly variable, with some areas having less than 30 mm.

GPR data was notably irregular, with poor signal clarity and strong, contrasting reflections. Subsurface responses were consistent with voiding and potential delamination effects. The slab bottom was not clearly defined in several areas, and overall data quality indicated significant material inconsistency and elevated moisture levels.

Moisture mapping identified a localised elevated moisture zone within the centre of the slab, with readings up to 6.9%. Visual inspection identified longitudinal cracking, while GPR analysis indicated very low concrete cover in some locations (<30 mm) and an irregular slab base profile. B-scan and depth-slice data exhibited diffuse reflections, bright, contrasting hyperbolas, and disrupted signal continuity, consistent with localised voiding and possible delamination beneath or within the slab system.

Overall data quality was poor due to heterogeneous subsurface conditions and signal scattering.

Targeted intrusive investigation is recommended in areas exhibiting the strongest anomalous GPR responses, particularly Locations 2, 4, and 6. This may include:

- Core drilling
- Localised breakout
- Verification of slab thickness and underside condition
- Inspection for voiding, delamination, or subgrade washout

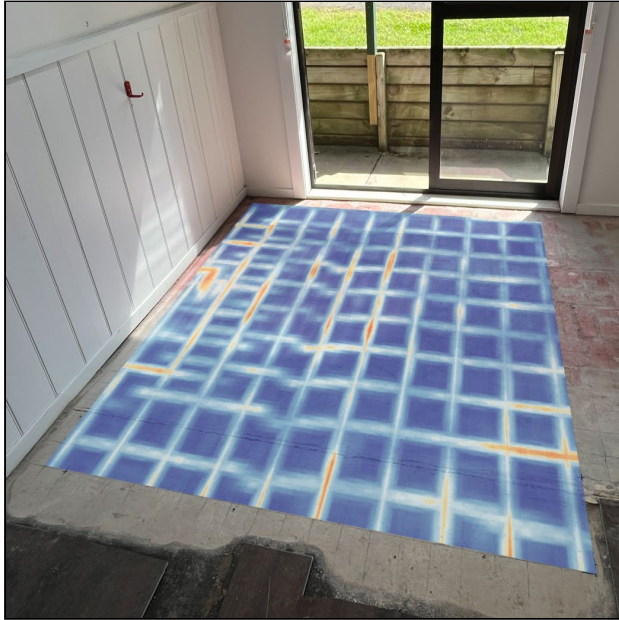
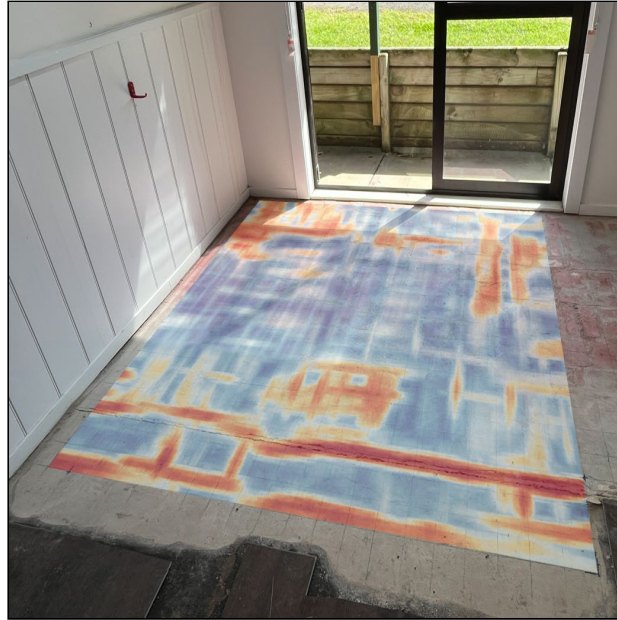
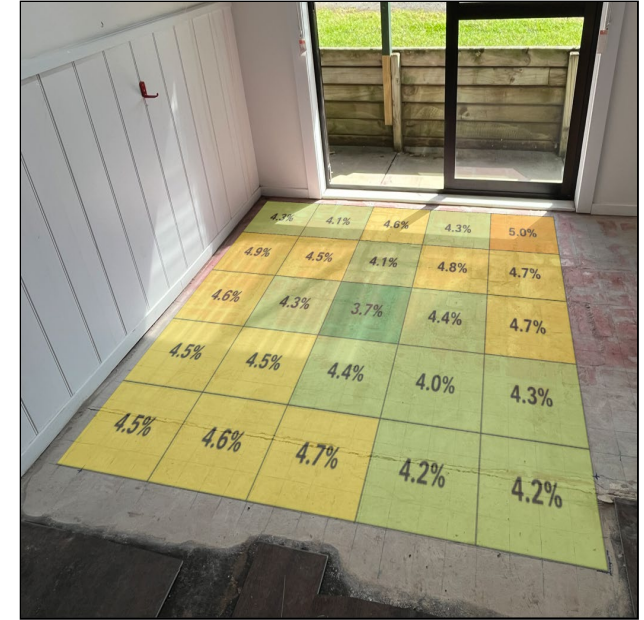
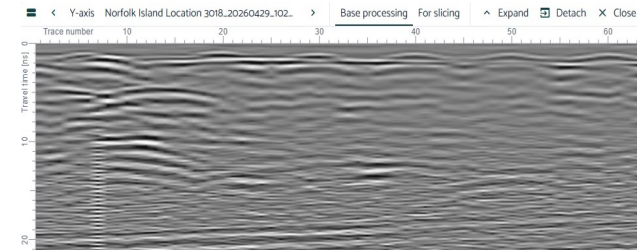
# Location 3 (Boardroom): Data and Interpretation

Moisture readings in this area were comparatively lower, generally ranging between 3.7% and 5.0%, although still indicative of elevated moisture presence. An expansion or construction joint was identified, and detachment of skirting boards was observed.

GPR data remained inconsistent, with subsurface reflections indicating possible underlying features or anomalies beneath the primary reinforcement layer. While this area did not exhibit the same level of distress as Location 2, the slab response was still inconsistent with that of a uniform, well-constructed system.

Moisture mapping identified generally moderate and relatively uniform moisture levels across the boardroom slab, with isolated elevated responses toward the external edge. Visual inspection identified an expansion joint and detached skirting board adjacent to the affected area. The slab surface also incorporated stamped concrete, contributing to variable signal response during testing. GPR depth slice analysis identified a prominent linear elevated reflection corresponding with a visible slab crack within the deeper subsurface layer. B-scan and depth slice data quality was generally poor across this location due to heterogeneous slab conditions and surface interference; however, the data suggests localised subsurface irregularities and moisture migration associated with the cracked section of slab.

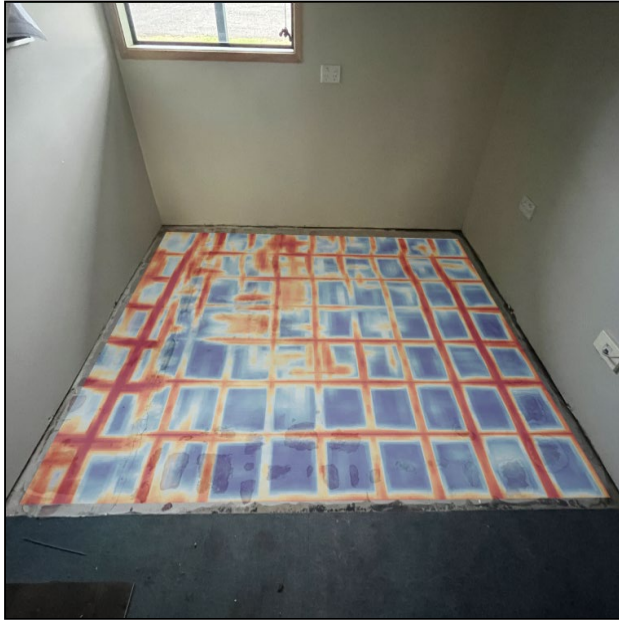
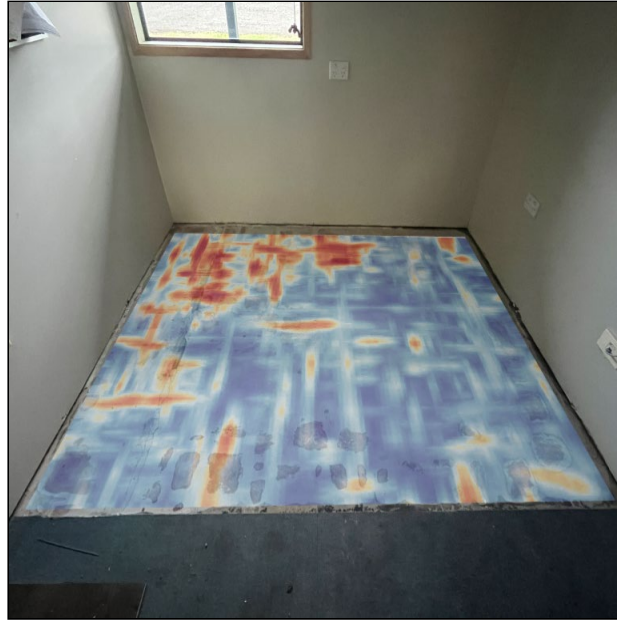
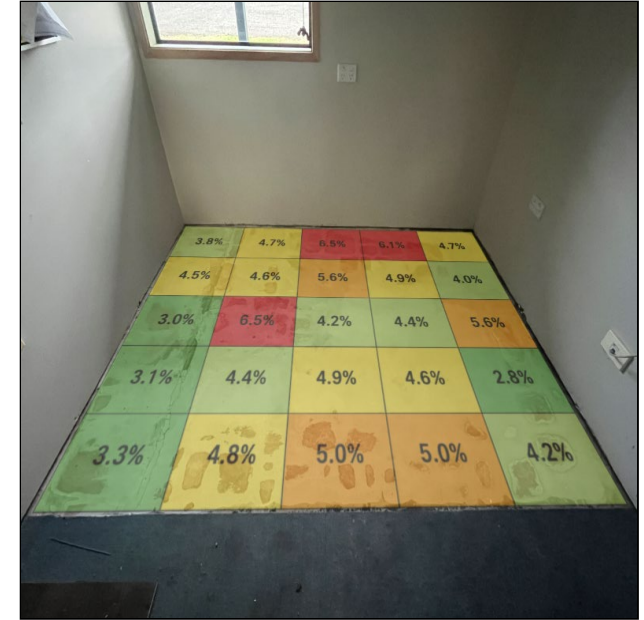
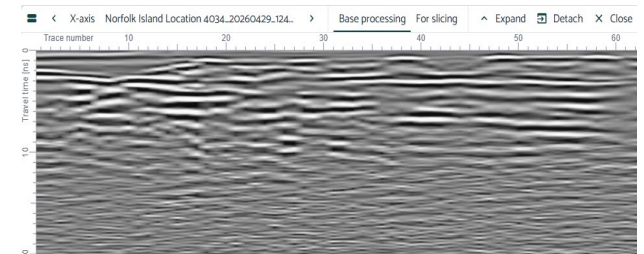
# Location 4 (North Corner): Data and Interpretation

Location 4 displayed clear evidence of moisture-related distress near the building perimeter.

Moisture readings ranged from approximately 2.8% to 6.5%, with elevated values concentrated along one side of the grid. A significant crack or joint was observed, and the presence of a deteriorated moisture barrier was visually confirmed within the crack.

GPR data in this area was particularly noisy, with strong reflections and irregular patterns observed near the external wall. These responses are consistent with increased moisture presence and potential subsurface irregularities in areas subject to ongoing ingress.

Moisture mapping identified elevated readings across the central and upper portions of the slab, with localised very high responses up to 6.5%. GPR data was collected at 100 mm scan spacings and identified irregular subsurface responses below the reinforcement layer. These deeper GPR responses did not align perfectly with the surface moisture readings, suggesting the anomalies are not solely moisture related and may also reflect variable slab support, cracking, a deteriorated moisture barrier, or localised voiding. A significant linear feature was observed along the left side of the slab, corresponding with a visible joint or crack. A deteriorated moisture barrier was visible within this feature, and the skirting board was noted to be separated from the slab perimeter. No obvious cracking was observed elsewhere; however, the combined data indicates localised subsurface irregularity associated with the apparent joint.

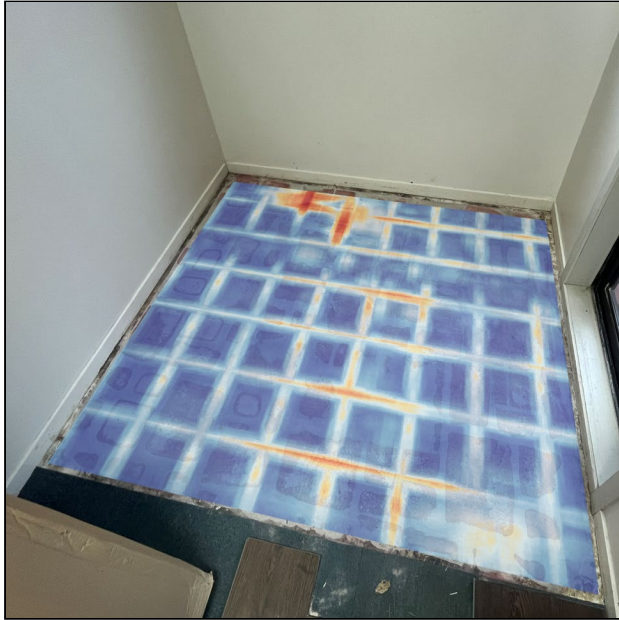
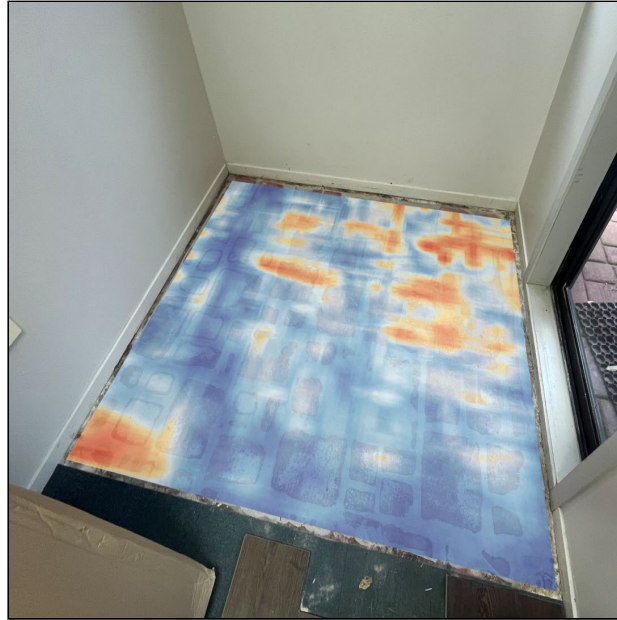
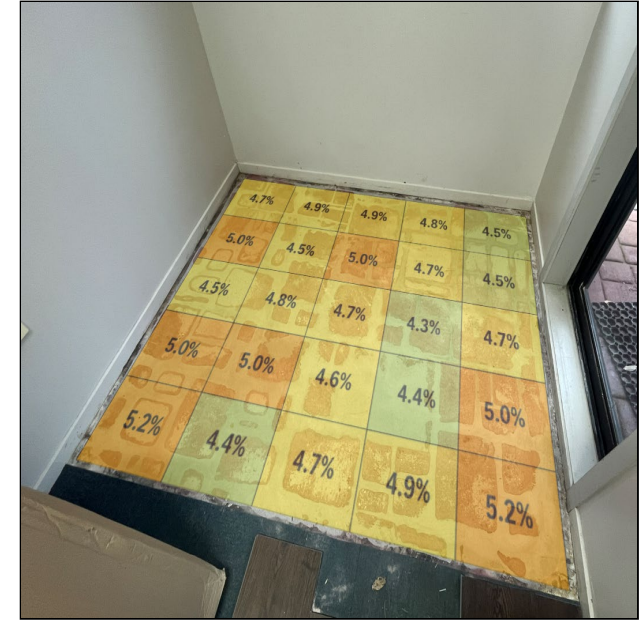
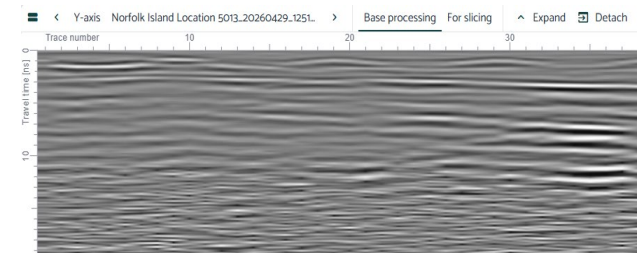
# Location 5 (East Corner): Data and Interpretation

Moisture readings ranged from approximately 4.3% to 5.2%, indicating moderate but consistent moisture presence. GPR data identified variations in subsurface response, with anomalies consistent with voiding and/or localised material inconsistencies.

Deeper reflections observed in the data suggest irregular conditions beneath the slab, potentially associated with subgrade variability or moisture accumulation.

Moisture mapping within the east corner area identified generally moderate moisture levels across the slab, with lower overall readings compared to previous locations. GPR data was collected at 100 mm scan spacings over a slightly smaller survey area. An edge beam was identified along the slab perimeter, producing a strong linear reflection within the reinforcement depth slice. Despite the comparatively lower moisture readings, deeper GPR slice data exhibited numerous elevated reflections and irregular subsurface responses beneath the reinforcement layer. The data displayed significant variability throughout the slab, including localised anomalies consistent with possible voiding, delamination, or heterogeneous slab support conditions. Overall, the deeper radar responses suggest subsurface irregularities not fully reflected within the surface moisture data alone.

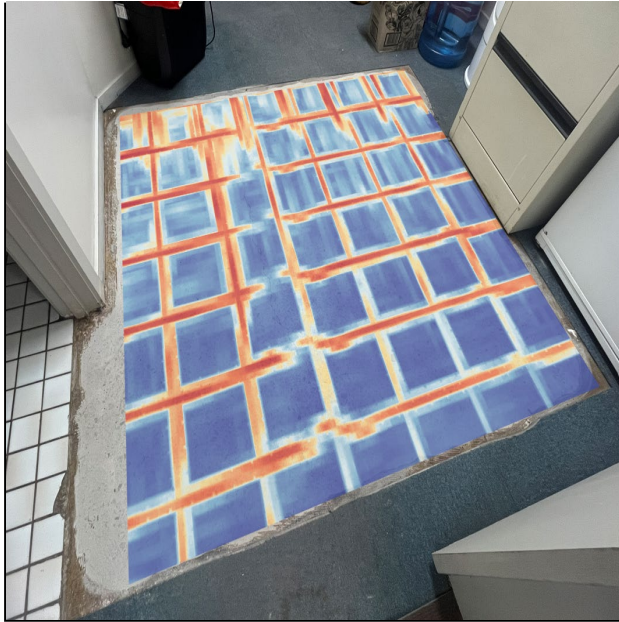
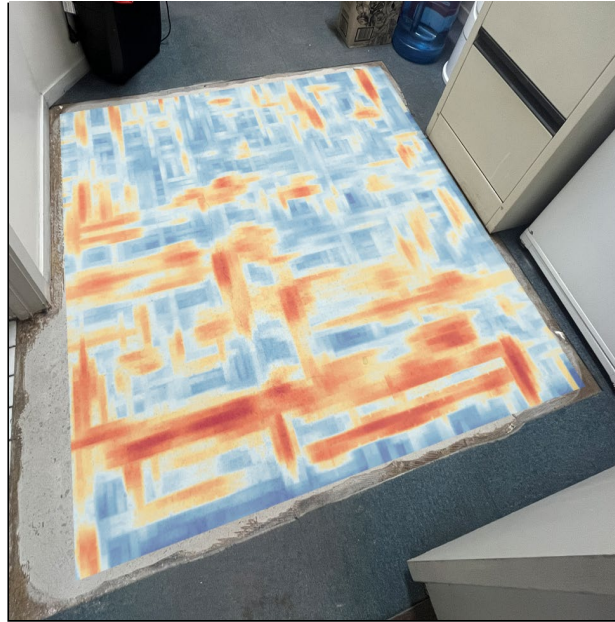
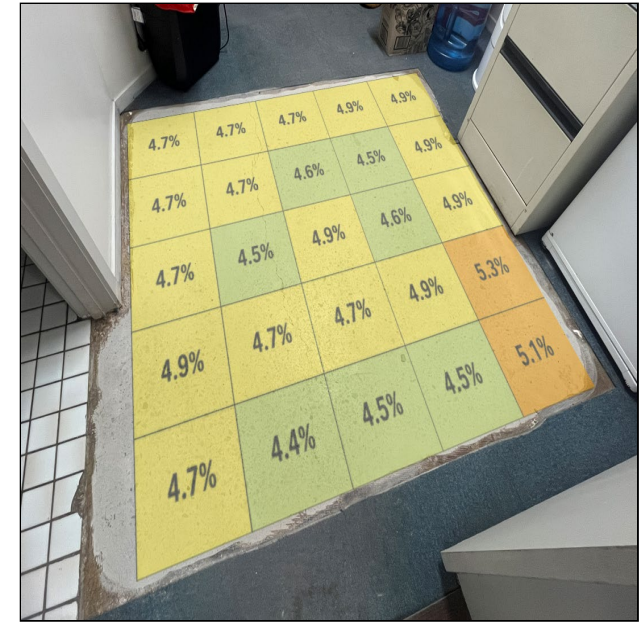
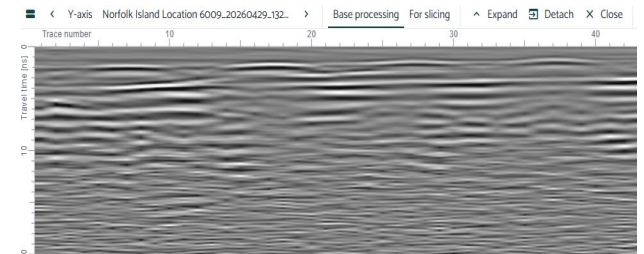
# Location 6 (Centre Area): Data and Interpretation

Moisture readings were relatively consistent across this area, generally ranging between 4.4% and 5.3%. A longitudinal crack greater than 1 mm in width was observed, located directly beneath the reinforcement layer.

GPR data was highly variable, with inconsistent reinforcement cover and widespread irregular reflections. Subsurface responses indicated reduced material homogeneity and possible voiding. Despite being centrally located, this area exhibited characteristics like those of perimeter zones, suggesting that moisture-related effects are not confined to slab edges.

Moisture mapping identified generally moderate and relatively uniform readings across the centre area, with slightly elevated responses toward the right-hand edge. GPR data was collected at tighter 50 mm scan spacings, improving resolution through the slab and reinforcement zone. Depth-slice data identified a prominent longitudinal response corresponding to the large visible crack, located directly below or in close association with the reinforcement layer. The deeper C-scan and B-scan data show inconsistent signal behaviour, disrupted continuity, variable reinforcement cover and spacing, and multiple elevated reflections below the rebar level. These responses are consistent with a non-homogeneous slab system and may indicate localised voiding, delamination, poor consolidation, or irregular slab support beneath the cracked section.
