GPR and Structural Assessment Report

Southern Downs Regional Council

WIRAC - 29 Palmerin St, Warwick QLD 4370

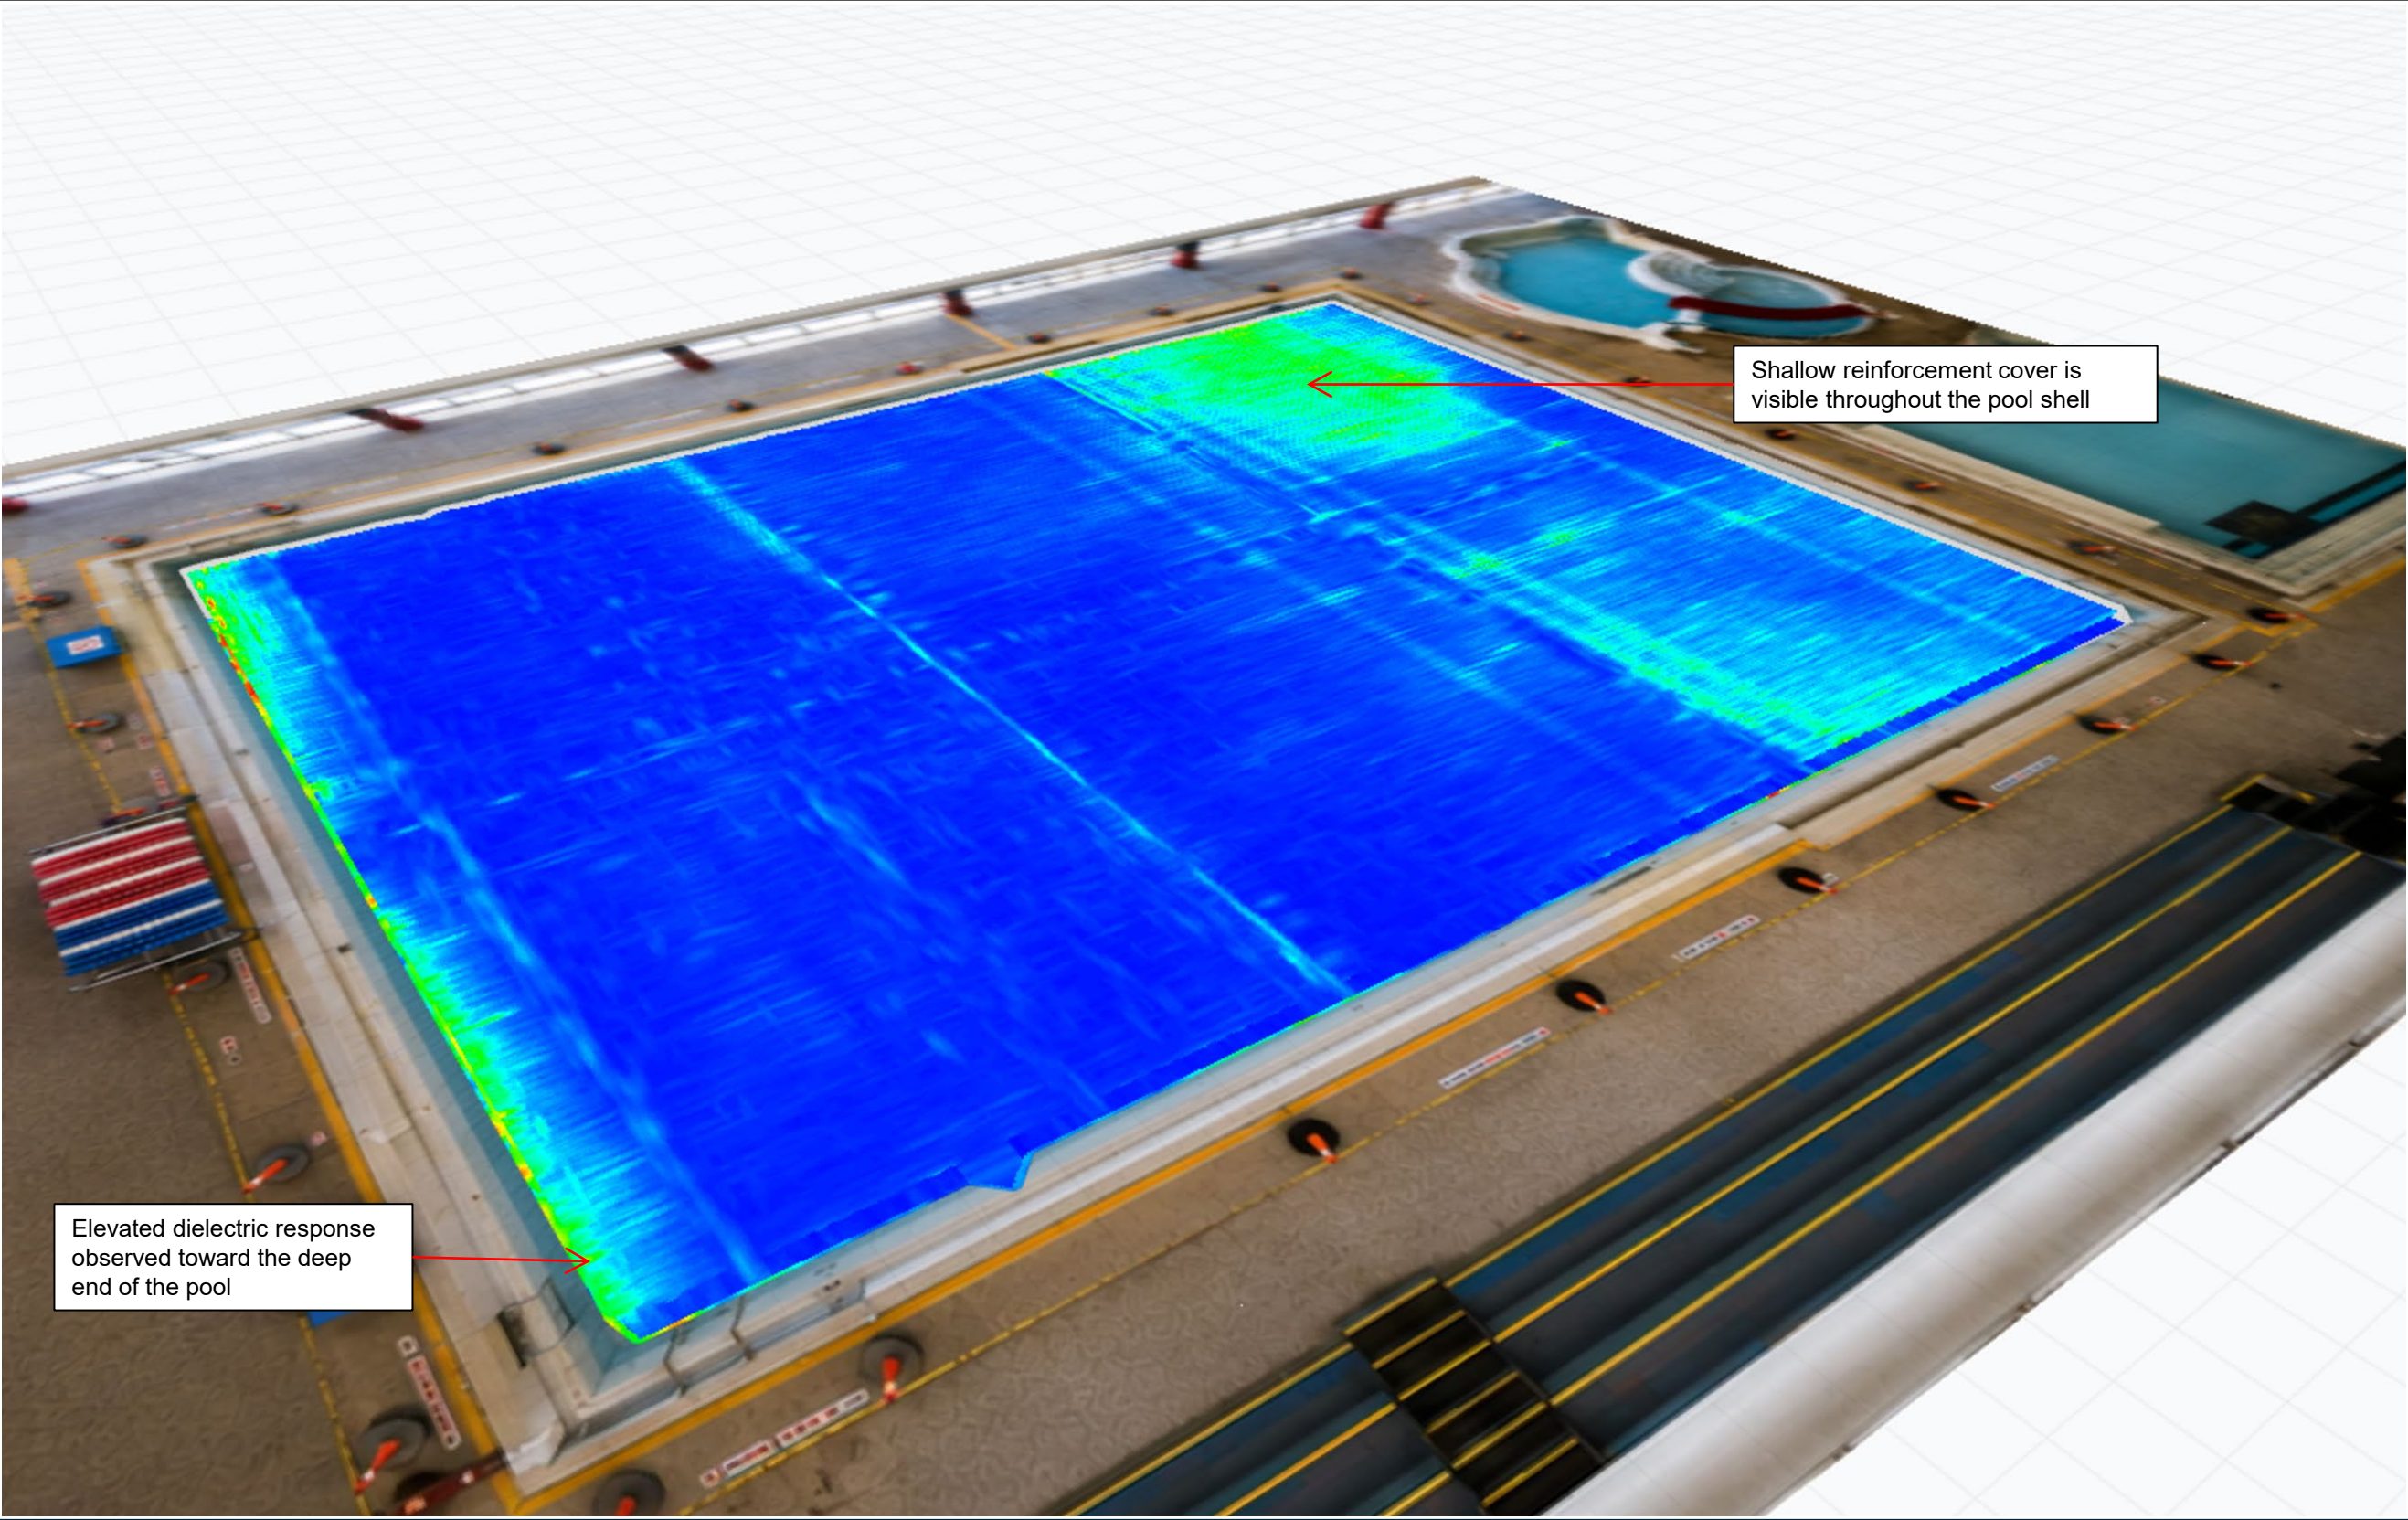
Olympic Pool – Shallow Reinforcement and Upper Pool Shell Assessment

Shallow reinforcement cover is visible throughout the pool shell

Elevated dielectric response observed toward the deep end of the pool

High-frequency 900 MHz GPR assessment of the Olympic pool shell revealed clear, consistent reinforcement reflections throughout the upper slab profile. Reinforcement cover appeared relatively shallow across the pool shell, with stronger dielectric reflections observed toward the deep end of the pool (left side of the dataset). These elevated reflections may indicate increased moisture retention, differing concrete properties, or localised changes in subsurface conditions; however, no evidence of significant voiding or major structural anomalies was identified within this depth range.

1. The Olympic pool datasets generally exhibited clear, coherent, and repeatable radar responses throughout both shallow and deeper depth intervals. High-frequency concrete scanning identified a regular reinforcement configuration and relatively shallow reinforcement cover throughout the upper pool shell, with no evidence of significant discontinuities, major voiding, or large-scale structural anomalies in the shallow datasets. Minor elevated dielectric responses were observed toward the deep end of the pool and adjacent to isolated reinforcement zones. These responses may indicate localised moisture retention, changes in material properties, or early-stage localised deterioration; however, the responses remained relatively minor and were not considered indicative of widespread structural distress.

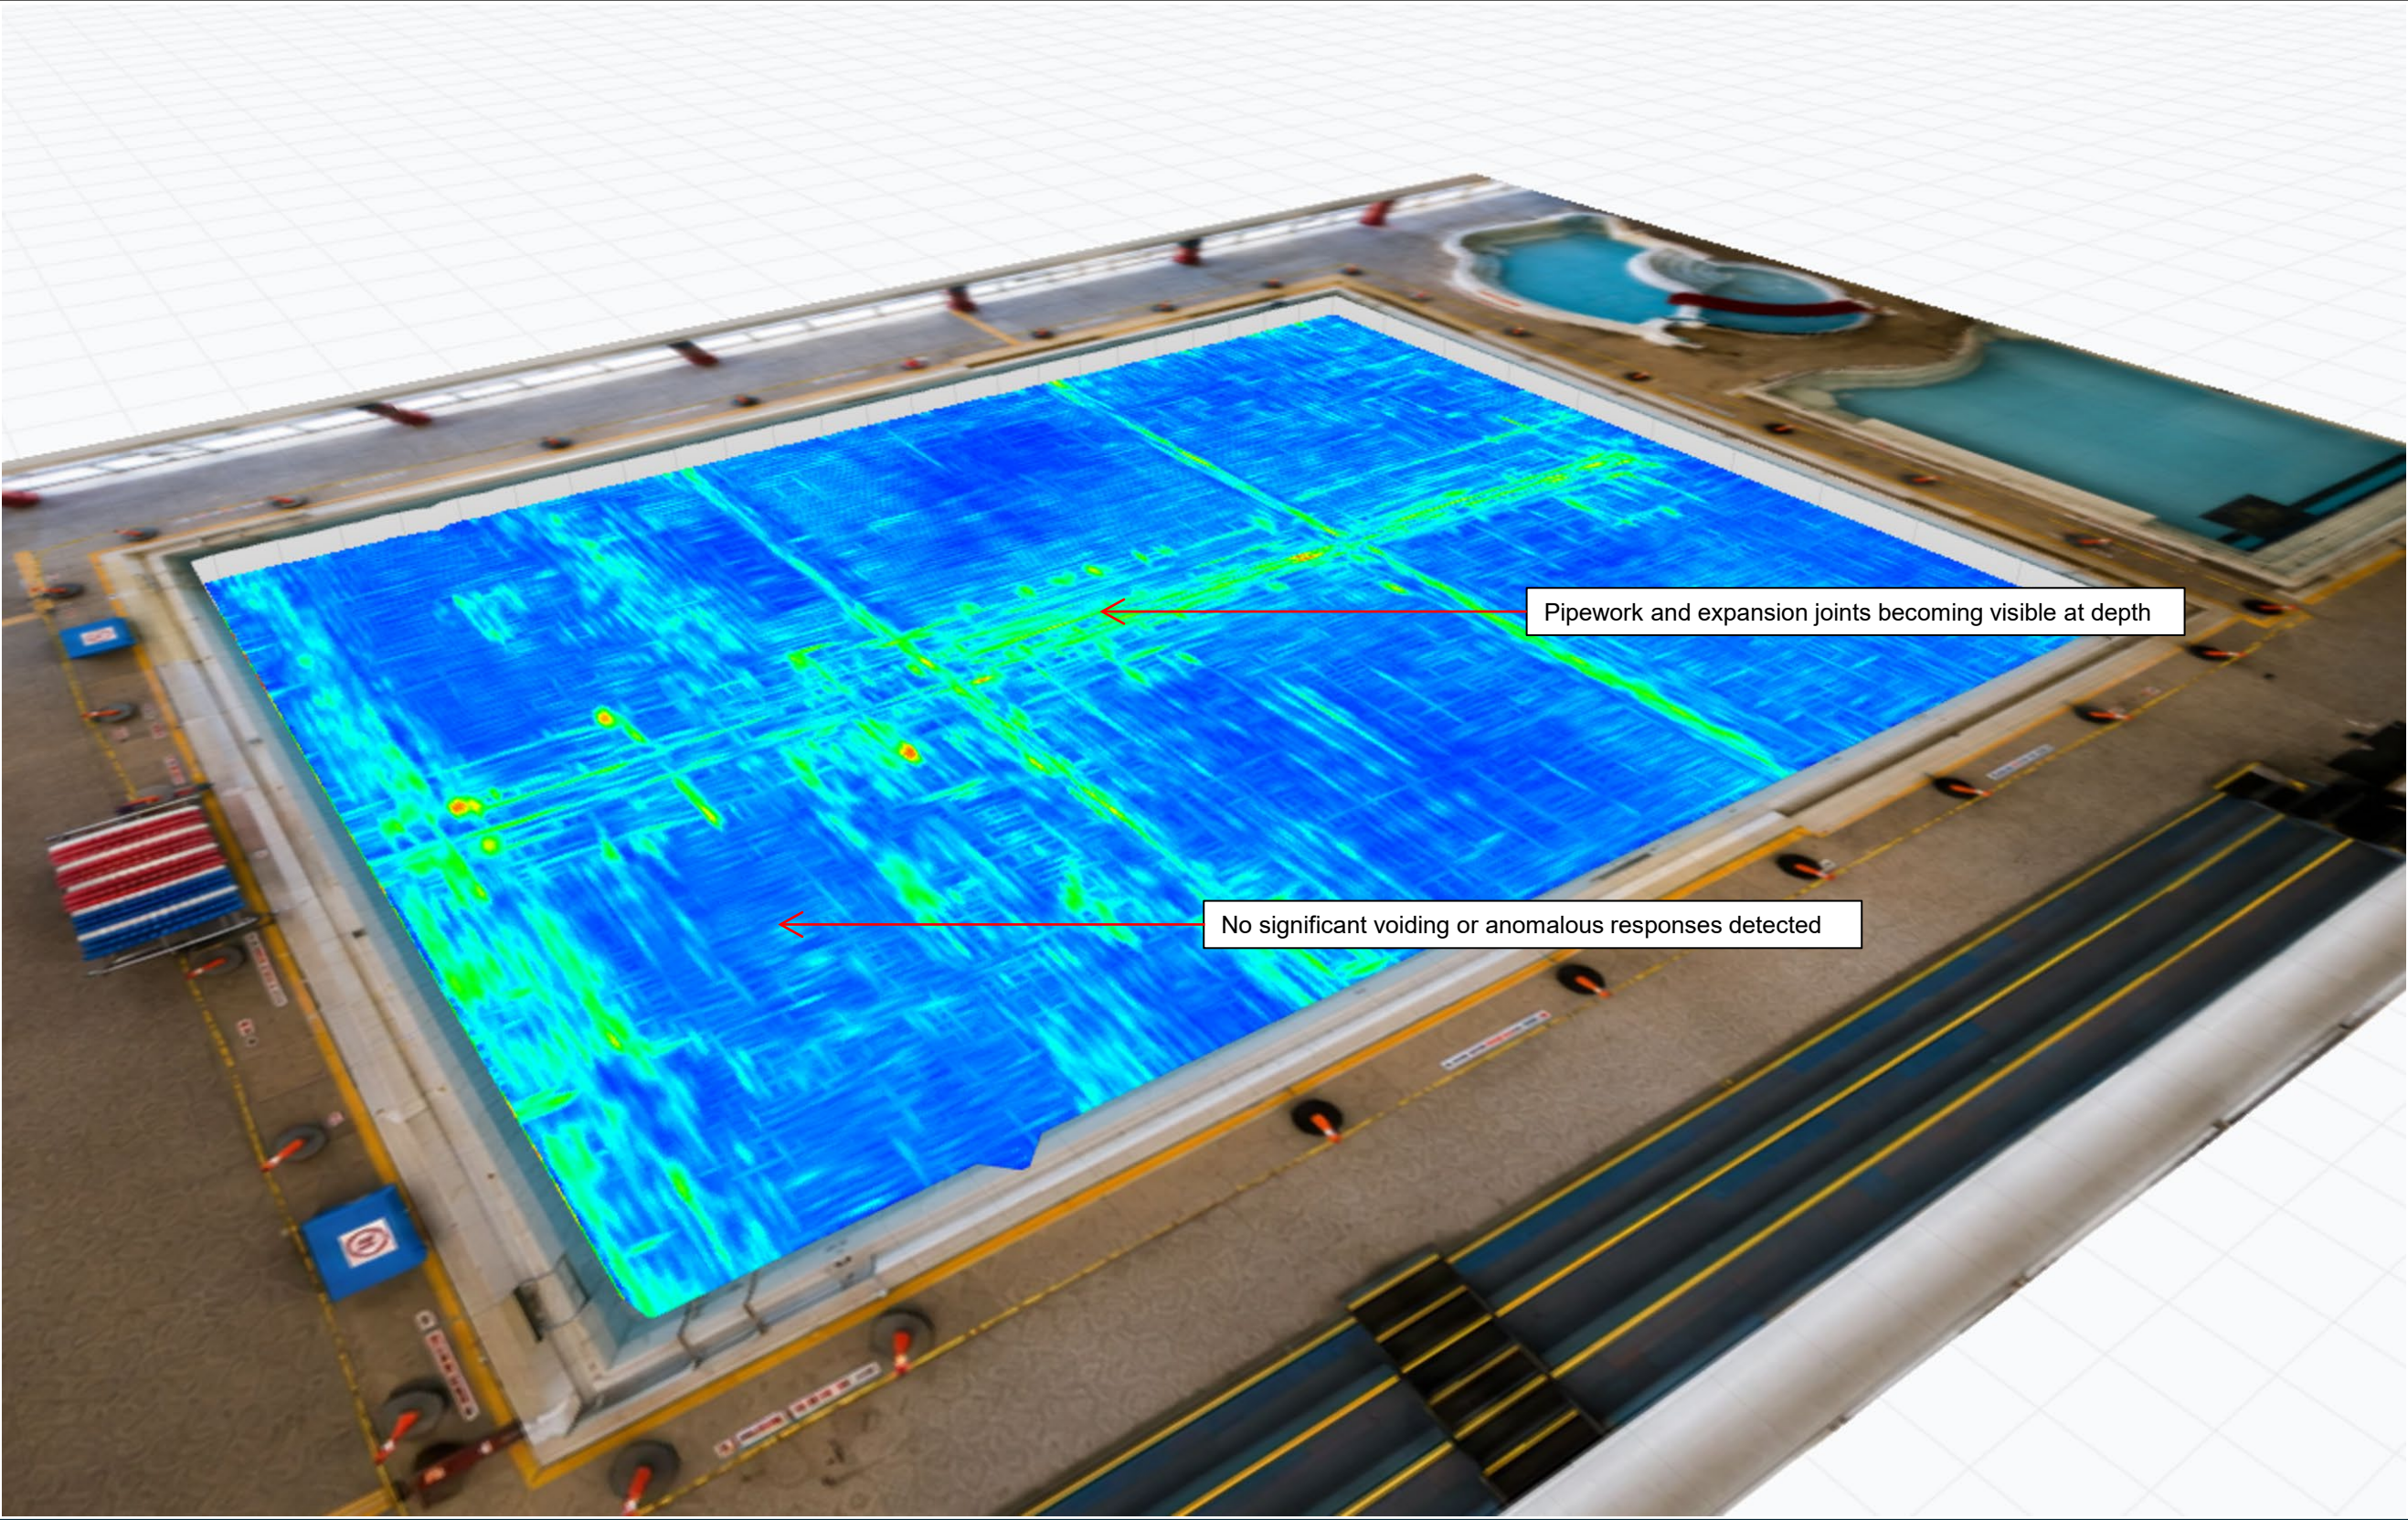
Olympic Pool – Intermediate Depth Assessment

The 900 MHz GPR assessment within the approximate 200–400 mm depth range identified generally consistent subsurface conditions beneath the Olympic pool shell. Pipework alignments and expansion joint features became increasingly visible at this depth interval. Minor reflective patches were observed locally; however, no significant voiding, anomalous subsurface responses, or major inconsistencies were identified within the dataset.

2. Intermediate-depth 900 MHz datasets identified generally consistent subsurface conditions beneath the Olympic pool shell, with pipework alignments and expansion joint features becoming increasingly visible at depth. Minor reflective patches were observed locally; however, no significant voiding, anomalous subsurface conditions, or major inconsistencies were identified within these datasets.

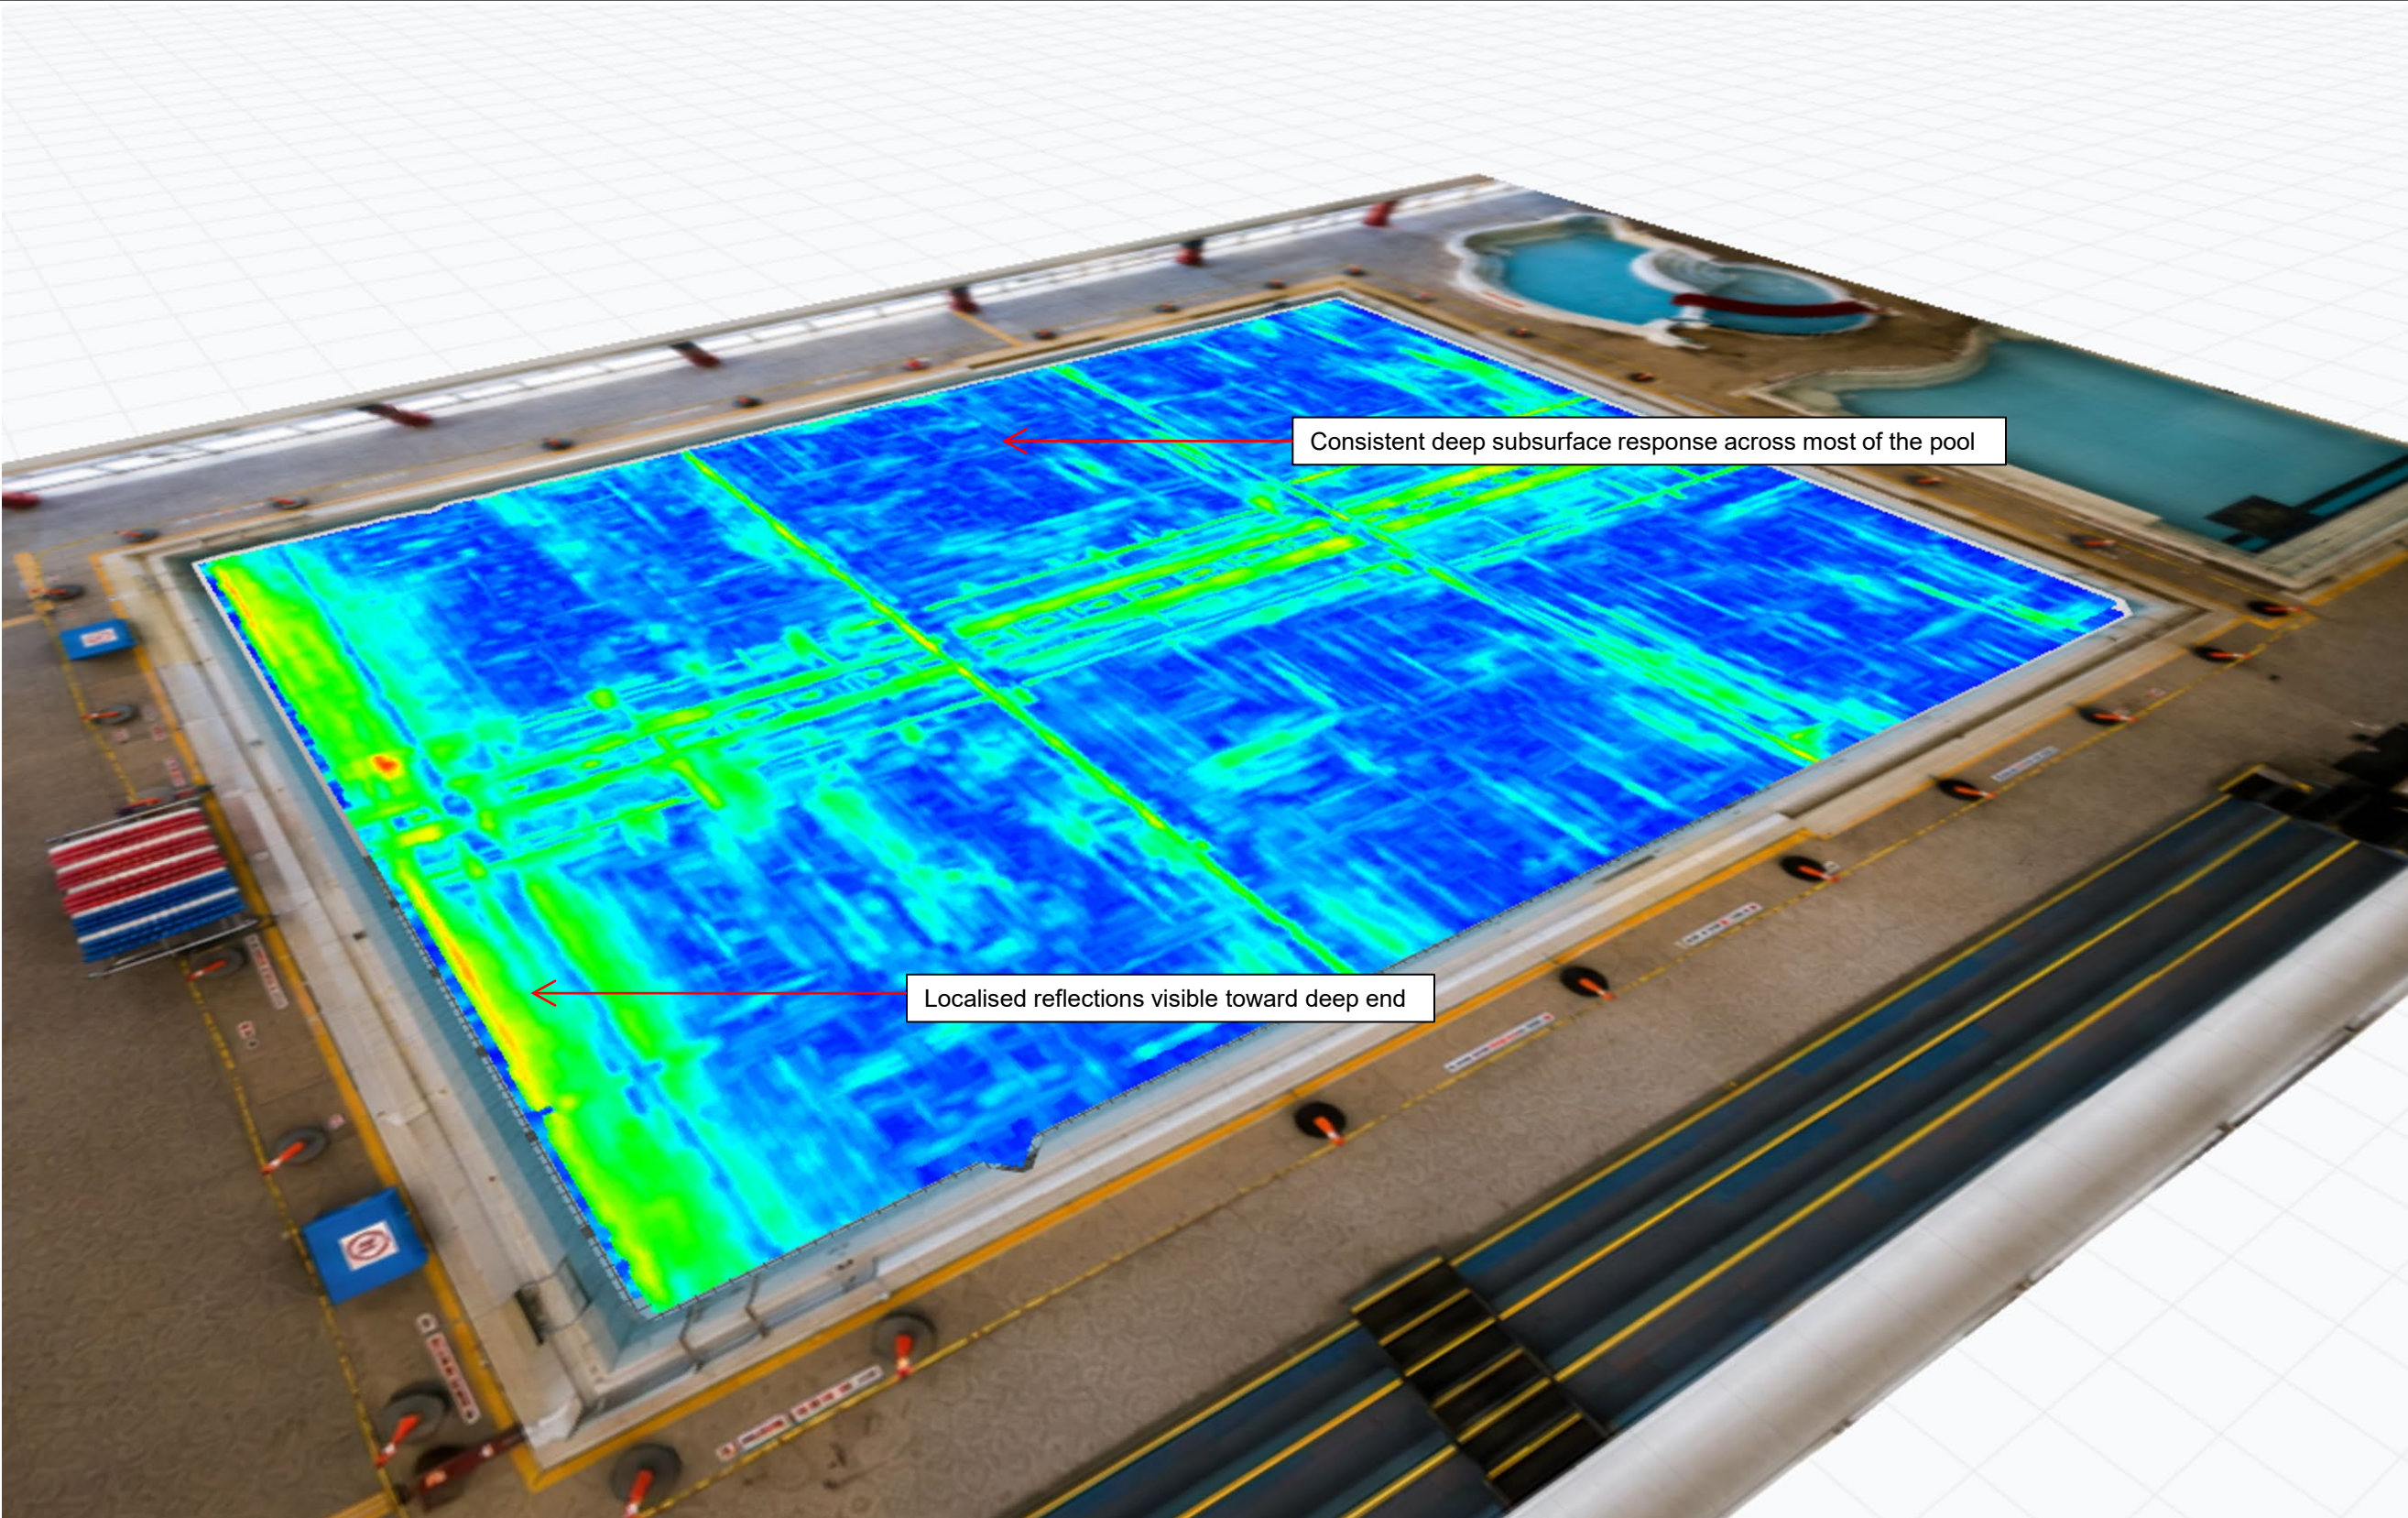
Olympic Pool – Deep Subsurface Assessment (500–600 mm)

The 200 MHz GPR assessment identified generally consistent subsurface conditions beneath the Olympic pool shell at greater depth. Pipework reflections remained visible throughout the dataset, while the deep end of the pool exhibited localised reflective responses that may indicate changes in subsurface material conditions or moisture content. No significant structural anomalies or widespread subsurface inconsistencies were identified.

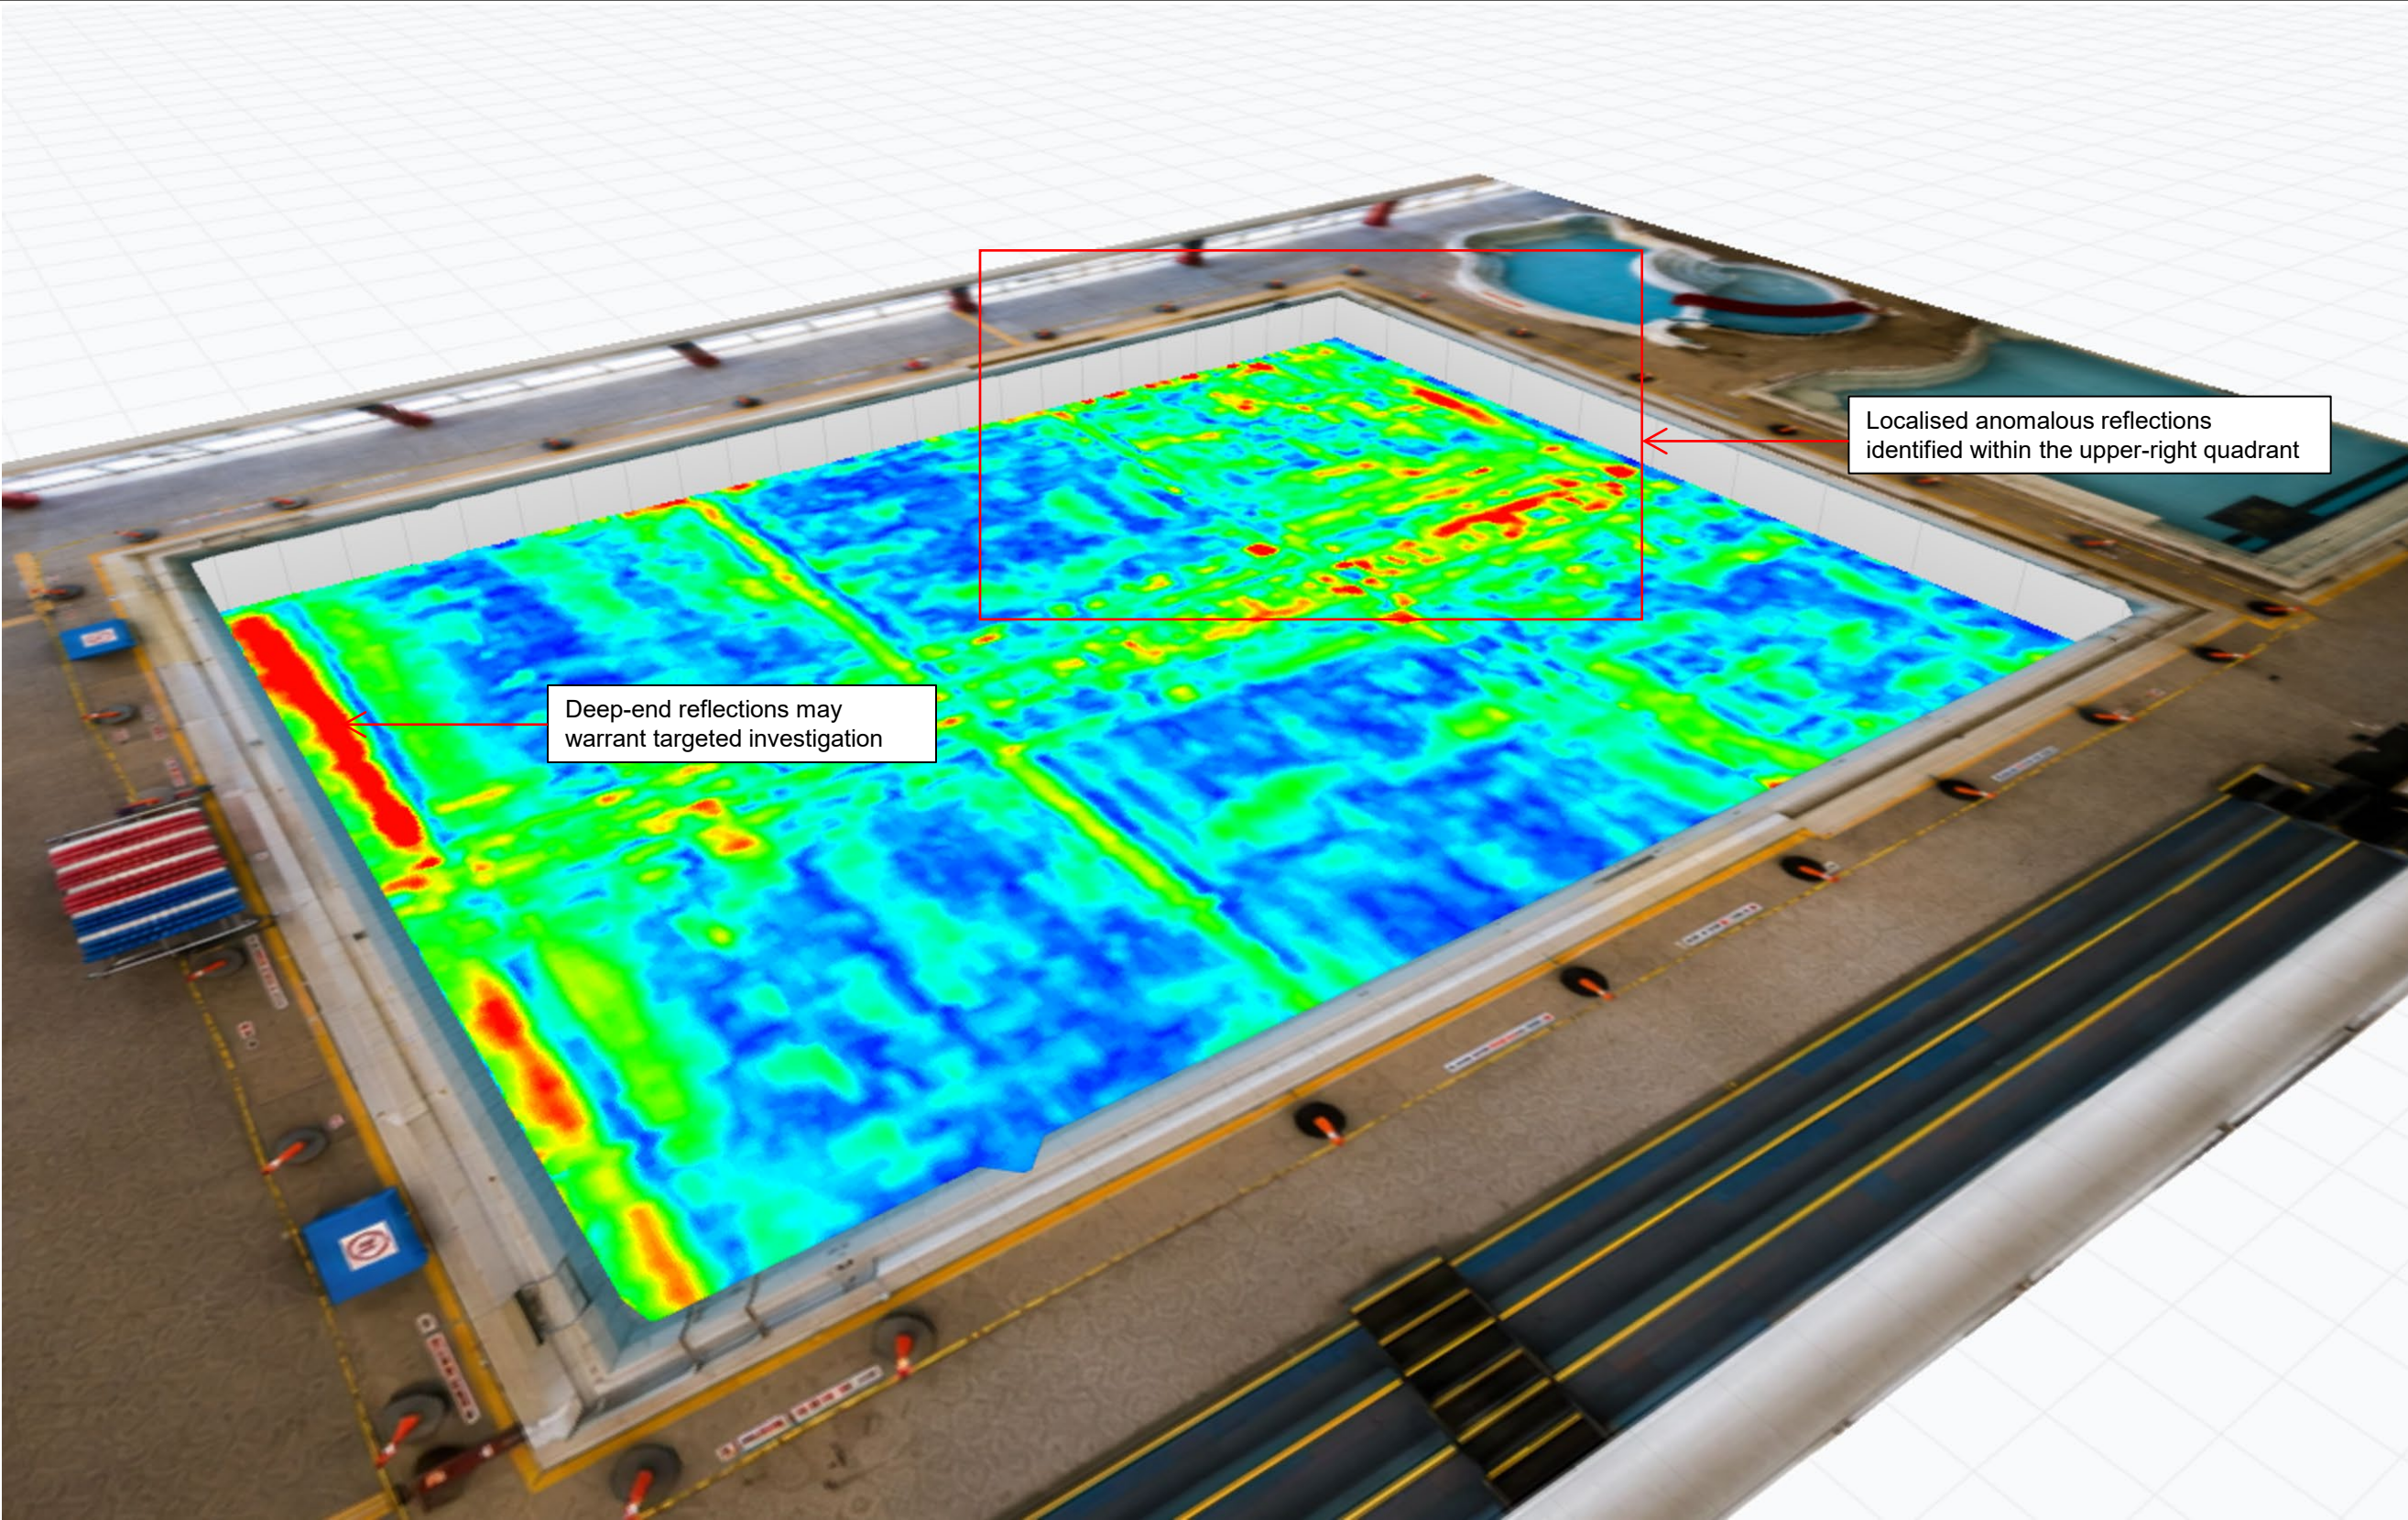
Olympic Pool – Deep Subsurface Assessment (600–1000 mm)

The deeper 200 MHz GPR assessment identified several localised anomalous reflections within the upper-right quadrant of the dataset, along with increased reflectivity beneath the deep end of the pool. These responses may warrant further targeted investigation to better characterise underlying conditions. Despite these localised areas, the overall dataset remained clear and relatively consistent, with no evidence of major voiding, widespread washout, or significant structural instability beneath the Olympic pool shell.

3. The deeper 200 MHz assessments identified generally consistent subsurface conditions beneath most of the Olympic pool slab. Localised anomalous reflections were identified toward portions of the deep end and within isolated areas of the upper-right quadrant of the dataset. While these responses may warrant further targeted investigation, the overall radar response remained comparatively coherent and consistent relative to typical ageing aquatic infrastructure datasets. No evidence of widespread washout, major support loss, or large subsurface voiding was identified beneath the Olympic pool shell.

- The deeper reflective responses identified toward portions of the Olympic pool deep end may warrant targeted intrusive verification if future remediation works or engineering assessment are planned within this area. While the responses do not currently indicate widespread instability, additional verification may help further characterise underlying material conditions.

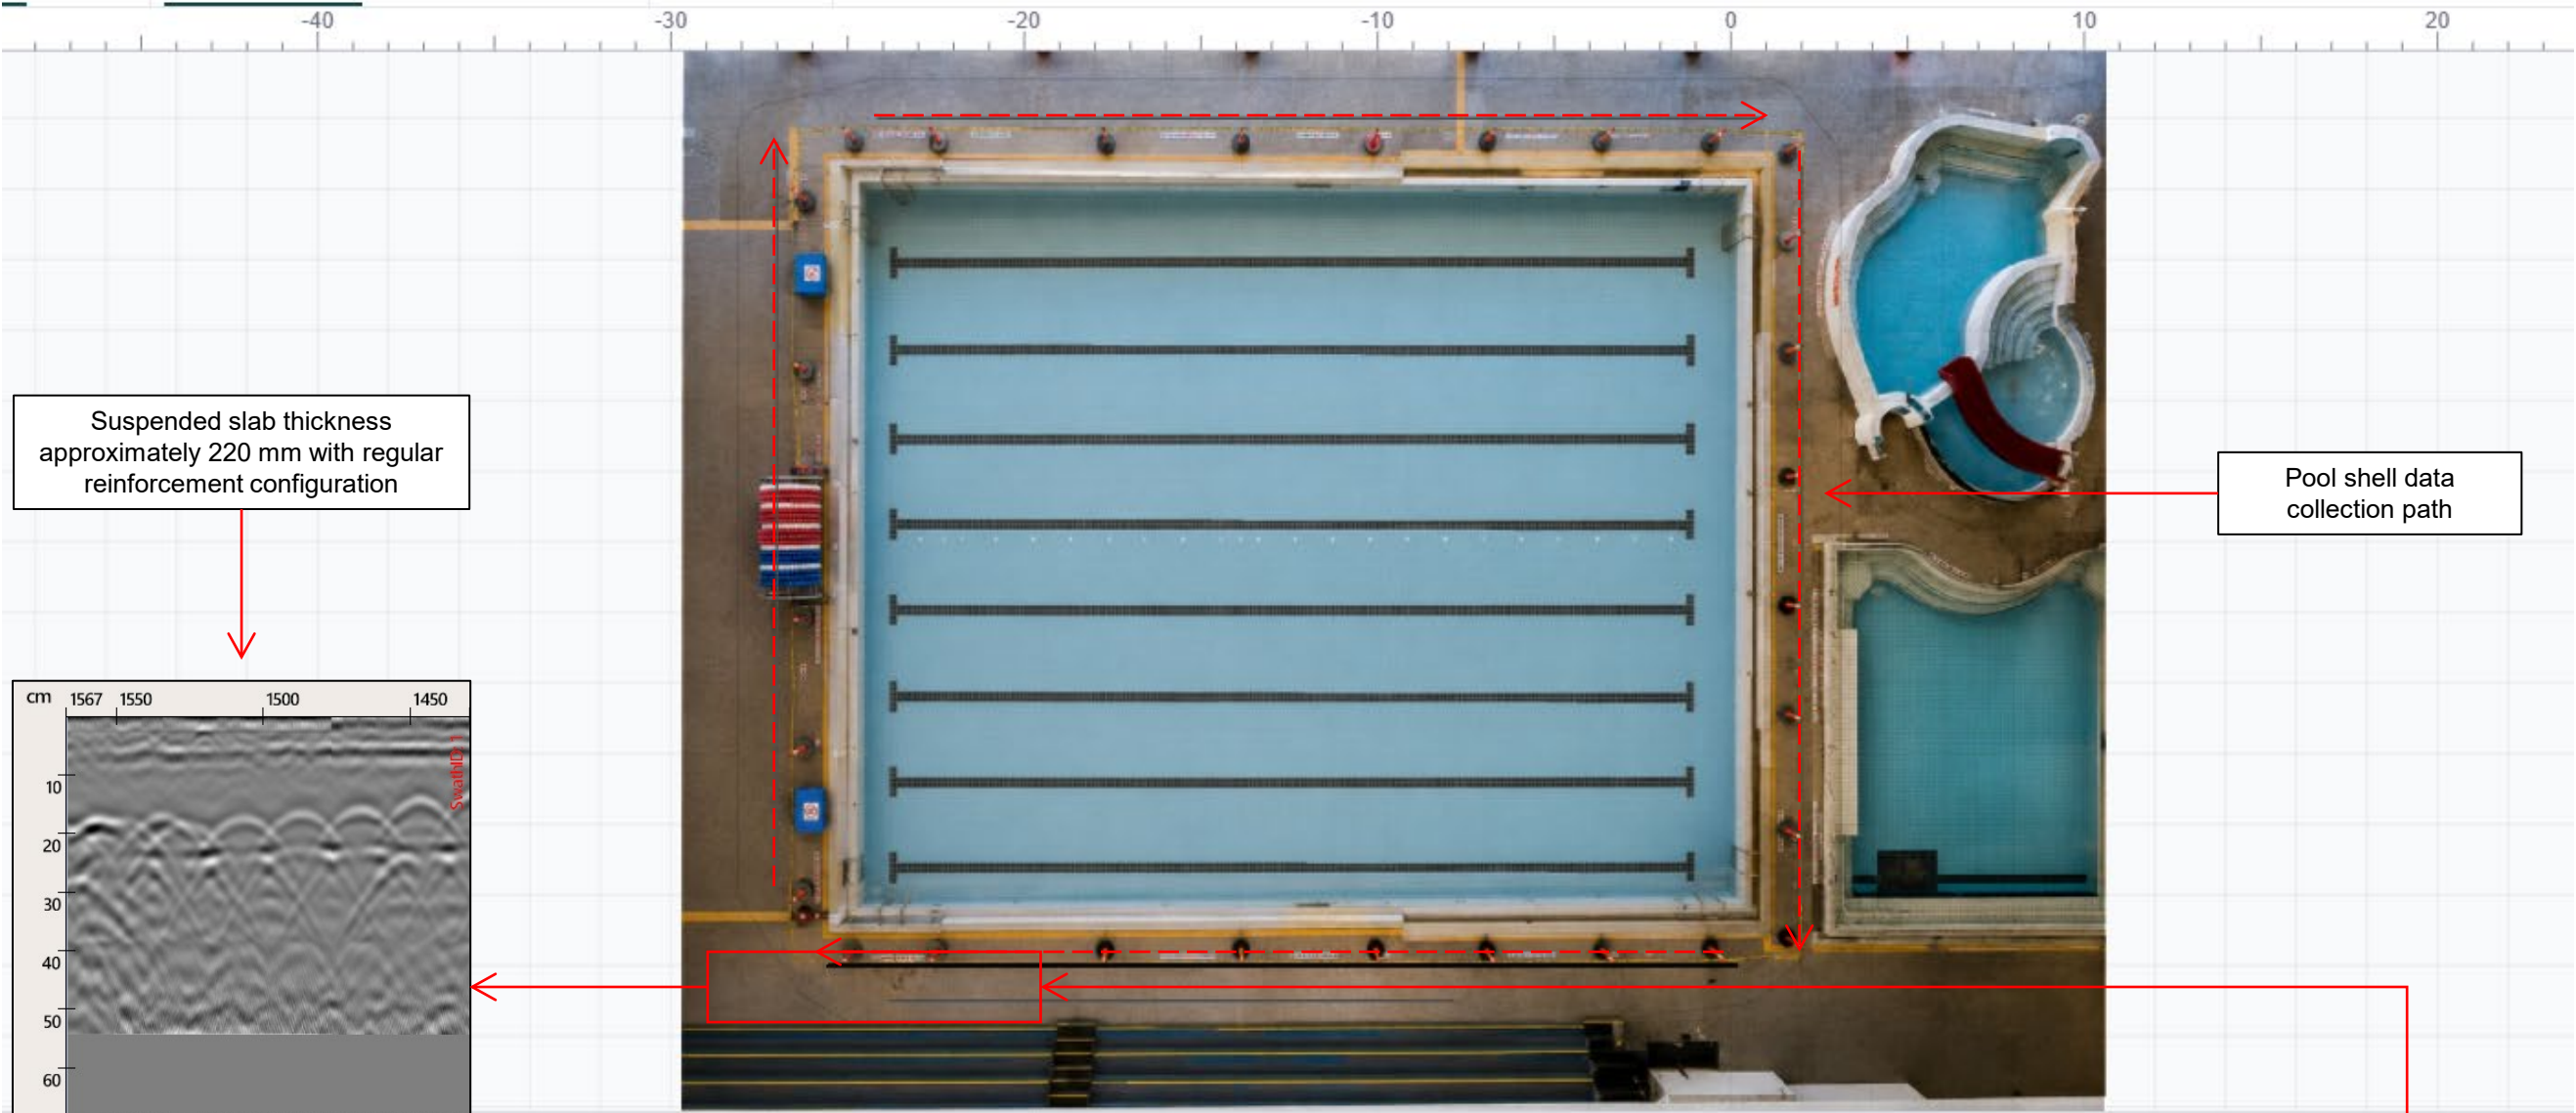
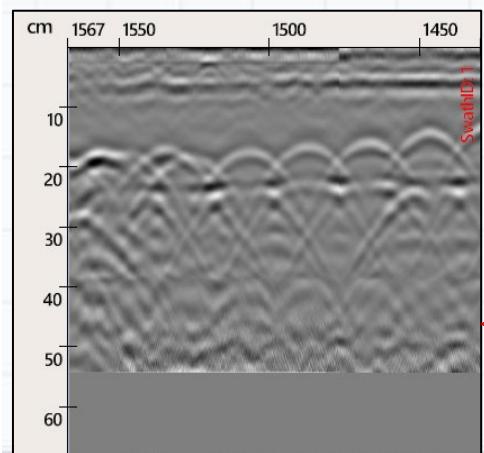
Olympic Pool Perimeter and Suspended Slab Assessment

Suspended slab thickness approximately 220 mm with regular reinforcement configuration

Localised noisy radar response corresponds with the reported settlement area

GPR assessment along the perimeter of the Olympic pool identified generally consistent subsurface conditions across the majority of the dataset. However, a localised noisy radar response was identified toward the far-right section of the B-scan data, corresponding approximately with an area where historical settlement or level variation had reportedly been observed onsite. While the exact cause of this response cannot be confirmed using GPR alone, the localised increase in signal variability may warrant further targeted investigation.

4. Additional perimeter scanning identified a localised noisy radar response corresponding approximately with the area where historical level variation and settlement had reportedly been observed onsite. While the exact cause of this response cannot be confirmed using GPR alone, the increased signal variability within this localised zone may indicate changing subsurface conditions, localised moisture ingress, or possible variations in slab support beneath the perimeter slab. The suspended slab datasets adjacent to this area indicated a slab thickness of approximately 220 mm, regular reinforcement spacing, and estimated concrete cover depths of 150–175 mm. Reinforcement reflections within the suspended slab remained clear and consistent with no major anomalies identified.

whether the observed variation in level was caused by historical settlement, original construction tolerances, infiltration, or ground movement, the increased signal variability in this area suggests that subsurface conditions differ from those at the surrounding pool perimeter. This may be consistent with localised moisture ingress, changes in support conditions, or localised material variation beneath or adjacent to the pool shell. Further intrusive verification would be required to confirm the underlying cause.

- The localised perimeter zone adjacent to the reported settlement area at the Olympic pool should be considered for further targeted investigation should ongoing movement, cracking, drainage issues, or further level variation continue to be observed. Targeted intrusive verification, such as core sampling or localised excavation, may further characterise subsurface support conditions in this area.

- Ongoing monitoring of the reported settlement-prone perimeter zones is recommended, particularly with respect to changes in surface levels, cracking, drainage behaviour, or water retention patterns. Should further movement be observed over time, a detailed structural engineering assessment and a formal level survey may help determine whether active movement is occurring.
