GPR and Structural Assessment Report

Southern Downs Regional Council

WIRAC - 29 Palmerin St, Warwick QLD 4370

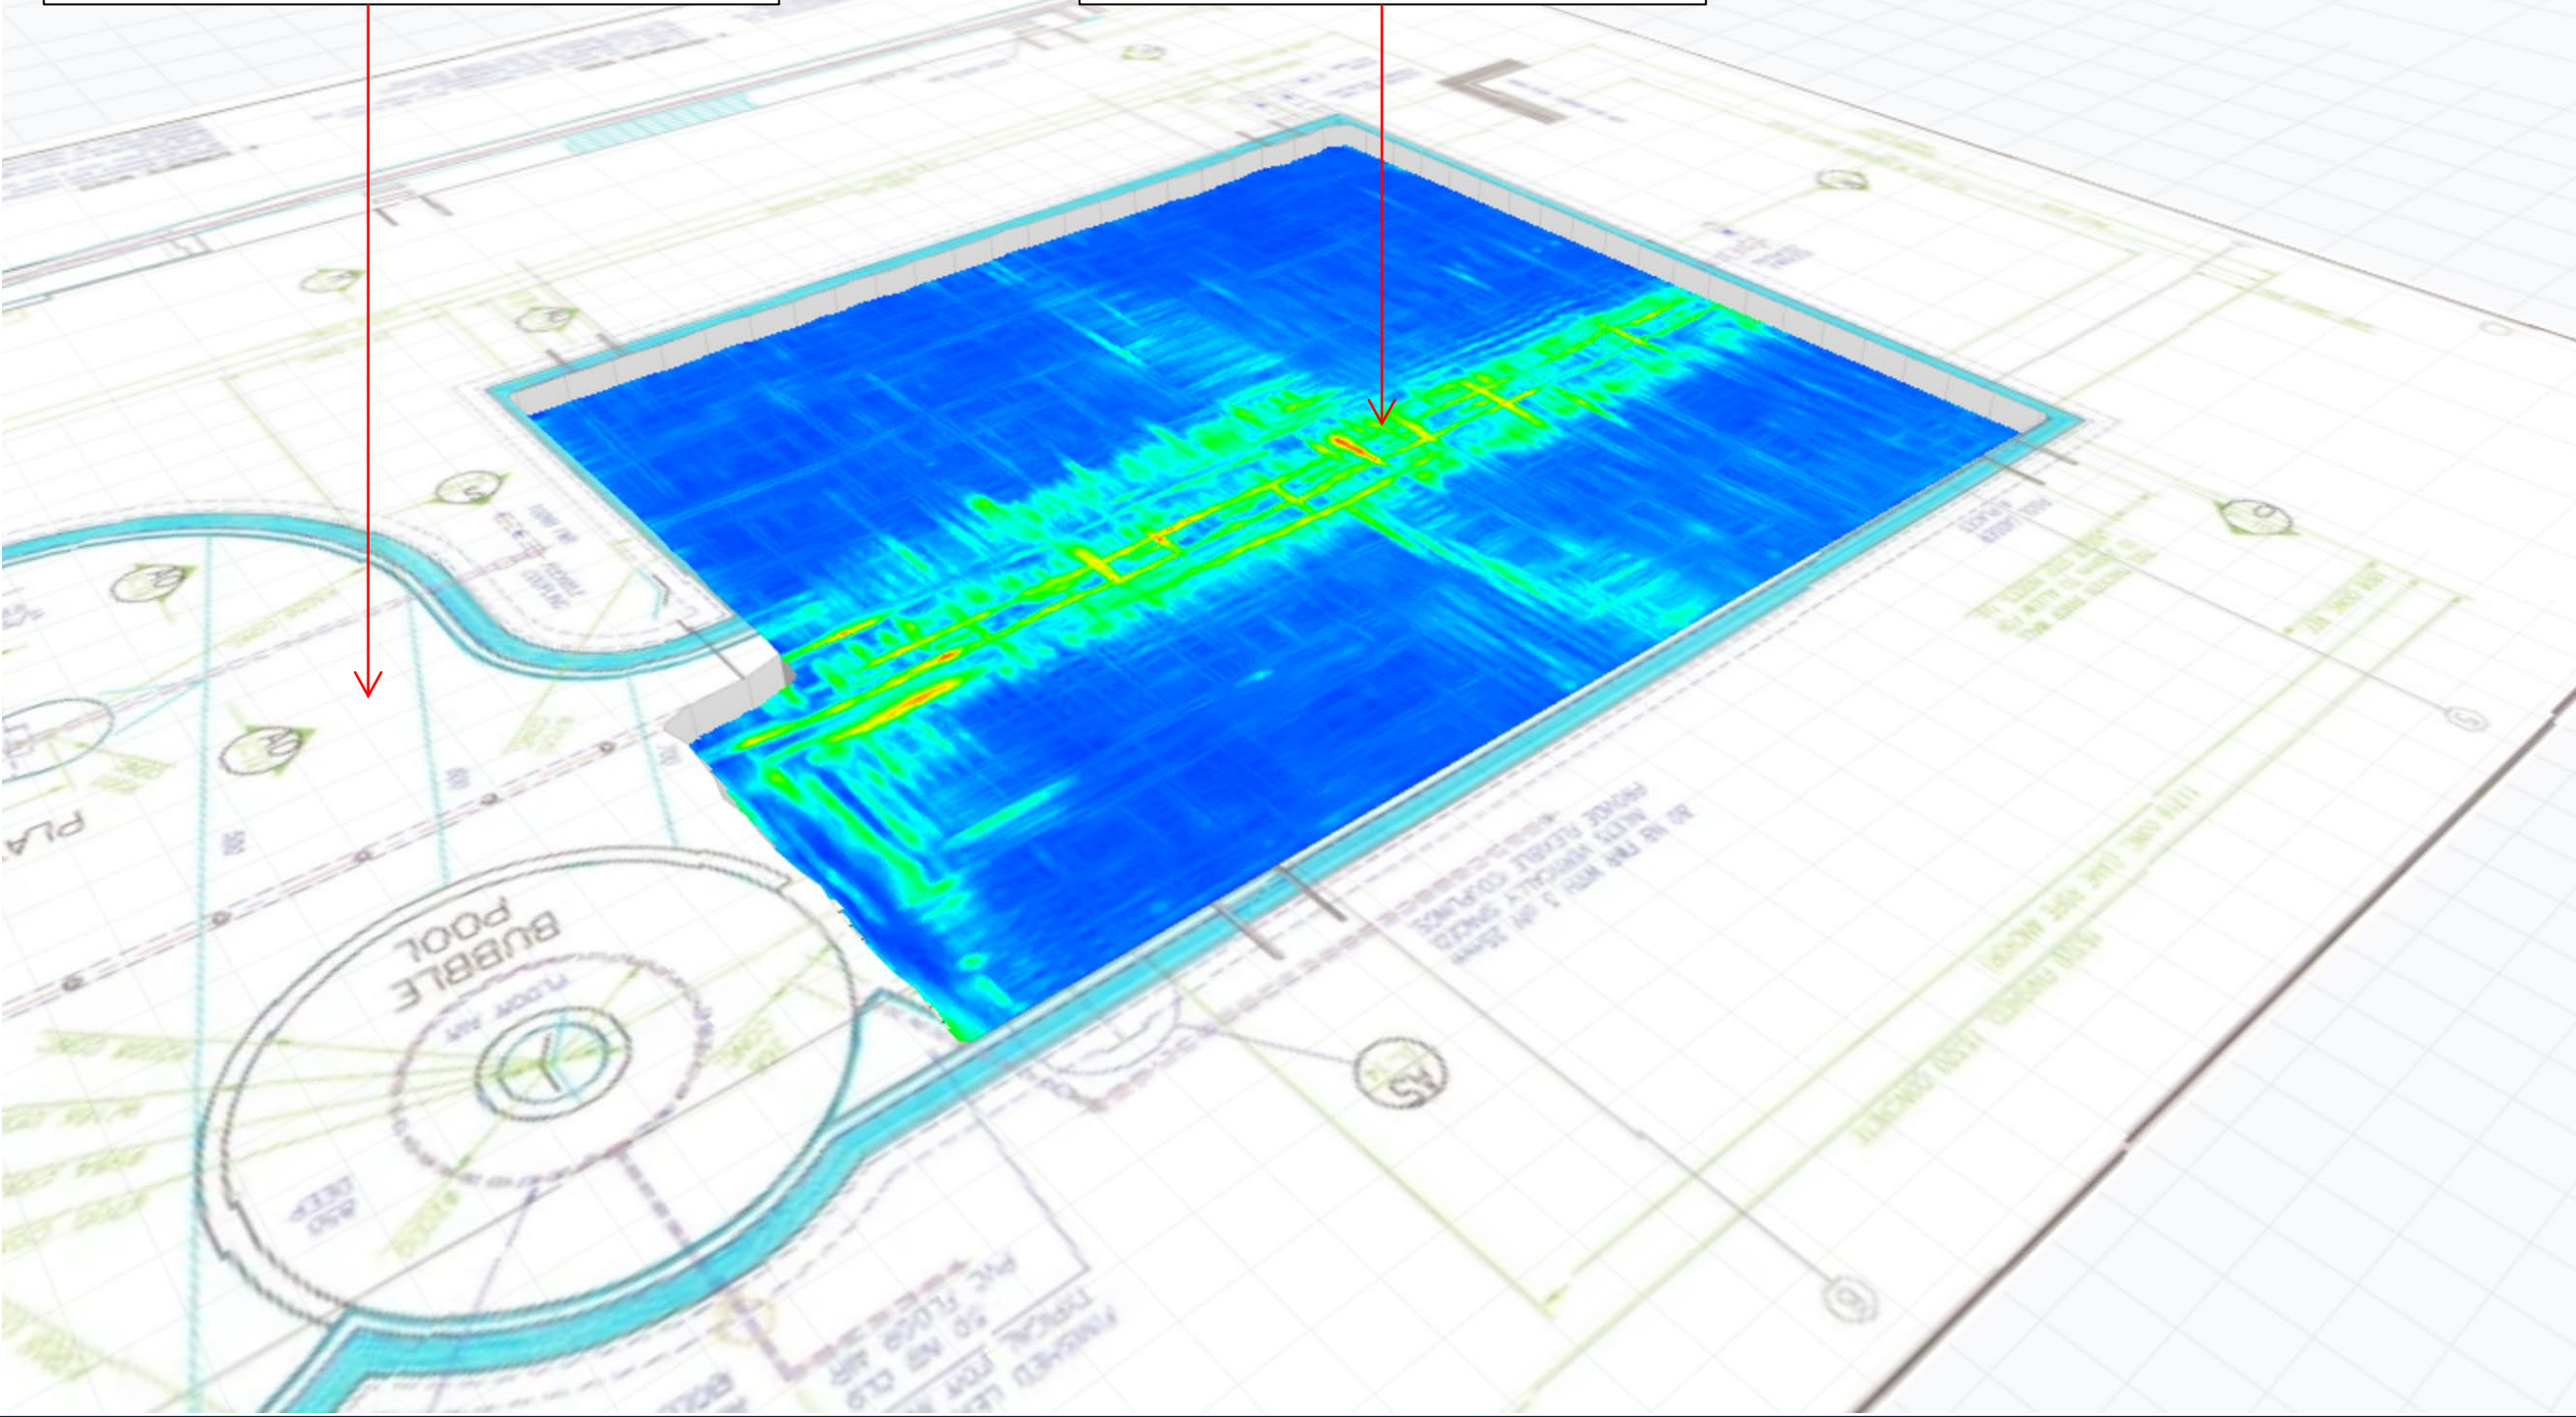
Children's Pool – Pool Shell Assessment

No significant voiding or major anomalies were detected; however, some reinforcement exhibited a higher dielectric response and is highlighted in green throughout this section.

High-frequency GPR assessment of the children's pool identified clear and consistent reinforcement reflections and a generally uniform pool shell response throughout the scanned area. Due to the curved geometry of portions of the pool shell, full grid-based C-scan acquisition was not achievable across all areas. In these locations, a representative 2D B-scan analysis was utilised instead. The B-scan datasets exhibited responses consistent with the C-scan results, indicating generally uniform construction conditions with no evidence of significant voiding or major anomalies. Some localised, elevated dielectric reflections associated with reinforcement were identified and may indicate minor moisture ingress or early-stage localised delamination.

3. Some localised, elevated dielectric responses adjacent to the reinforcement were identified in portions of the pool shell. These responses may indicate minor moisture ingress, localised material variability, or early-stage localised delamination adjacent to reinforcement; however, the overall datasets remained coherent and structurally consistent.

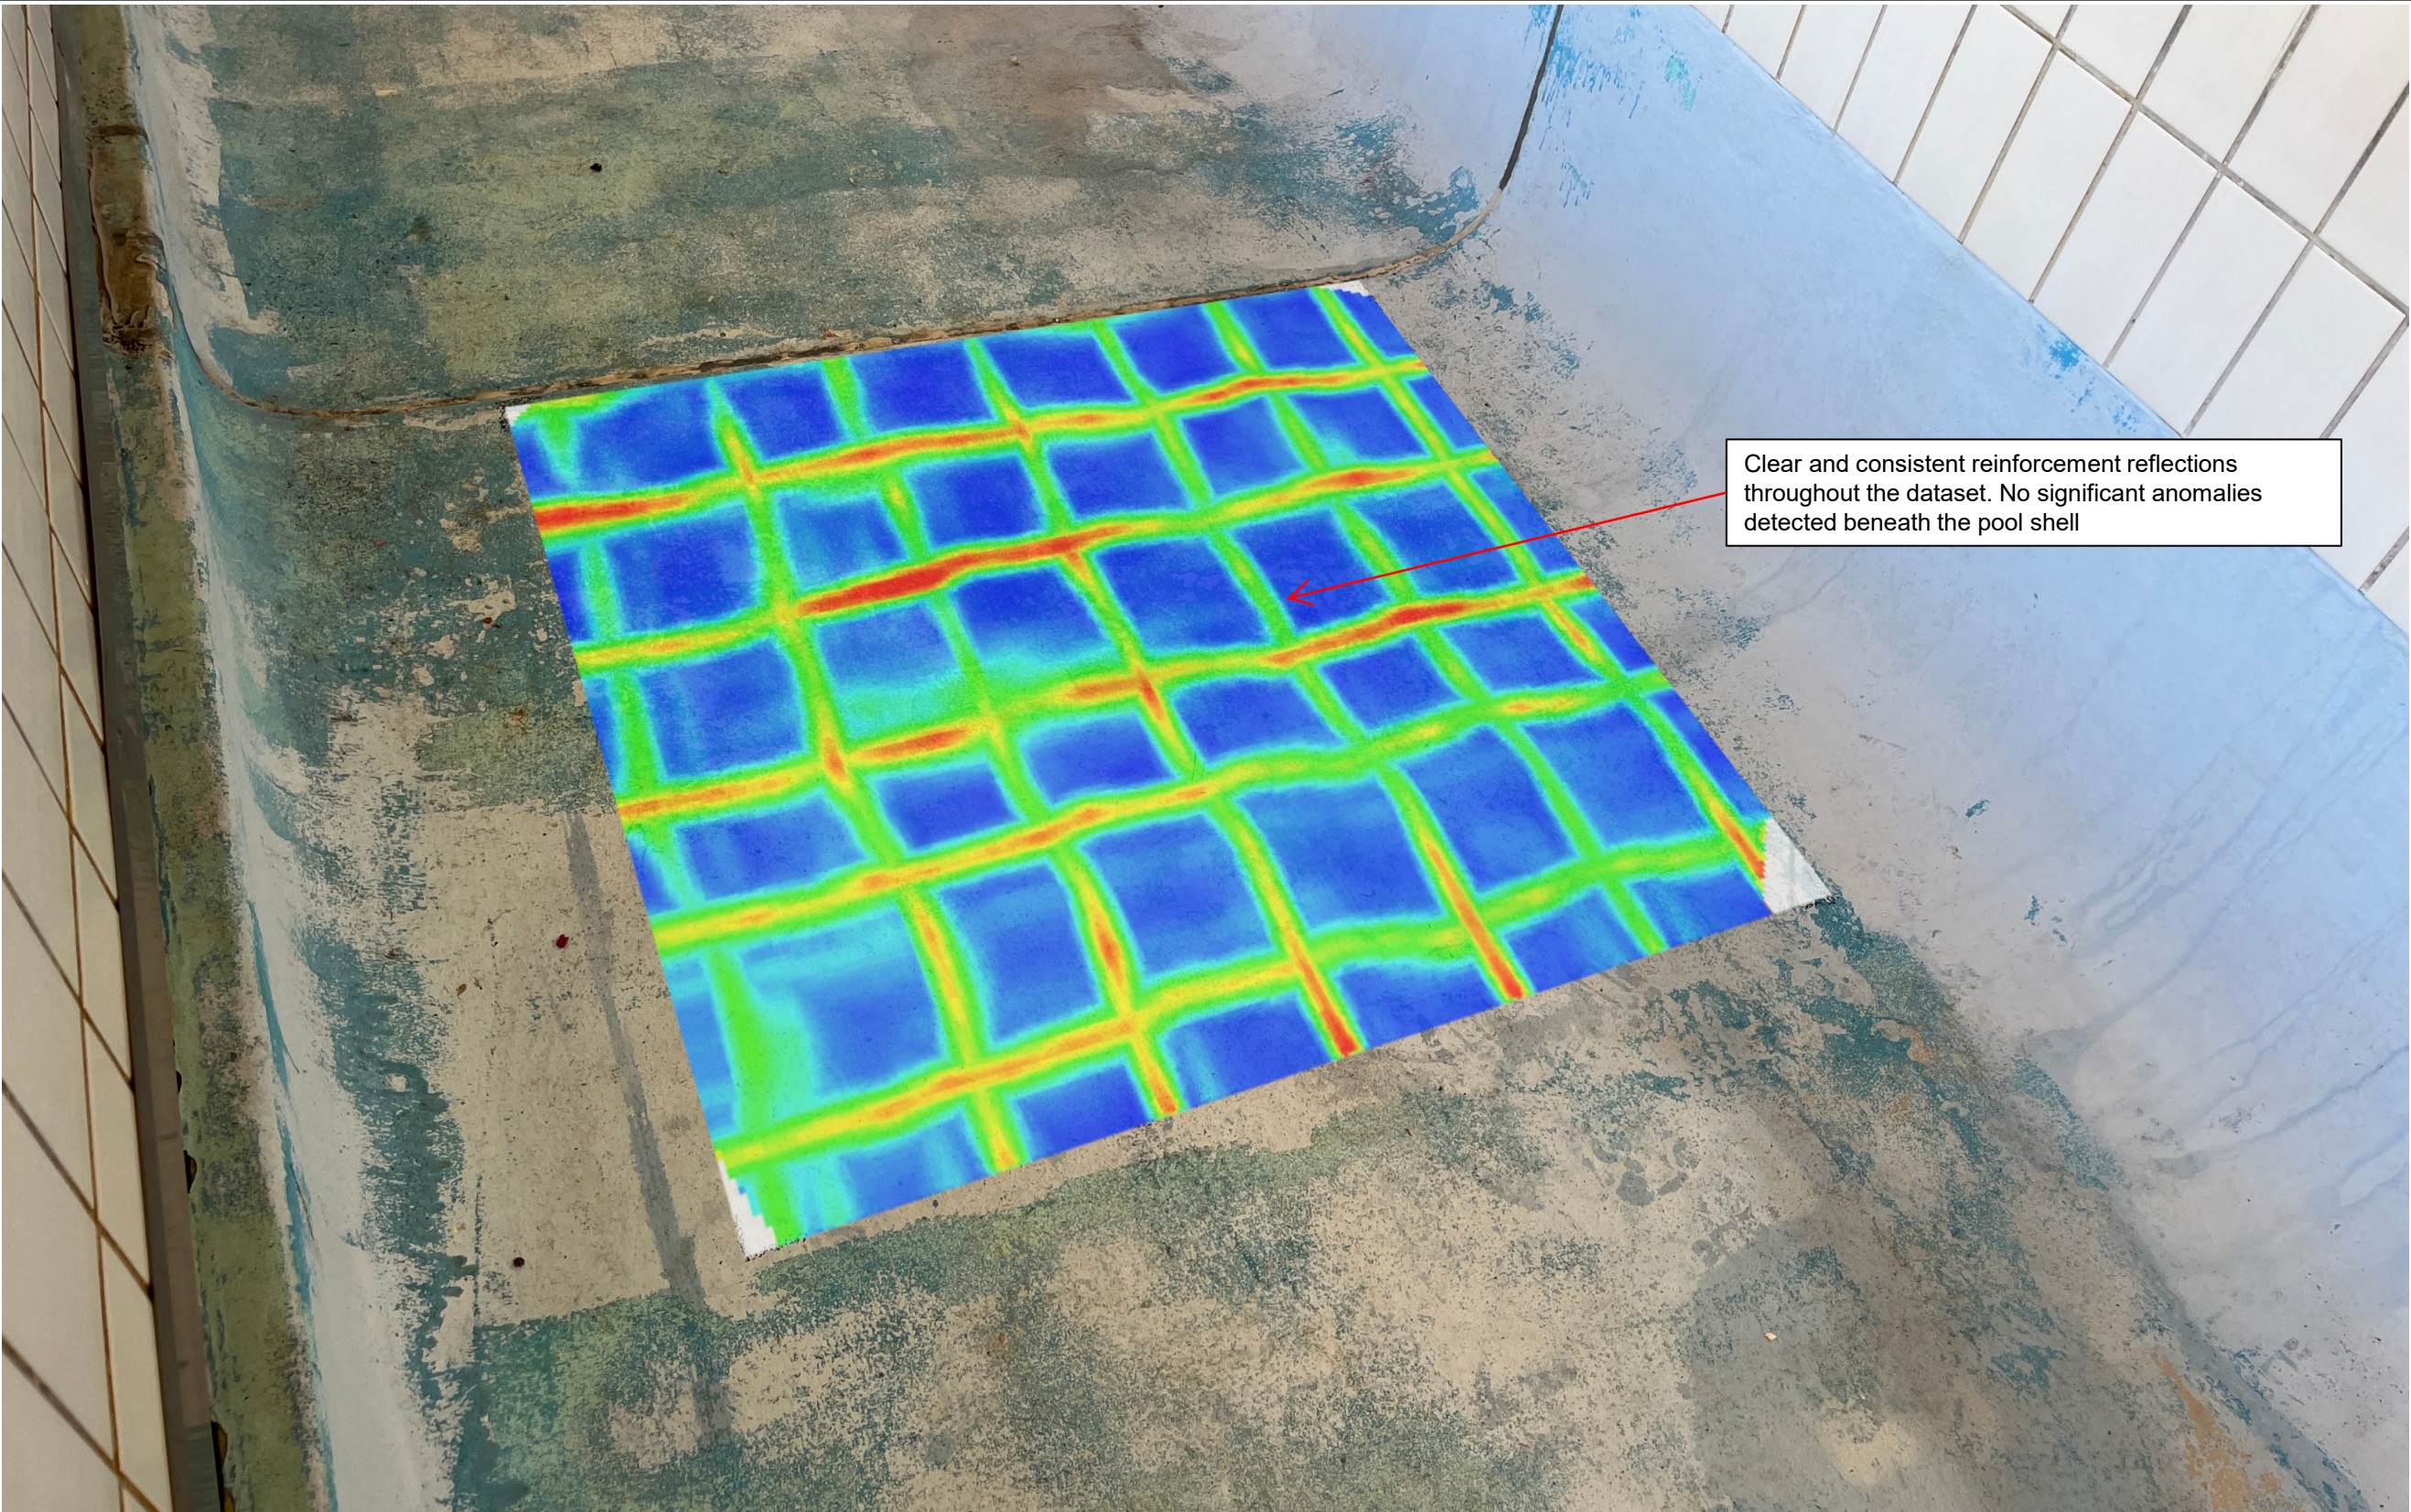
Rapid Pool – Base Slab Assessment

Clear and consistent reinforcement reflections throughout the dataset. No significant anomalies detected beneath the pool shell

GPR assessment of the rapids pool base slab revealed clear, consistent reinforcement reflections throughout the surveyed area. The dataset demonstrated a generally uniform pool-shell response, with no evidence of significant voiding, washout, or structural anomalies beneath the slab. Overall data quality was considered strong and representative of consistent construction conditions.

1. The rapids pool base slab datasets identified generally clear and consistent reinforcement reflections throughout the surveyed areas. High-frequency GPR responses demonstrated relatively uniform pool shell construction conditions with no evidence of significant voiding, major washout, or widespread structural anomalies beneath the base slab. Overall radar response quality throughout the primary slab areas was considered strong and representative of relatively consistent construction conditions.

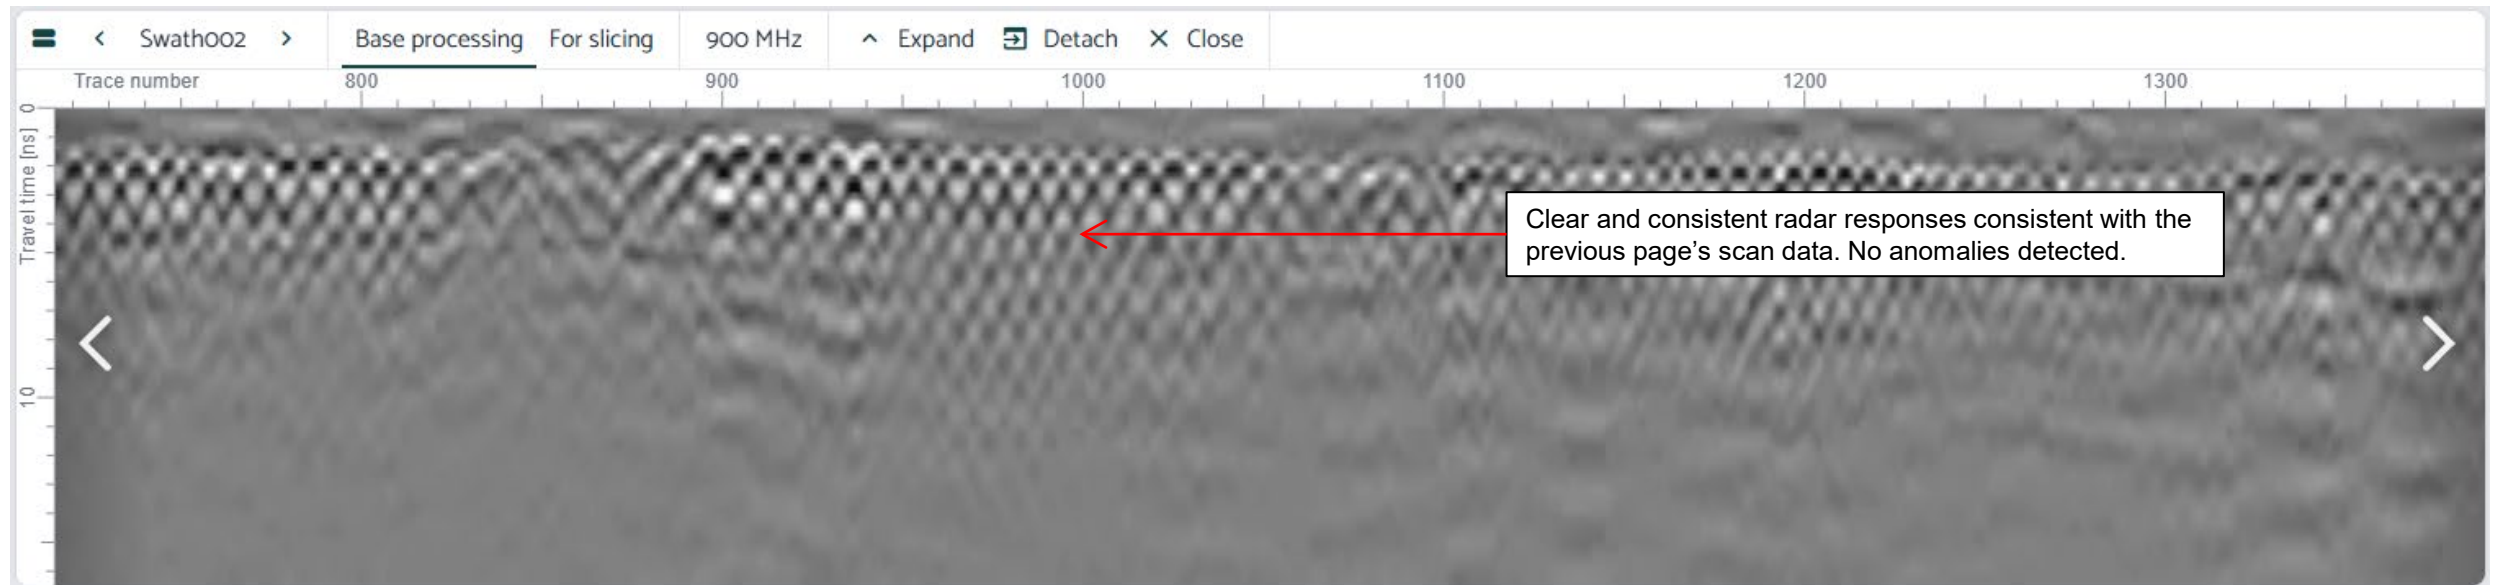
Rapids Pool – Slab Bottom (Swath 2 – Centre)

Due to the complex figure-eight geometry of the rapids pool and the lack of indoor positioning capability, full grid-based C-scan acquisition was not feasible in this area. Representative B-scan datasets were therefore collected across both the pool base and the exterior pool shell using linear-scan acquisition at approximately 200 mm spacing. The upper dataset, representing the pool base slab, showed clear, consistent reinforcement reflections with no evidence of significant voiding or anomalous subsurface conditions. The lower dataset, representing the exterior pool shell, exhibited a comparatively noisier radar response with several localised areas suggestive of minor subsurface washout or void-like conditions beneath the slab. While these responses appear relatively minor and may be typical of ageing aquatic structures, targeted intrusive verification, such as core sampling, may help further characterise these areas.

3. The representative B-scan datasets collected across the pool base slab exhibited clear and consistent reinforcement reflections with no evidence of significant anomalous subsurface conditions. In contrast, portions of the exterior pool shell datasets exhibited comparatively noisier radar responses with several localised areas suggestive of minor subsurface washout, localised support variability, or small void-like conditions beneath the slab. While these responses appear relatively limited in extent and may be typical of ageing aquatic infrastructure, the affected areas may warrant targeted intrusive verification, such as core sampling, should further characterisation be required.

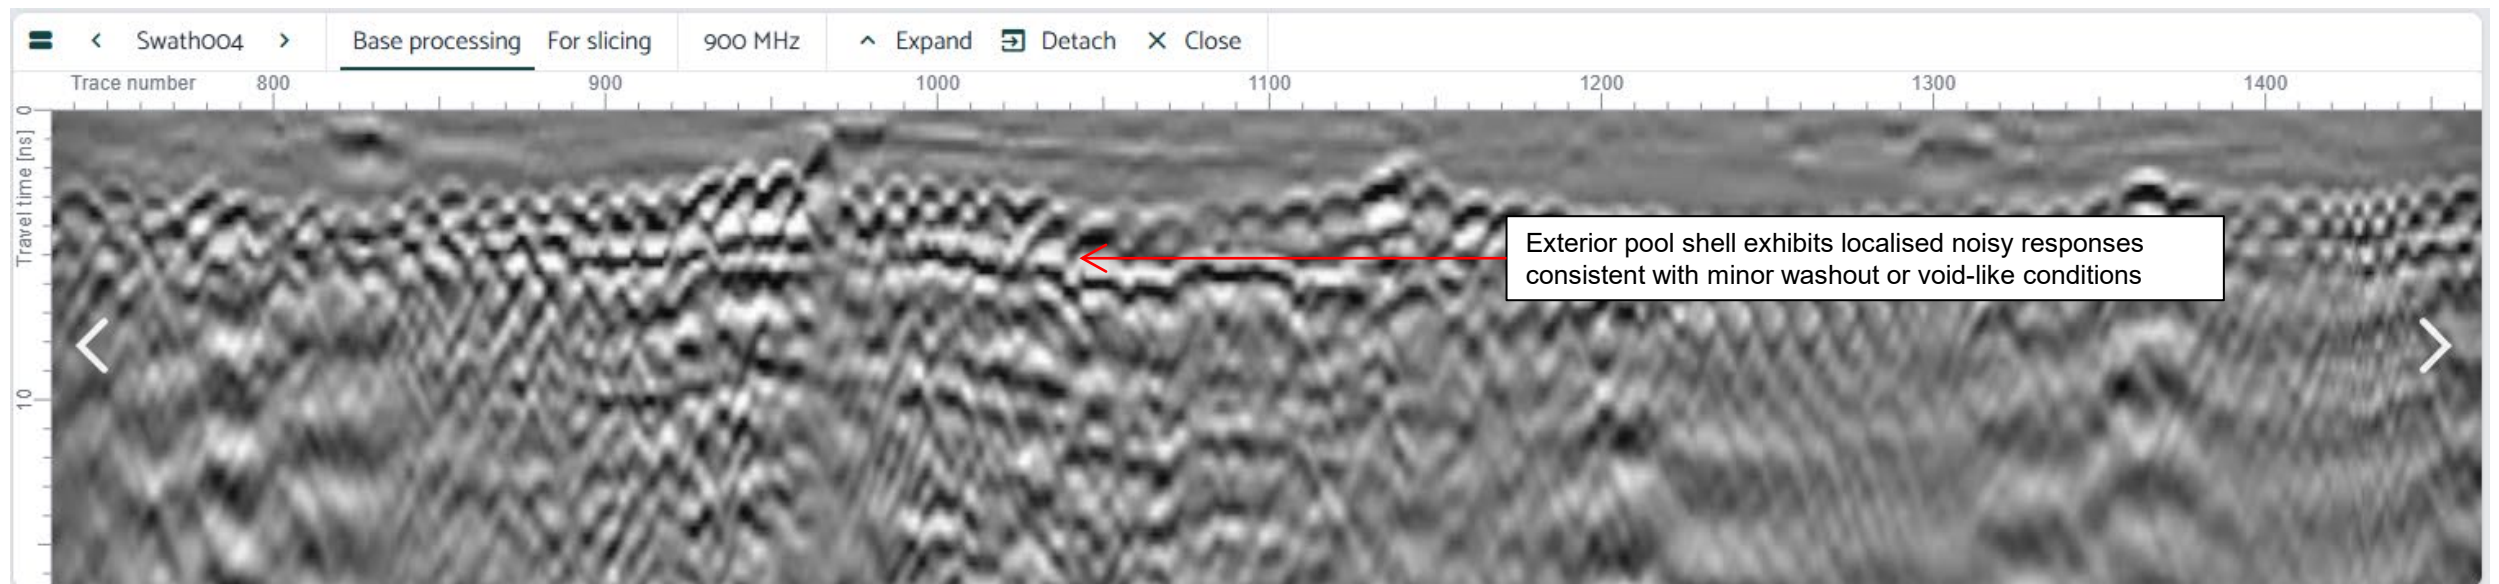
Rapids Pool – Pool Surrounding Slab (Swath 4)

The rapids pool base slab also appears generally consistent, with clear reinforcement reflections and no evidence of significant anomalies beneath the main pool base. The exterior pool shell, however, produced comparatively noisier radar responses with several localised areas suggestive of minor subsurface washout, support variability, or small void-like conditions beneath the slab.

- The localised noisy radar responses identified beneath portions of the rapids pool exterior shell are considered suitable candidates for targeted intrusive investigation, particularly if concerns regarding support loss, water ingress, or ongoing deterioration persist. Core sampling or limited verification works may help confirm whether localised washout or minor void-like conditions are present beneath the slab.

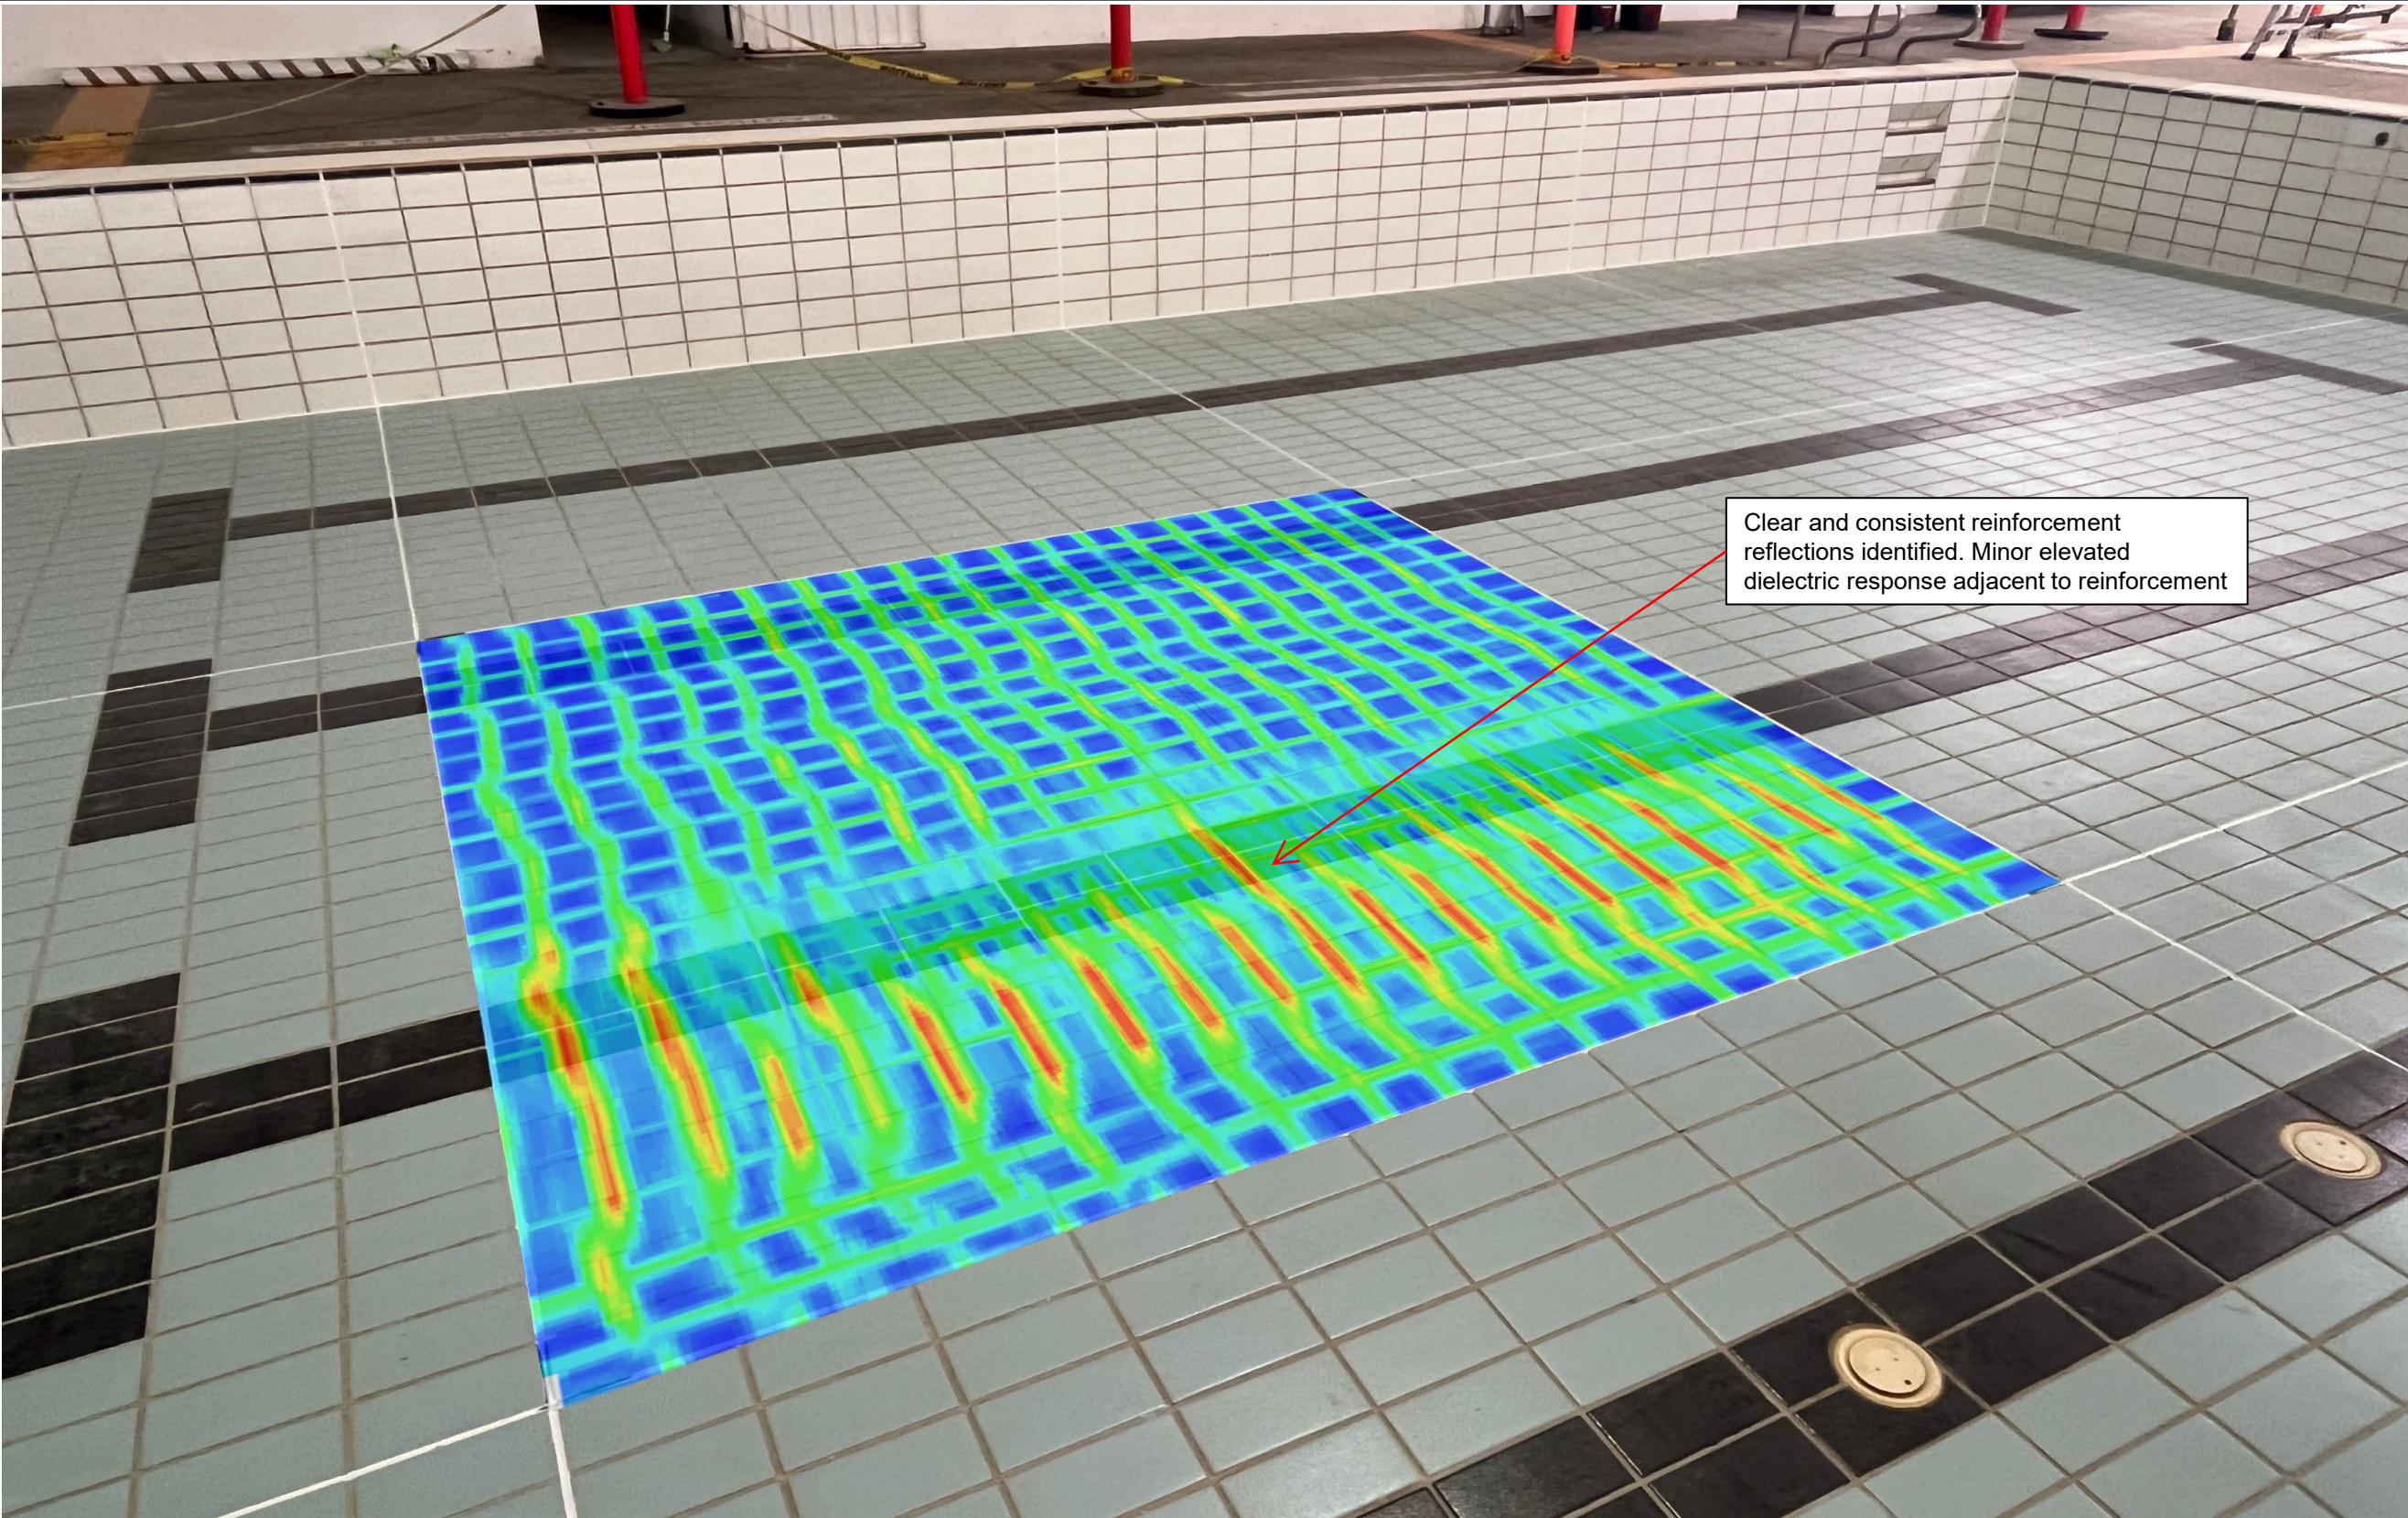
Kids Pool – Reinforcement Verification Scan

Clear and consistent reinforcement reflections identified. Minor elevated dielectric response adjacent to reinforcement

High-frequency IDS C-Thru GPR assessment using a 250 x 250 mm scan grid identified clear and highly consistent reinforcement reflections throughout the pool shell. Reinforcement spacing and slab construction appeared regular and uniform, with no evidence of major structural anomalies. Some localised, elevated dielectric responses associated with reinforcement reflections were identified and may indicate minor moisture ingress or localised changes in the concrete condition adjacent to the reinforcement.

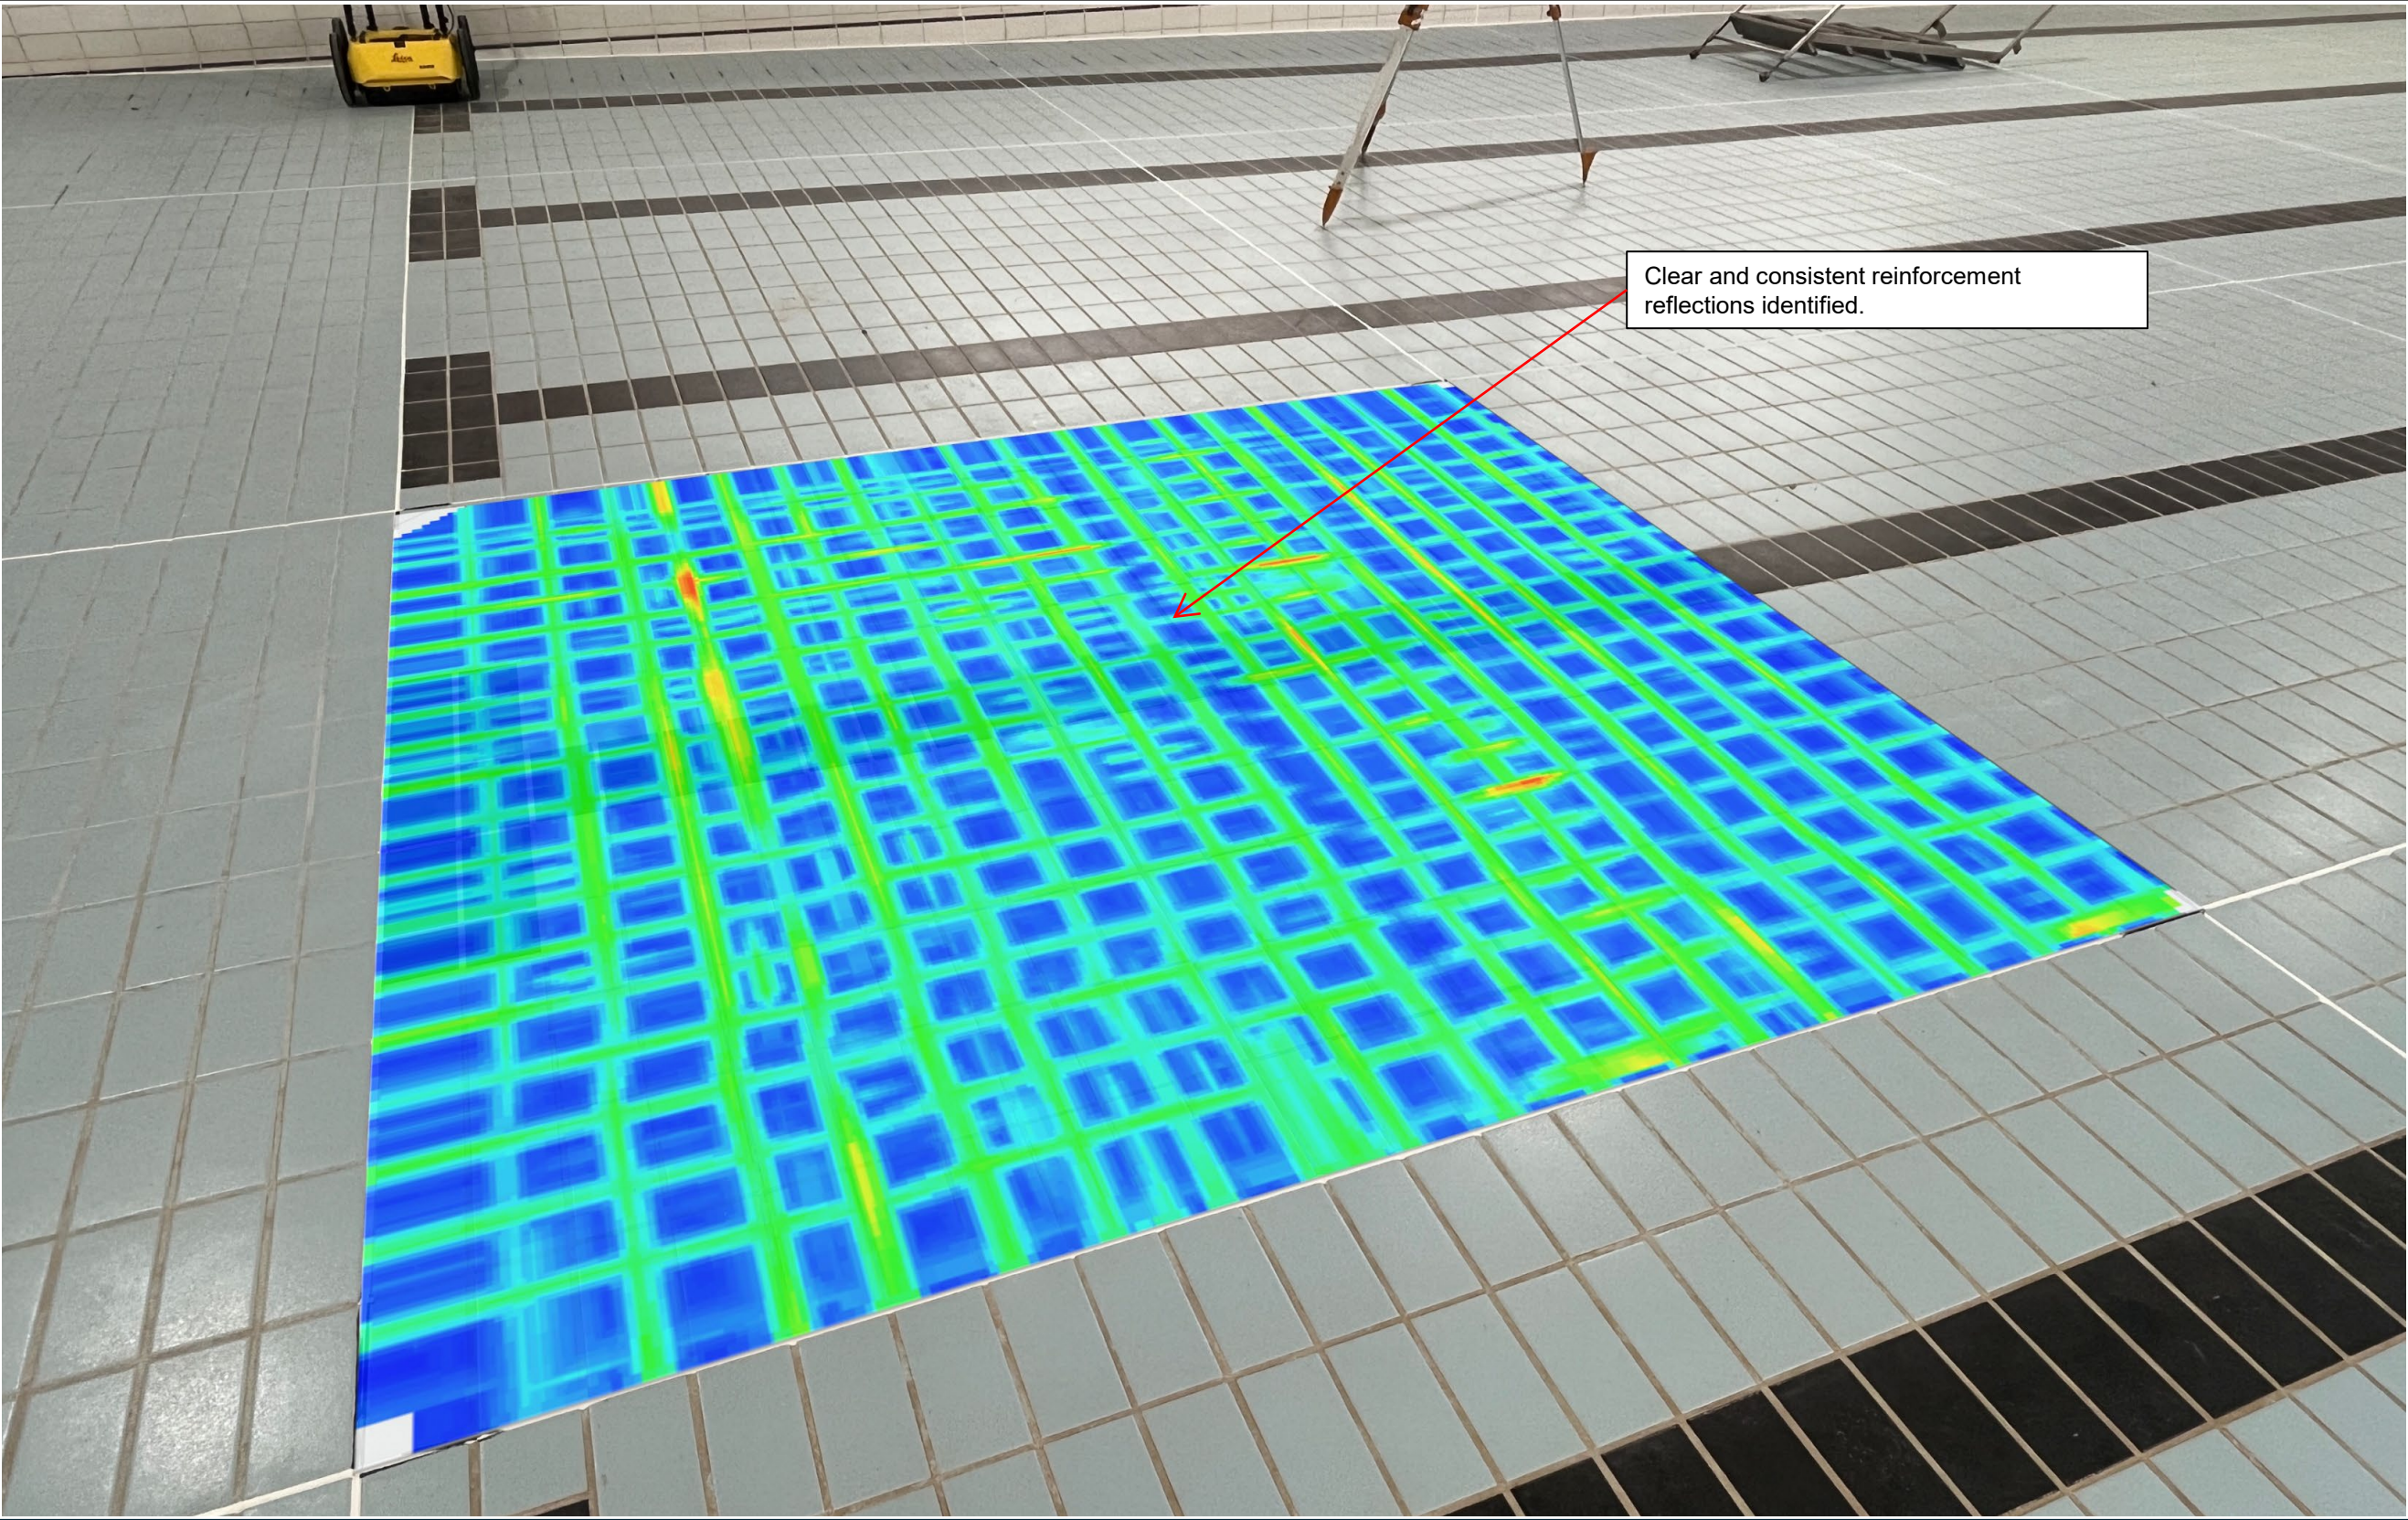
Olympic Pool – Reinforcement Verification Scan (Shallow End)

Clear and consistent reinforcement reflections identified.

The IDS C-Thru reinforcement assessment identified strong, repeatable reinforcement reflections throughout the scanned area, consistent with a well-constructed, relatively uniform pool shell. No evidence of significant discontinuities, voiding, or major structural irregularities was identified within the dataset. Localised dielectric variations associated with reinforcement were present but remained relatively minor.
