GPR and Structural Assessment Report

Southern Downs Regional Council

WIRAC - 29 Palmerin St, Warwick QLD 4370

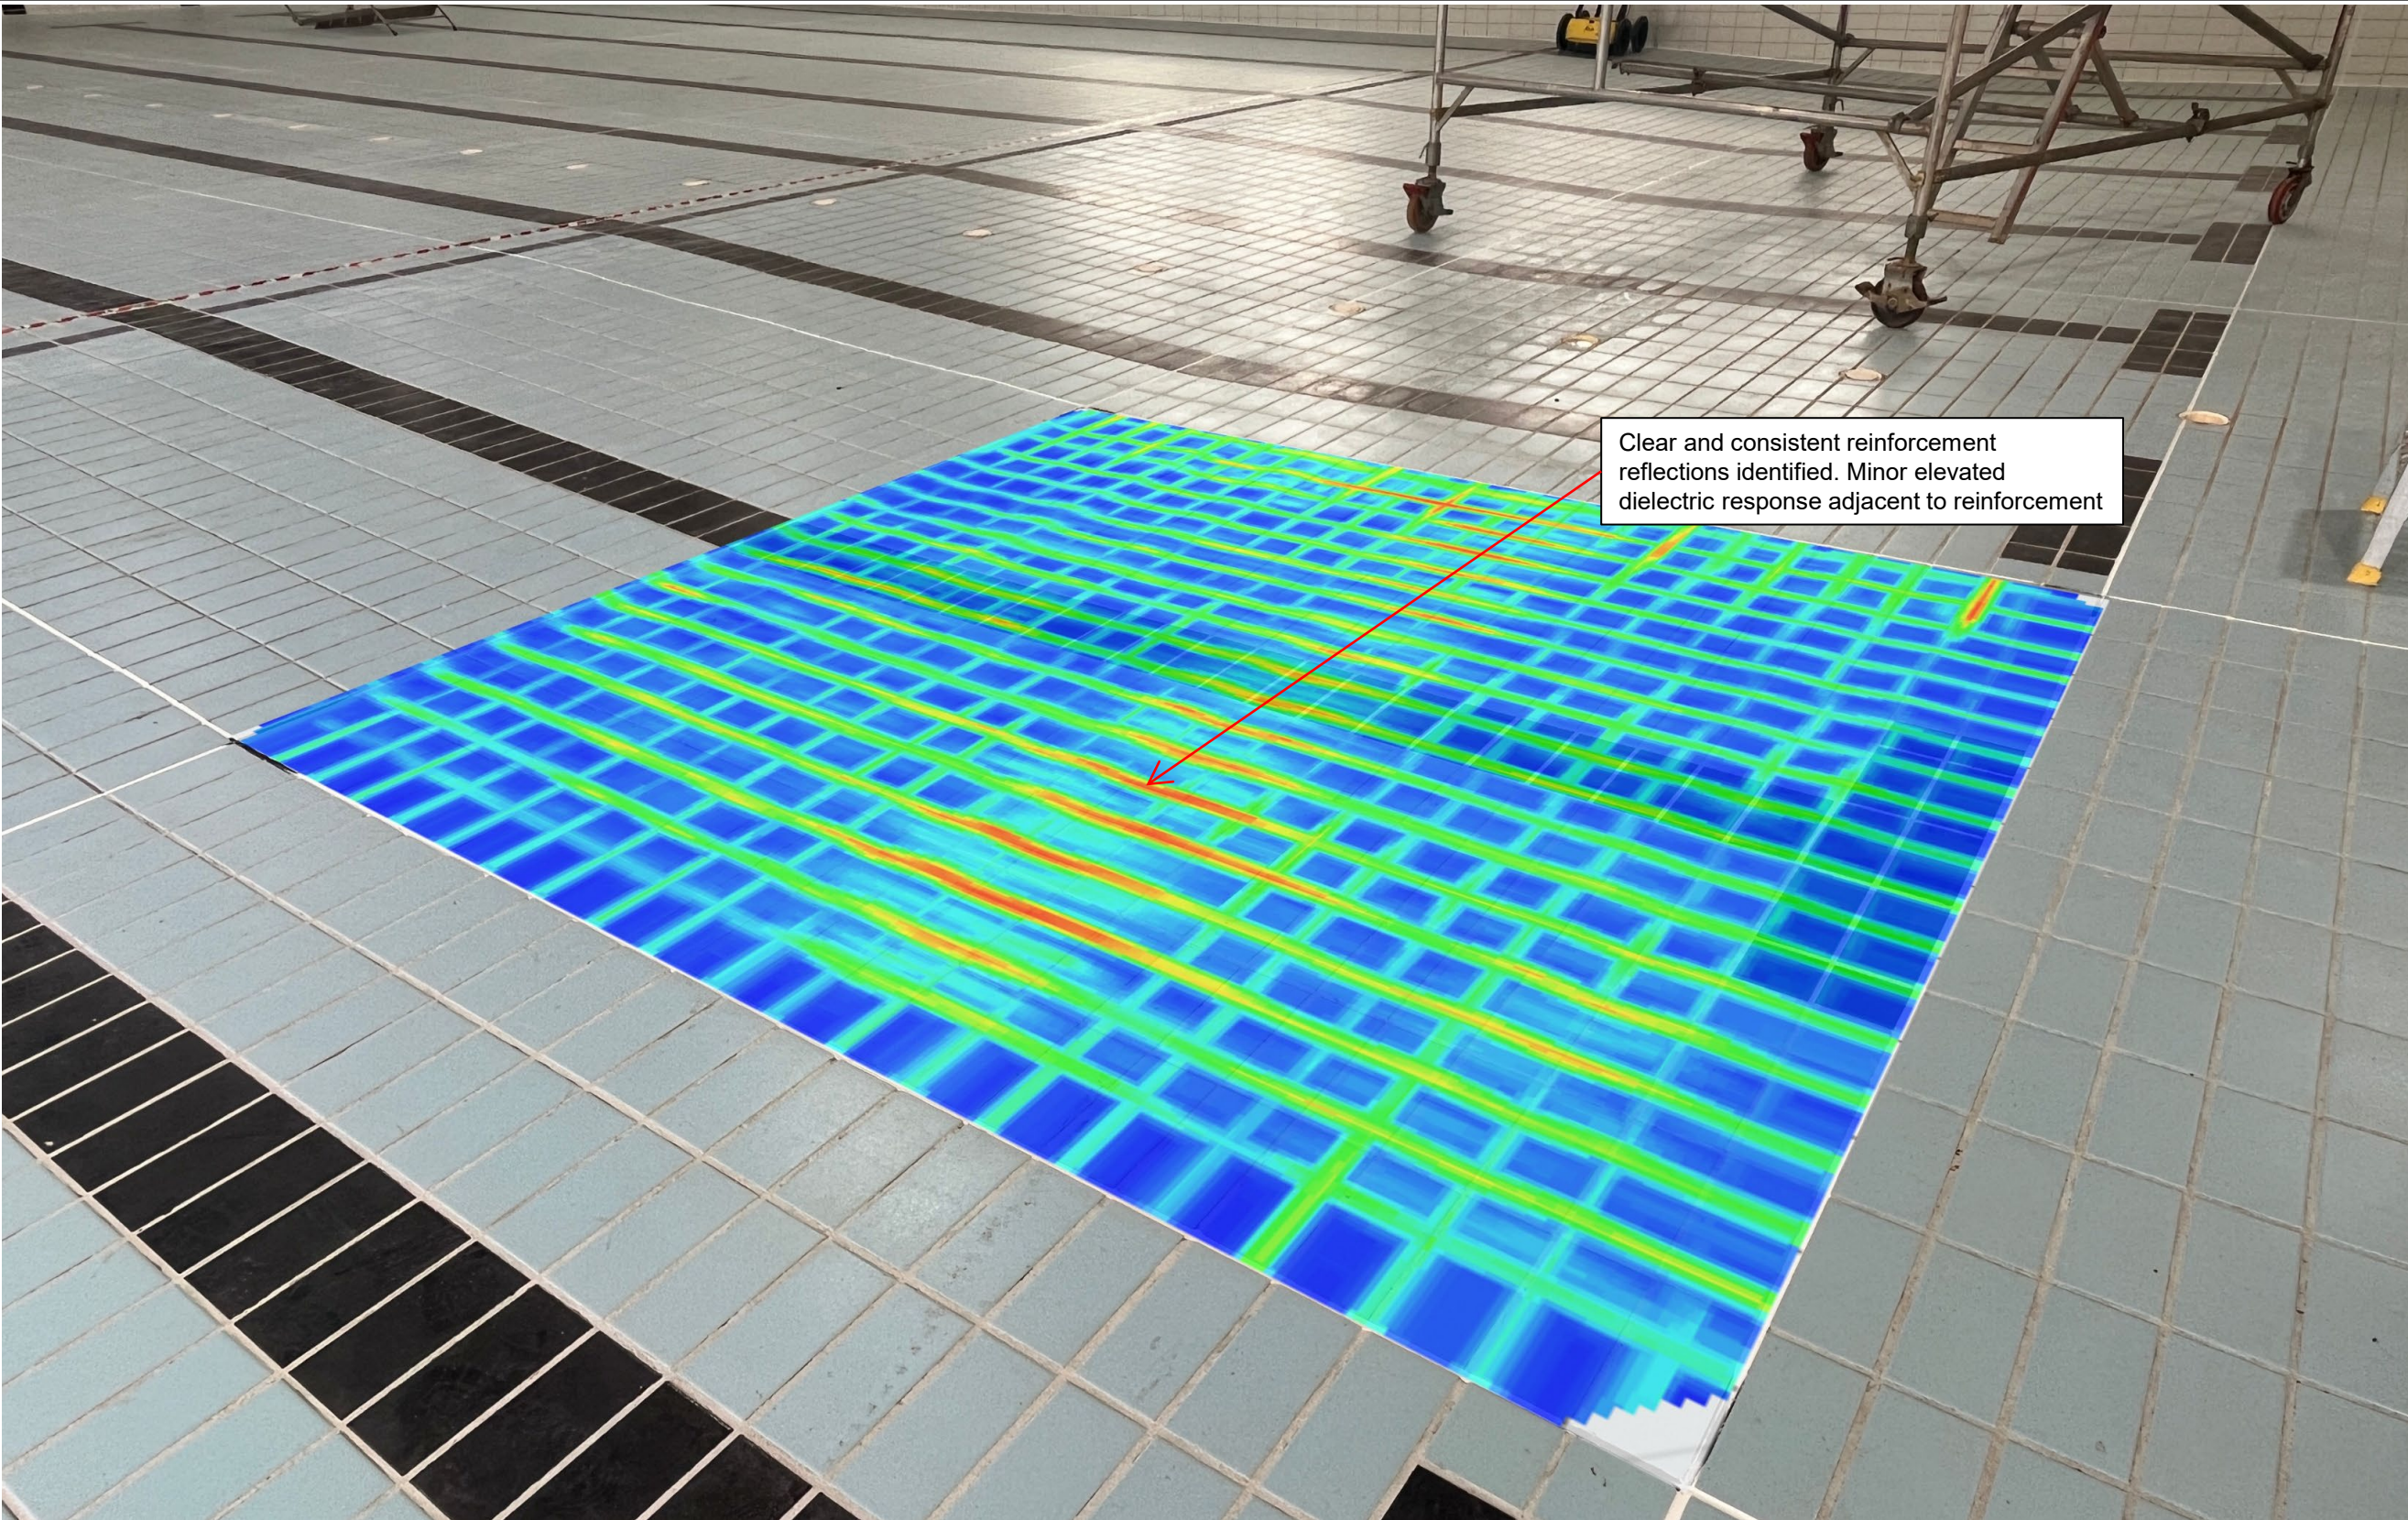
Olympic Pool – Reinforcement Verification Scan 2 (Deep End)

Clear and consistent reinforcement reflections identified. Minor elevated dielectric response adjacent to reinforcement

Detailed reinforcement assessment using high-frequency concrete scanning identified highly coherent and consistent radar responses across the surveyed area. Reinforcement configuration and slab response appeared regular, with no major anomalies identified. Minor elevated dielectric responses associated with reinforcement may indicate localised moisture presence or early-stage material variability adjacent to reinforcement.
