GPR Survey Report

Client: RoadTek Mackay (TMR)

Location: Marion Creek Bridge QLD

Evaluation of asphalt cover depths and GPR data assessment.

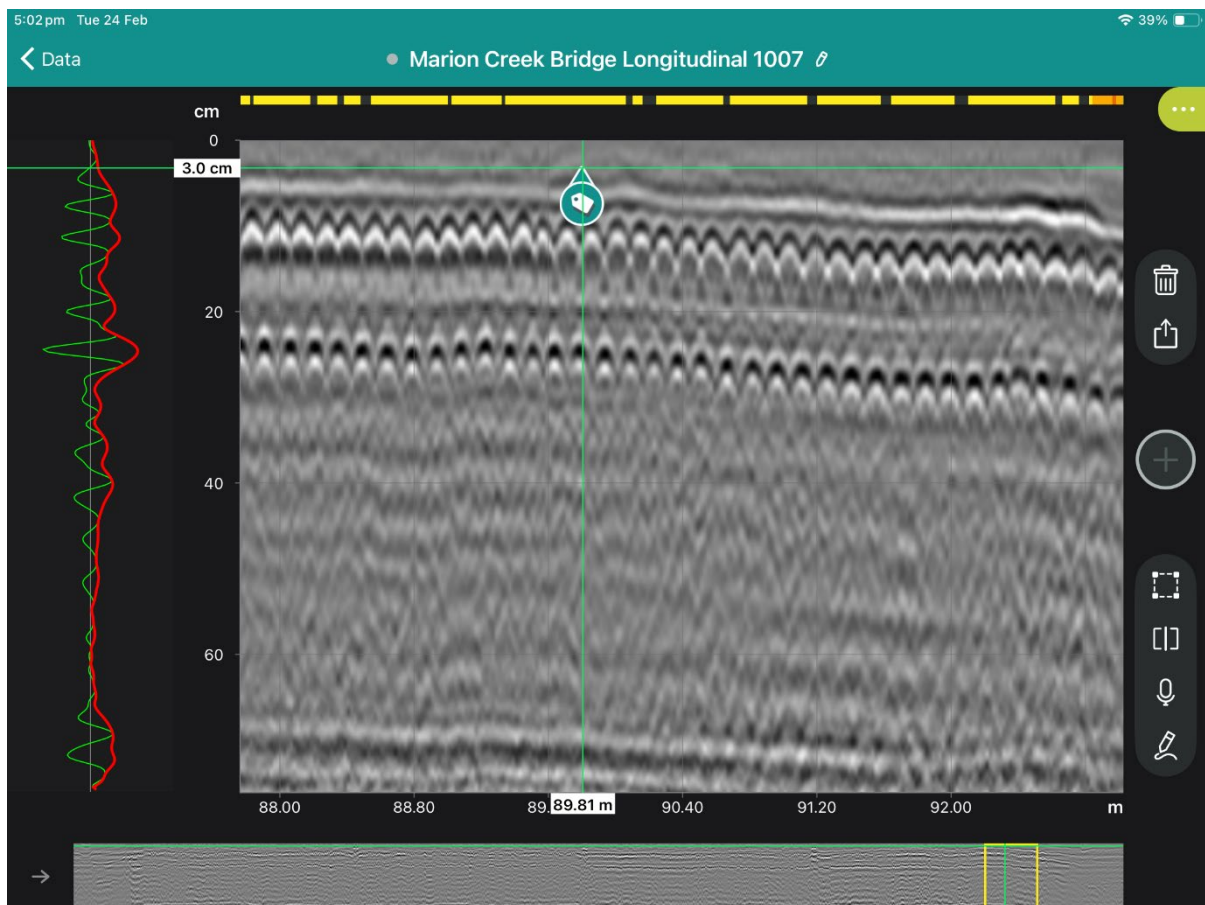
Figure 2: Longitudinal GPR profile illustrating a thinner asphalt section, with the asphalt–concrete interface interpreted at approximately 30 mm depth. The interface is less clearly defined on the B scan, requiring confirmation through detailed A-scan wiggle-trace analysis. The green waveform identifies the correct phase of the reflected signal, while the red envelope highlights reflection strength. The A-scan confirms a shallow wearing surface at this location, consistent with the localised thinning observed across the bridge.
