## GPR Structural Investigation Site Report for Capital Consulting Engineers Anna Creek Bridge, Burton QLD

# Anna Creek Bridge GPR and Profometer Inspection Report

This report presents the results of a Ground Penetrating Radar (GPR) and Profometer survey conducted on 06/05/2025 at the Anna Creek Bridge in Burton, QLD. The survey was performed for Capital Consulting Engineers to non-destructively inspect the internal reinforcement of the bridge's concrete elements. Key findings indicate that the bridge is a conventionally reinforced concrete structure with no evidence of pre-tensioned or post-tensioned tendons. GPR scans revealed regularly spaced stirrups (vertical reinforcement) in the bridge beams at approximately 200 mm intervals (with a denser ~100 mm spacing in a central region of each span), and a concrete cover of roughly 50 mm over the beam reinforcement. Two layers of longitudinal steel were identified in the outer beams, and the deck slab was found to be ~200 mm thick with distinct top and bottom reinforcement layers. Scans of the supporting plinth (pier headstock) confirmed a grid of reinforcement (horizontal and vertical bars at ~150 mm spacing). Profometer (eddy-curre

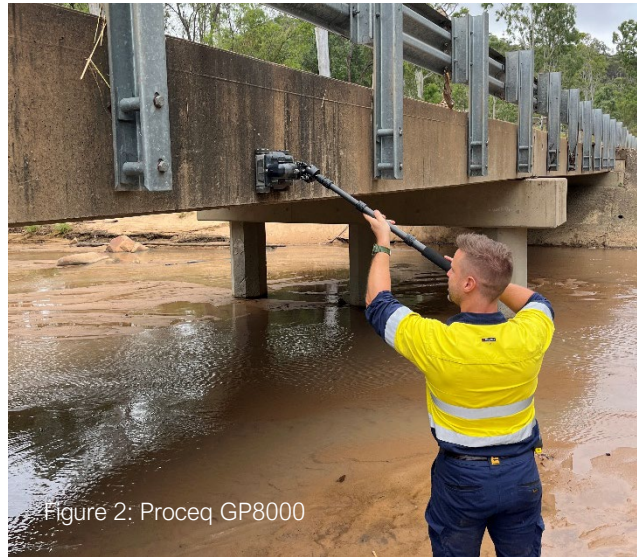
Figure 2: Proceq GP8000

The survey was conducted using a Proceq GP8000 GPR unit and a Proceq Profometer PM8000 cover meter. The Proceq GP8000 is a high-resolution ground penetrating radar device designed for concrete inspection, which emits radio frequency pulses into the concrete and records reflections from embedded objects or interfaces. The GPR system self-calibrates each time it is powered on, so no factory calibration was needed on-site. However, the team performed on-site calibration checks for depth accuracy: the concrete's dielectric constant was adjusted in the GPR

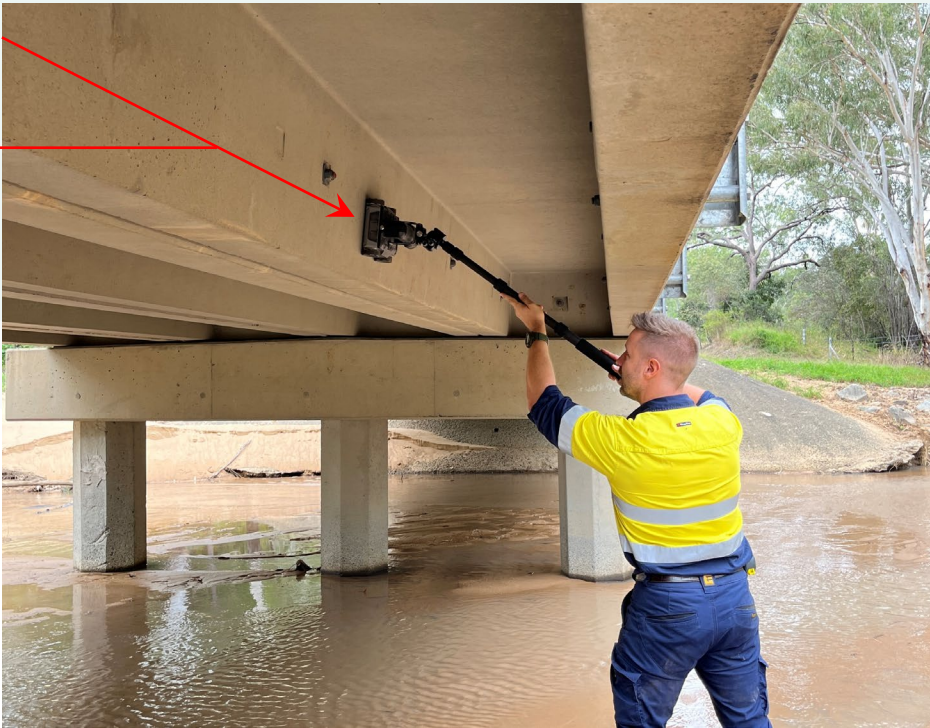
Main Girder – Vertical Rebar

This scan shows clear vertical rebar (stirrups) spaced approximately every 200 mm along the beam, with a concrete cover of ~50 mm. The regularity of spacing demonstrates consistent construction, and the radar intensity supports the presence of standard shear reinforcement.

The bridge has longitudinal concrete beams (girders) supporting the deck. GPR scans of the beam webs (the vertical sides of the beams) revealed a pattern of closely spaced vertical reinforcement along the length of each beam. These are interpreted to be stirrups (shear reinforcement) or the vertical legs of a shear cage. The stirrups are generally spaced at roughly 200 mm intervals along the beam (with a tolerance of about  $\pm 10\%$  as some variance was noted). Notably, a denser stirrup spacing zone is near the bridge's centre. For approximately 1.5 m to either side of the bridge centre (a ~3 m wide central segment of each span), the stirrup spacing tightens to around 100 mm. This effectively means every second stirrup is closely paired in that centre zone. In design terms, such a pattern is somewhat unusual when considering a supported span (since shear demand is typically highest near the supports); however, in this case, the bridge's "mid-span" corresponds to the area over the central support (for a two-span continuous deck, the centre of the bridge is at the pier). Therefore, the dense stirrup region likely correlates with the high shear and negative moment region over the central pier (support). Outside of this central zone, towards the end supports/abutments, the stirrup spacing is the standard ~200 mm. The concrete cover to the stirrups on the beam sides was measured to be approximately 50 mm, meaning the outermost rebar is about 50 mm beneath the concrete

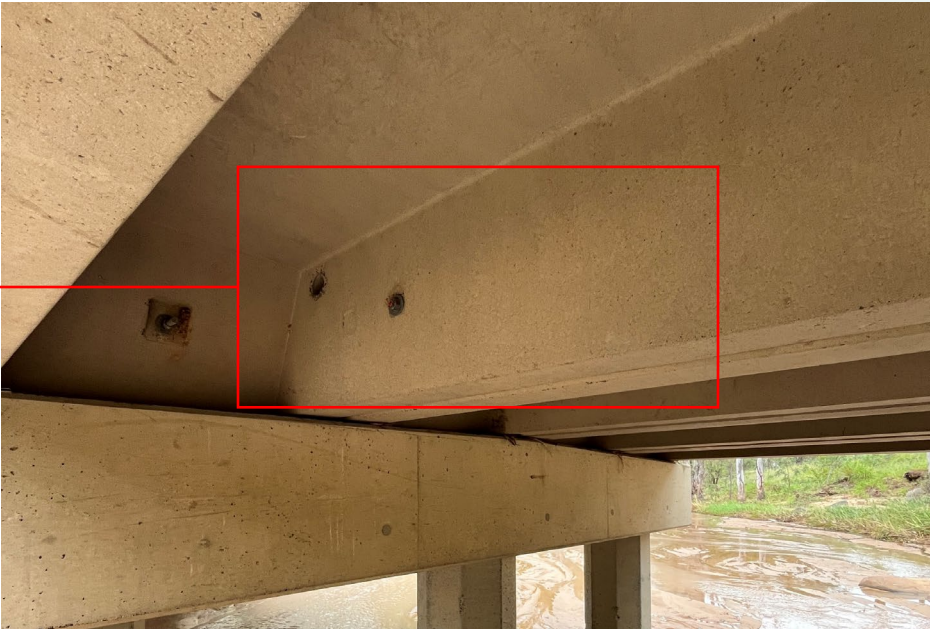
Main Girder – 100 mm Stirrup Spacing at Centre

The radargram shows dense, evenly spaced hyperbolas at ~100 mm intervals, confirming tighter stirrup spacing in the mid-span region over the support plinth. This reinforcement pattern matches expected detailing in high shear and negative moment zones.

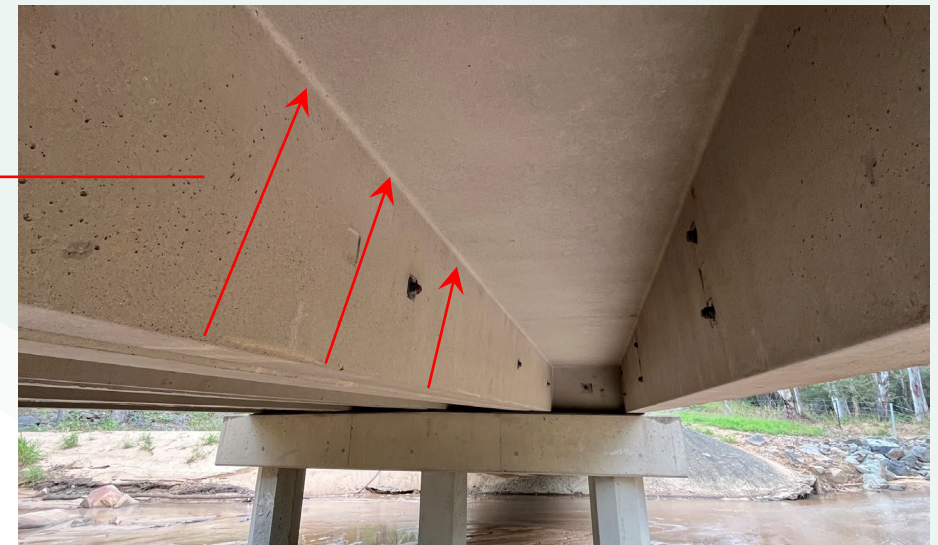
Girder - Horizontal Rebar Scan

This vertical scan up the beam face captures three distinct radar reflections in a U-shaped pattern, typical of stirrup or shear cage configurations. The depth and pattern of these signals indirectly confirm the presence of longitudinal reinforcement enclosed by stirrups.

It should be noted that directly imaging the beams' longitudinal (horizontal) bars (the primary flexural reinforcement running along the span) was more challenging. Because these bars run lengthwise, a GPR scan along the beam is parallel to them and thus does not strongly capture them, and a vertical scan on the side only grazes them at best. However, the radar data provided indirect evidence of these longitudinal bars. In some cross-sectional radargrams, a characteristic three-hyperbola pattern was observed within a ~600 mm width of the beam's cross-section. This pattern corresponds to a U-shaped stirrup or cage: essentially, the radar picks up the two vertical legs and the bottom horizontal segment of a stirrup. This indicates that the longitudinal bottom bars are present and enclosed by these stirrups (since the bottom of the stirrup would typically loop under or around the bottom longitudinal bars).

In summary, while we did not get a direct, clear image of the main bottom bars (due to orientation and access limitations), the presence of a well-defined stirrup cage strongly implies that the primary tension reinforcement (bottom bars) and any top bars in the beam are in place as expected. Additionally, where the GPR scans were done near the beam bottoms (at an angle), there were faint reflections consistent with two layers of longitudinal bars, which are likely the bottom layer of steel and an upper layer (possibly at the top of the web or as part of a flange). This ties in with the findings on the outer beams, described next.

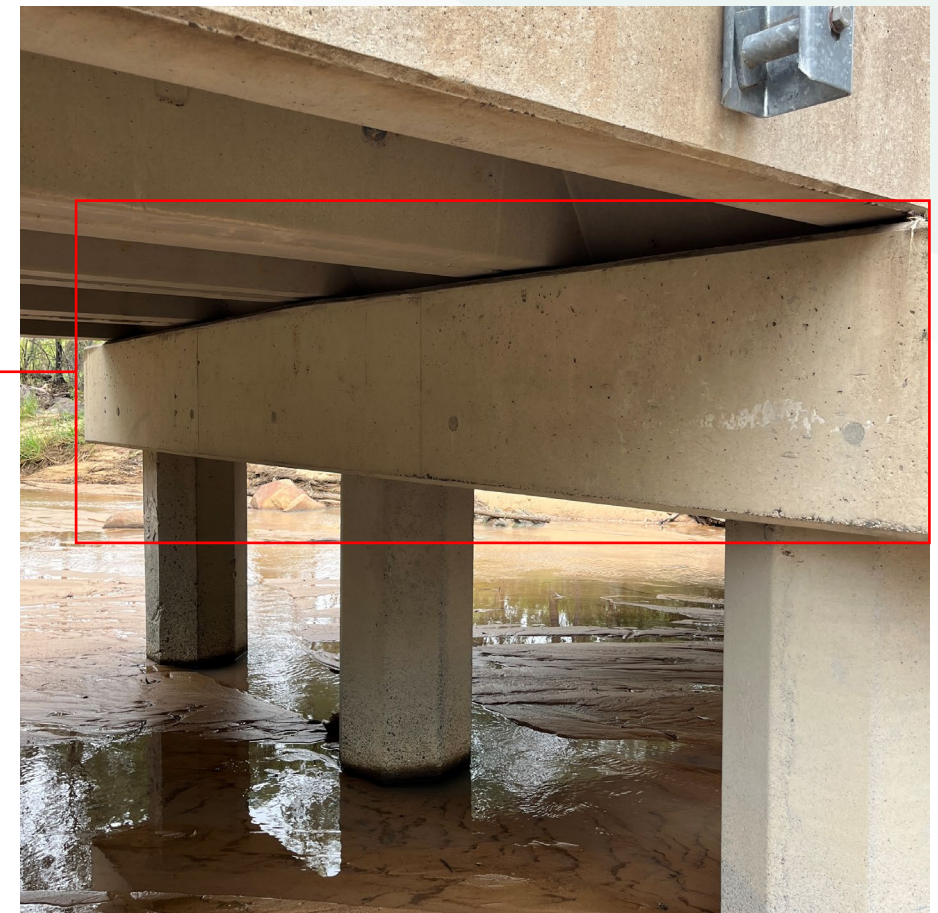
## Plinth Scan

This scan of the supporting plinth reveals multiple hyperbolic reflections in both X- and Y-axes, indicative of a rebar grid at ~150 mm spacing. The signal intensity and spacing confirm the presence of a dense reinforcement mat designed to distribute support loads from the superstructure.

The supporting plinth refers to the concrete block or headstock atop the central pier columns on which the bridge spans rest (as visible in the photographs of the mid-span support). This element was also scanned on its accessible faces. The GPR results for the plinth indicate a dense mesh of reinforcement within. In the horizontal direction (along the length of the headstock), approximately four parallel reinforcement bars were detected within the depth range of the GPR on each scanned face. These appear as four distinct hyperbolas, suggesting roughly 150 mm spacing between each bar (since the plinth's face likely covers around 450 mm to 500 mm of depth where four bars were seen). The cover for these horizontal bars was about 100 mm from the surface of the plinth.

In the vertical direction (scanning up the side of the plinth), similarly frequent reflections were observed, indicating vertical bars spaced roughly 150 mm apart (likely the dowels or stirrups within the plinth), with a cover of around 90 mm from the top of the plinth surface to the first bar (or from the side surface to side vertical bars, if any). The plinth contains a rebar grid at approximately 150 mm centre-to-centre spacing in both directions. The slightly larger cover on the horizontal bars (100 mm) compared to the vertical bars (90 mm) could be due to orientation or measurement tolerance. Still, it shows the rebar is well embedded (3-4 inches cover, which is reasonable for a significant structural element to protect the steel). This heavy reinforcement in the plinth is expected because it has to distribute the column loads to the beams and vice versa. The scan of the plinth did not show any unusual features; the reinforcement layout there is typical of a heavily reinforced support block (with likely a cage of rebars forming a mat in both directions).

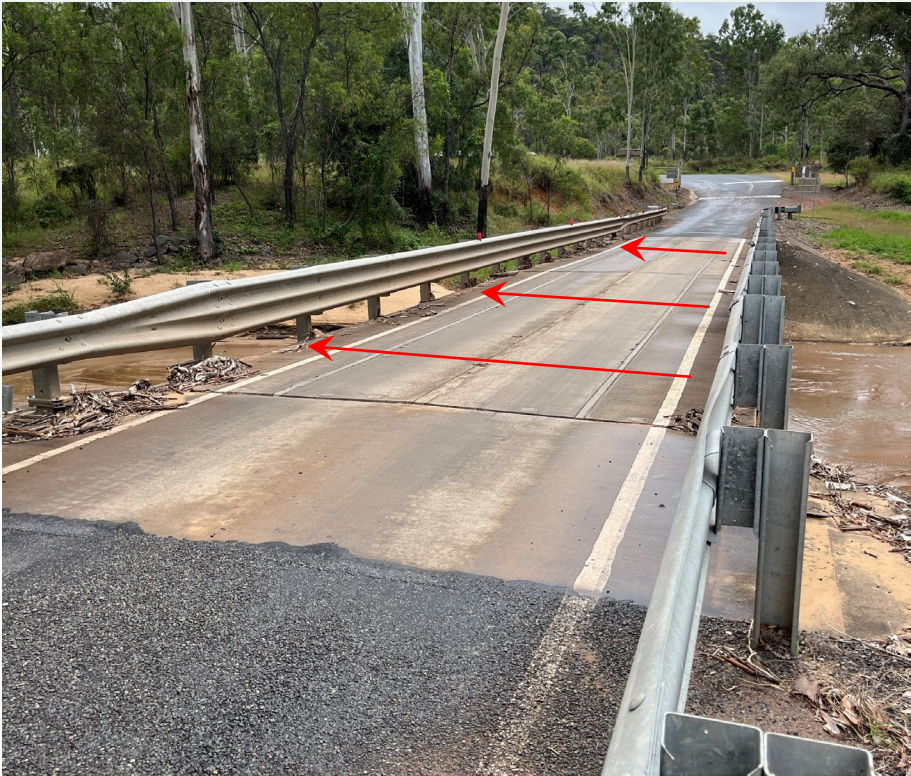
Bridge Deck – Cross Section

This cross-sectional scan of the bridge deck reveals two clear layers of reinforcement, with the upper layer at approximately 70 mm depth and the lower around 130 mm, consistent with a 200 mm slab thickness. The spacing and pattern indicate individual rebar placement rather than mesh, confirming the slab’s reinforcement arrangement from the underside.

The bridge deck was found to be a reinforced concrete slab ~200 mm thick, spanning between the main girders. Scans of the underside of the slab provided a precise measurement of this thickness (the radar showed the concrete-to-air interface at ~200 mm depth across the deck). Within the slab, two layers of reinforcement were detected: one near the bottom and one near the top. The longitudinal GPR scans (running along the length of the bridge, i.e., parallel to traffic) primarily intersected the transverse deck reinforcement (the bars running perpendicular to traffic, which are often the primary reinforcement in the slab). These scans showed reflections corresponding to a top layer at 70 mm and a bottom layer at 130 mm. This two-layer

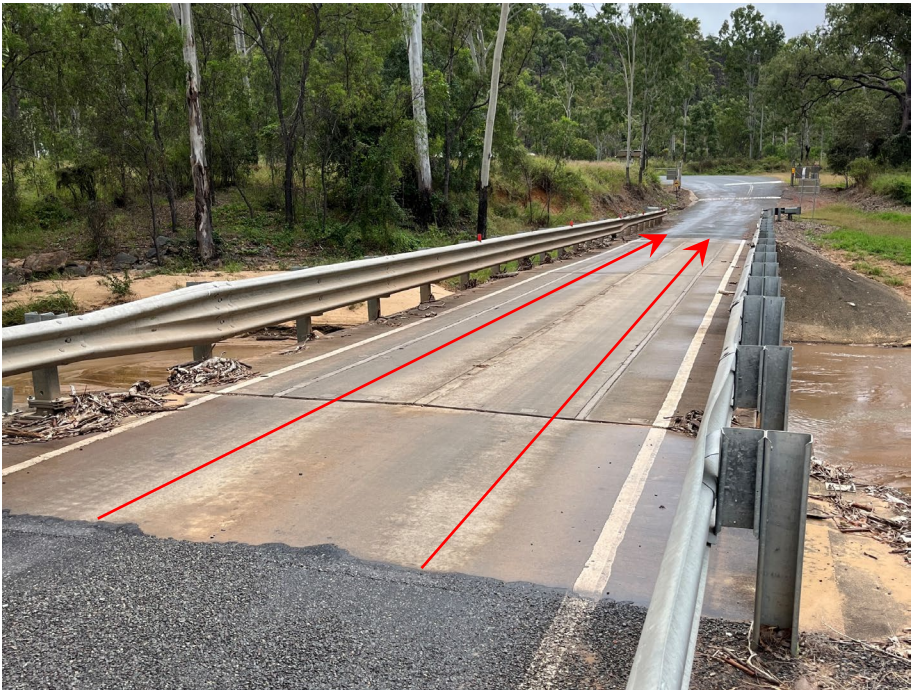
Bridge Deck – Longitudinal Scan

The longitudinal GPR scan shows a consistent series of hyperbolae representing transversely oriented bars at approximately 70 mm and 130 mm depths, validating the presence of two reinforcement layers. The relatively even spacing and depth align with manual bar placement, and no anomalies such as voids or delamination were detected.

Interestingly, the spacing of the slab bars (particularly the bottom layer as seen from below) did not appear perfectly uniform. The GPR intensity and spacing between hyperbolas varied, which suggests the deck likely uses individual rebar placed at designed spacings rather than a standard welded wire mesh. If mesh were used, one would expect very evenly spaced signals. Instead, the slight irregularity (some gaps slightly larger or smaller) points to manually placed rebar, which is common in cast-in-place bridge decks for flexibility in positioning. Crosswise scans (transverse to the bridge's length) were also performed on the deck soffit in a few locations. These scans (essentially looking for longitudinal running bars in the slab) predominantly picked up one layer of reinforcement at about 90 mm cover from the scanned face. The observed depth and spacing align with the anticipated design specifications. No anomalies (such as large voids or missing bars) were noted in the slab; its construction seems consistent throughout.

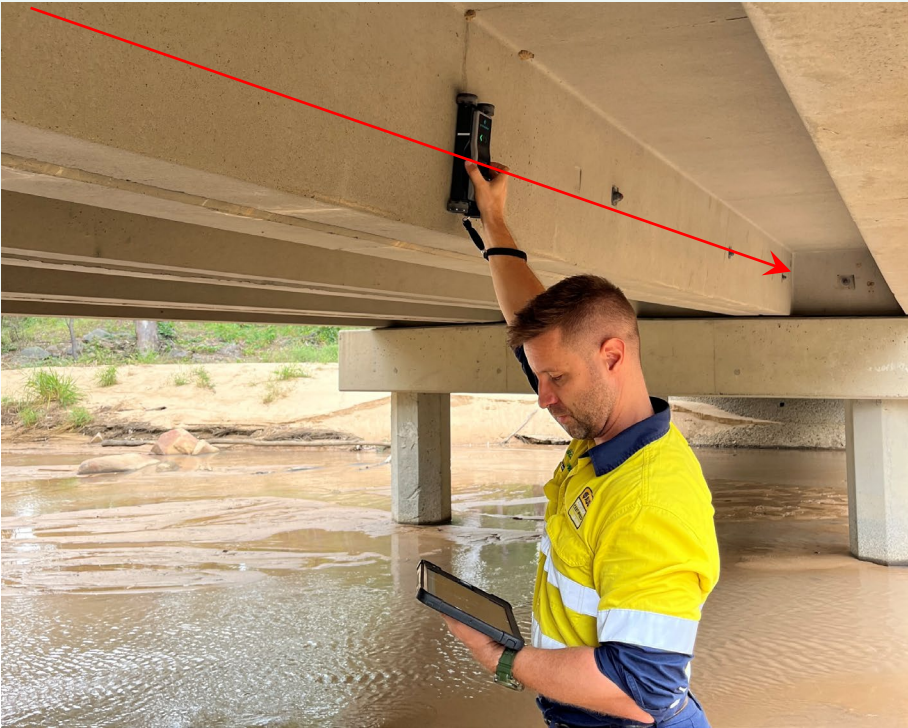
Profometer Data – Underside Beam Face

Consistent cover depths between 17–40 mm were recorded on the underside of the beam, again with diameter estimates centering around Ø36 mm. These results support the GPR findings and suggest robust, high-capacity reinforcement throughout the structure.

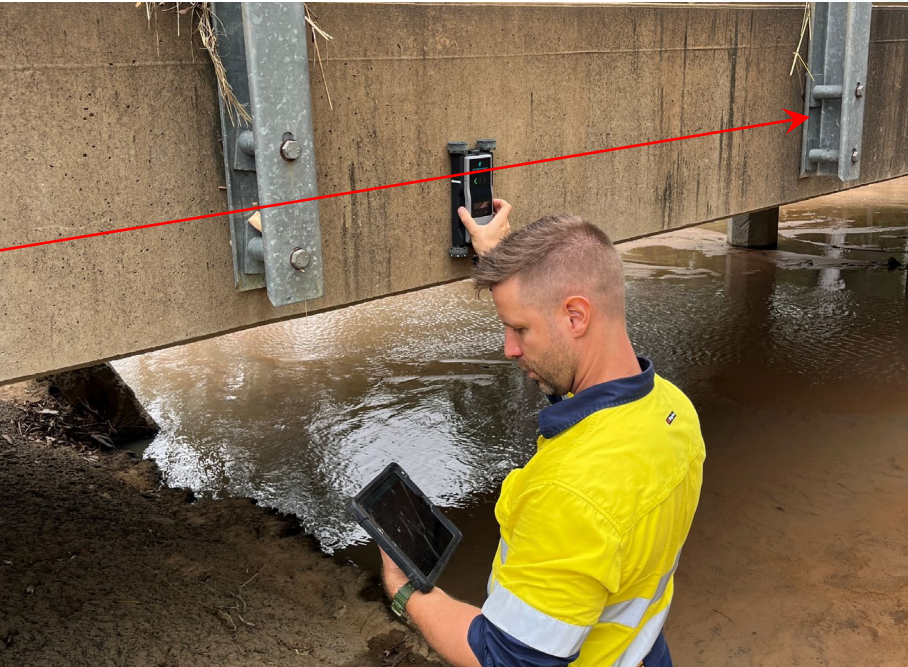
Profometer Data – Beam Face

Cover readings on the beam face ranged from 18–40 mm, with the Profometer estimating most bar diameters as Ø36 mm. While coil balance was inconsistent due to steel congestion, the results indicate using large-diameter bars in the beam's main reinforcement layer.
