## Site Report for QNP Moura

### Structural Assessment Report for QNP Moura

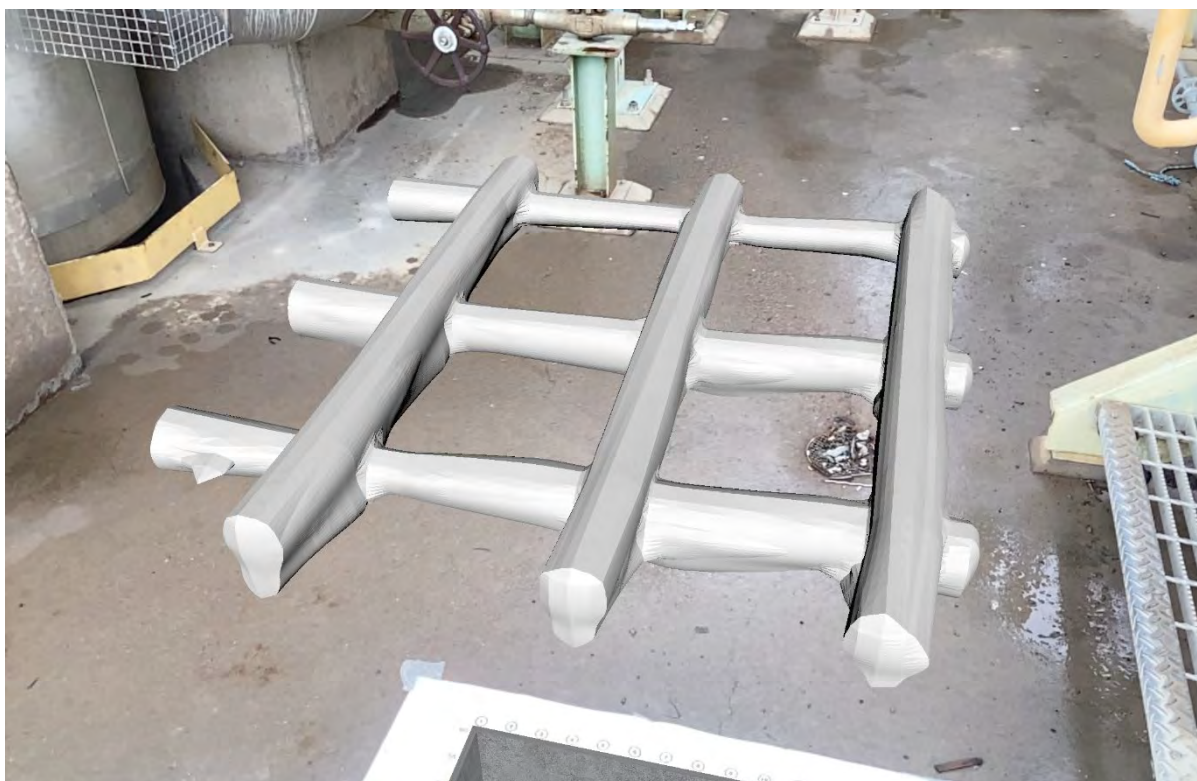
**Figure 11:** 3D visualisation of the scan data procured for Figure 9 above, confirming the overlap of the bars, including the placement of the east-to-west bars over the north-to-south bars (alternate angle)

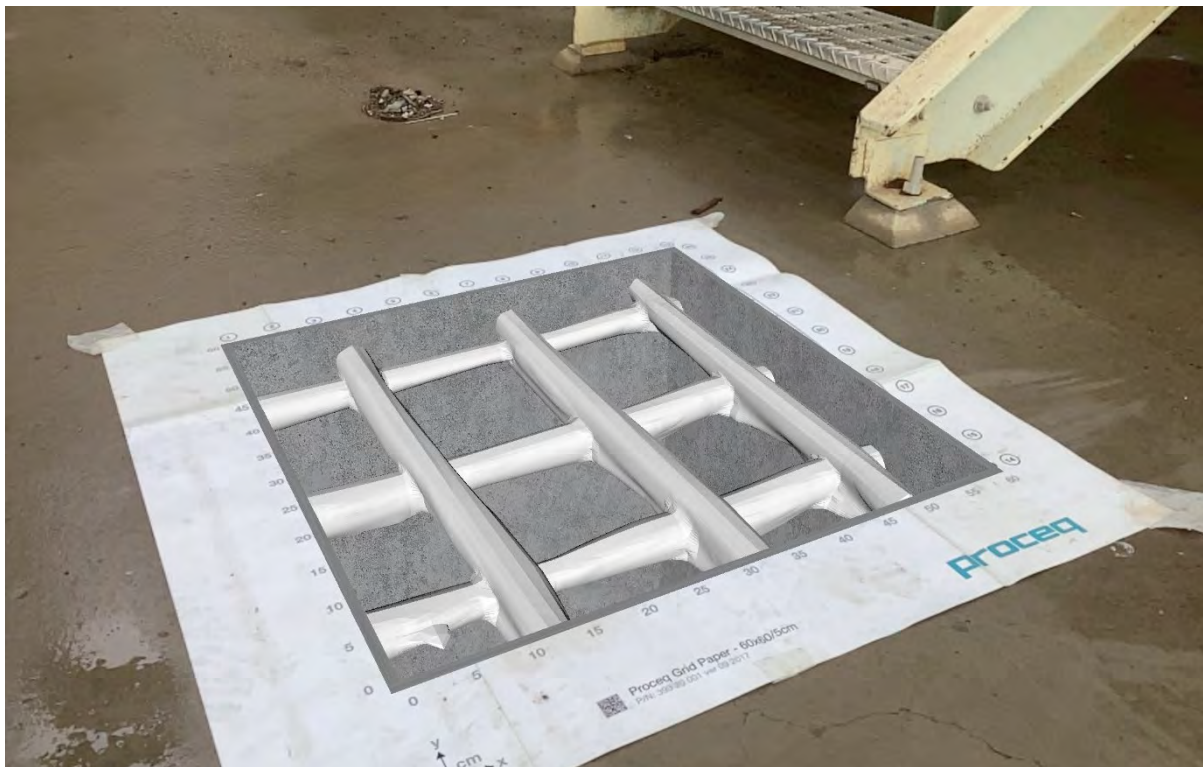
**Figure 12:** 3D visualisation of the scan data procured for Figure 9 above, confirming the overlap of the bars, including the placement of the east-to-west bars over the north-to-south bars (bars in place of scan over grid paper).

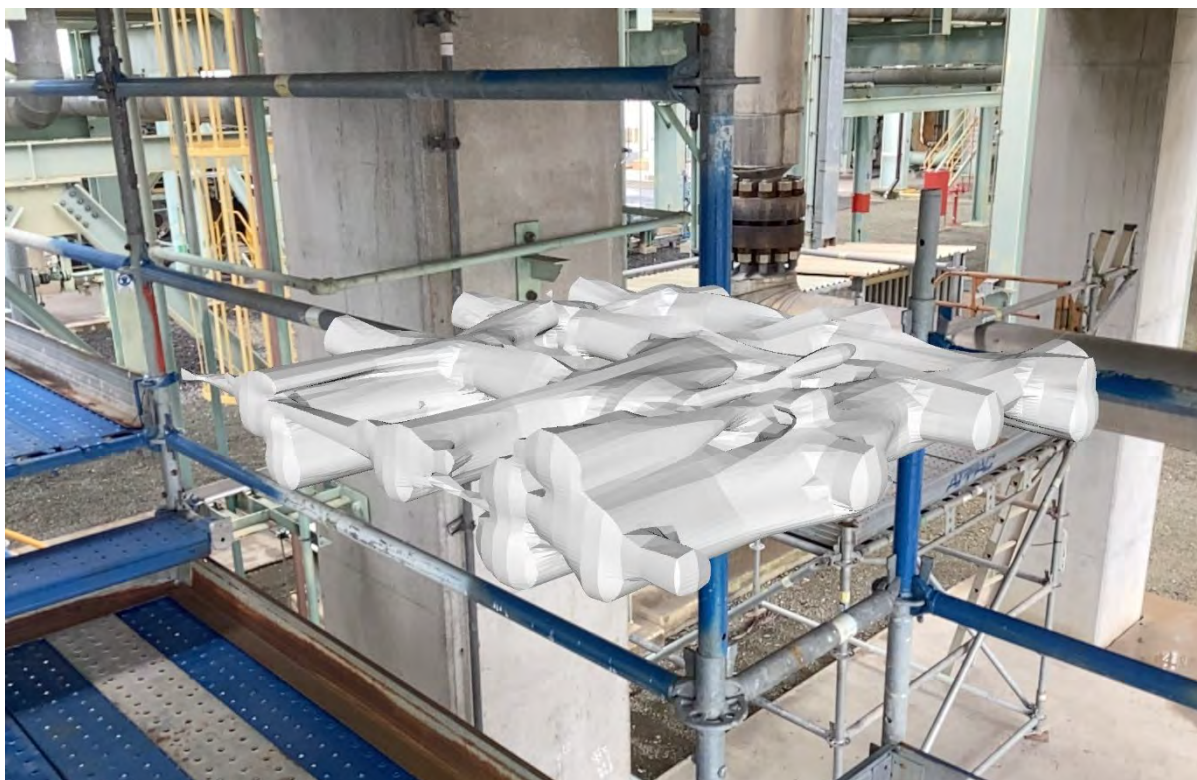
**Figure 14:** 3D visualisation of the slab underside, confirming the additional bar placements on the right of the image, strengthening the slab's centre in place of trimmer bars. The overlap of the multiple bars is visible.

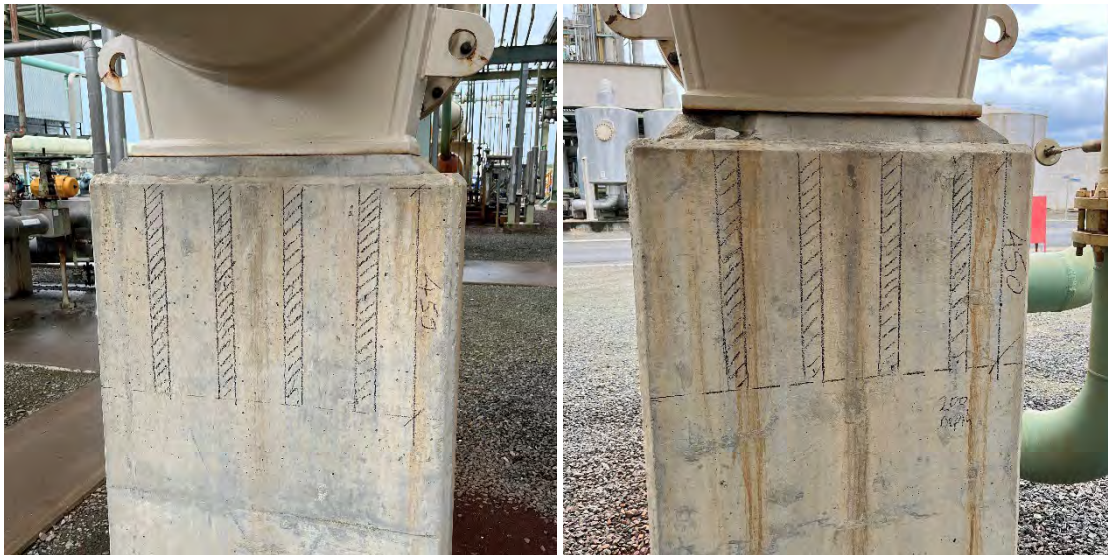
- Bolt penetration depth was measured at 450mm. See Figures 16 and 17 below.
- Post-processing analysis indicated minor dielectric variability within the plinth. However, the data beyond the reinforcement was insufficiently clear for a definitive assessment.
- Destructive testing, including drilling, will be necessary to verify the internal composition and homogeneity of the plinth.

**Figure 16:** Bolt penetrations detected using GPR scanning on the side of the pipeline plinths. The penetrations extended to approximately 450mm, placed in the centre of the plinth with ~200mm of concrete cover.

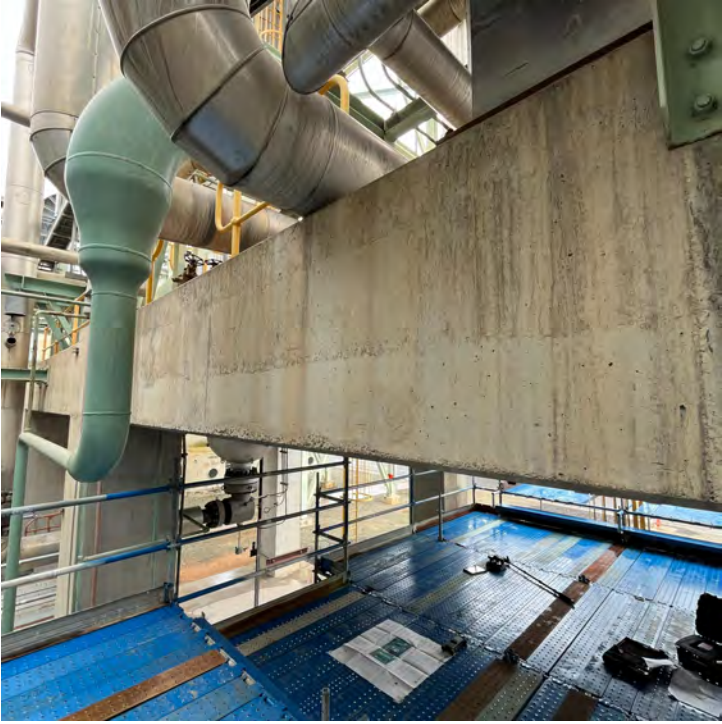
Site photo 9

- **Horizontal Scans (X-axis):** Reinforcement bars were detected with close spacing, ranging between 100mm and 200mm. The cover depth alternated between 50mm and 100mm in different sections.
- **Vertical Scans (Y-axis):** Four horizontal reinforcement bars, with cover depths ranging from 75mm to 120mm, were identified.
- See site photos 9 and 10 below for the scanning location.

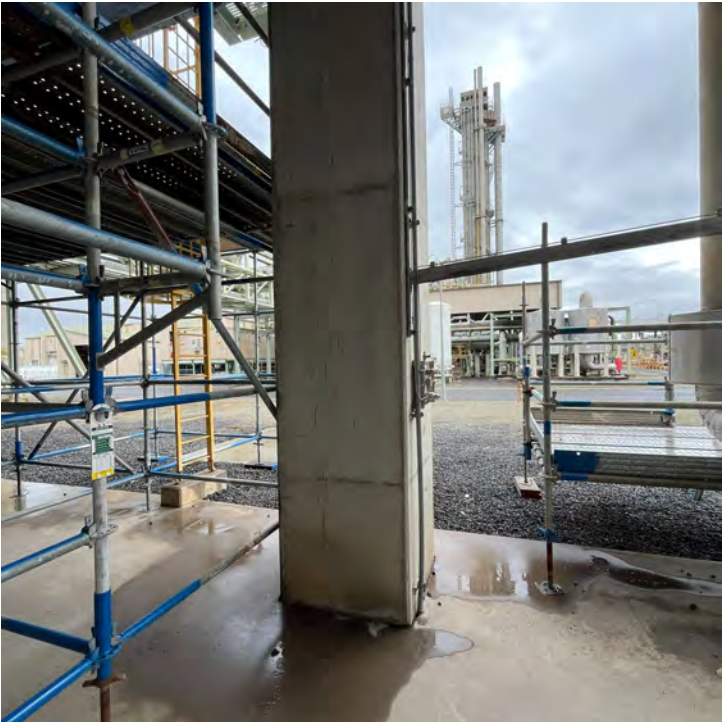
Site photo 11

- The four supporting columns contained horizontal reinforcement with 50mm concrete cover and spacings of 400mm.
- Vertical reinforcement comprised five bars, spaced approximately 200mm apart, with 75mm cover.
- See site photo 11 below for the scanning location.
