# SOUTH-EAST SCANNING

## GPR Concrete Scanning Site Report

**SITE ADDRESS:** Woolworths Robina North

Concrete scanning prior to fence installation

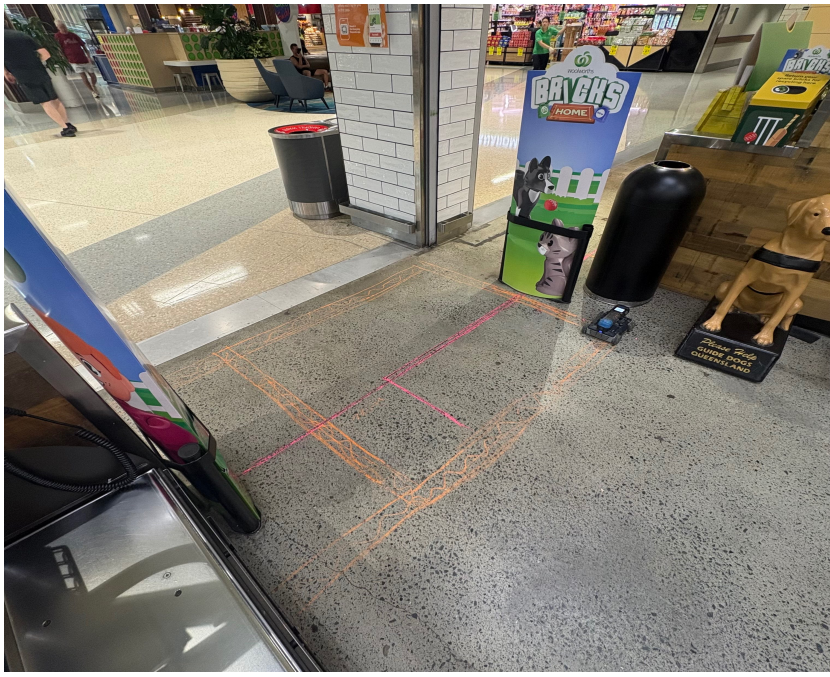
Location # 1

GPR scanning of the suspended slab identified an approximate slab thickness of 200 mm with reinforcement spaced at 200 mm centres and an estimated concrete cover of 40 mm. Post-tensioning (PT) tendons were identified and marked in orange. Low-voltage services associated with existing gate infrastructure were detected and marked in pink

Slab depth	200mm	+/- 20%
Reinforcement	200mm	
Services	Yes	
Post-tension cables	Yes	
Beams or footings	No	
Risk profile	Medium
